1. Report No. DOT/FAA/CT-90-10		2. Government Accession No.		3. Recipient's Catalog No.	
4. Title and Subtitle FUSELAGE BURNTHROUGH FROM LARGE EXTERIOR FUEL FIRES				5. Report Date July 1994

6. Performing Organization Code ACD-240	
7. Author(s) Harry Webster				8. Performing Organization Report No. DOT/FAA/CT-90-10	
9. Performing Organization Name and Address Federal Aviation Administration Technical Center Atlantic City International Airport, NJ 08405				10. Work Unit No. (TRAVIS)

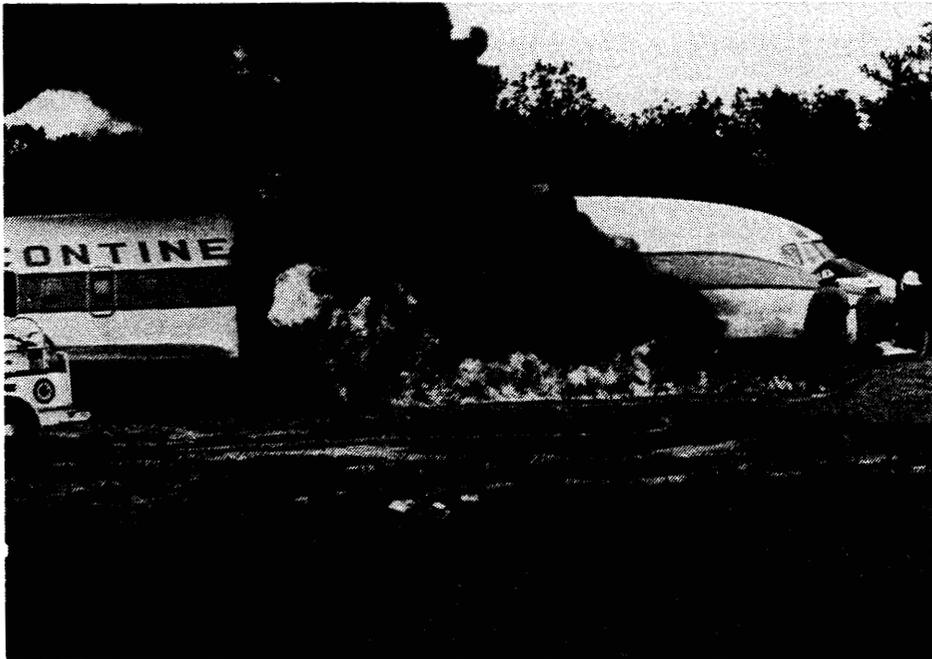
FIGURE 5. TEST 2 DC-8 FLAME EXPOSURE

FLAME IMPINGEMENT. The flame plume was blown against the fuselage and aft by a light wind that measured a steady 3 knots. This shifted the fire towards the rear of the compartment. The exterior baffles prevented the flame from damaging the center compartment. The fuselage was exposed to flame that extended from station 440 forward to station 284 at which point the flame trailed off toward the cockpit (figure 5). Instrumentation locations are shown in figure B-1. The fire temperatures measured at the windows (station 287 and 241) ranged from 1500 to 1800 °F (figures B-2 and B-3). The fire temperature measured at station 226 peaked at 1800 °F, while the fuselage skin at this location only reached 600 °F (figure B-4). The forward calorimeter located at station 228 registered a peak heat flux of 5.8 BTU/FT²-second and the aft calorimeter registered a peak value of 16.8 BTU/FT²-second foot (figures B-5 and B-6).

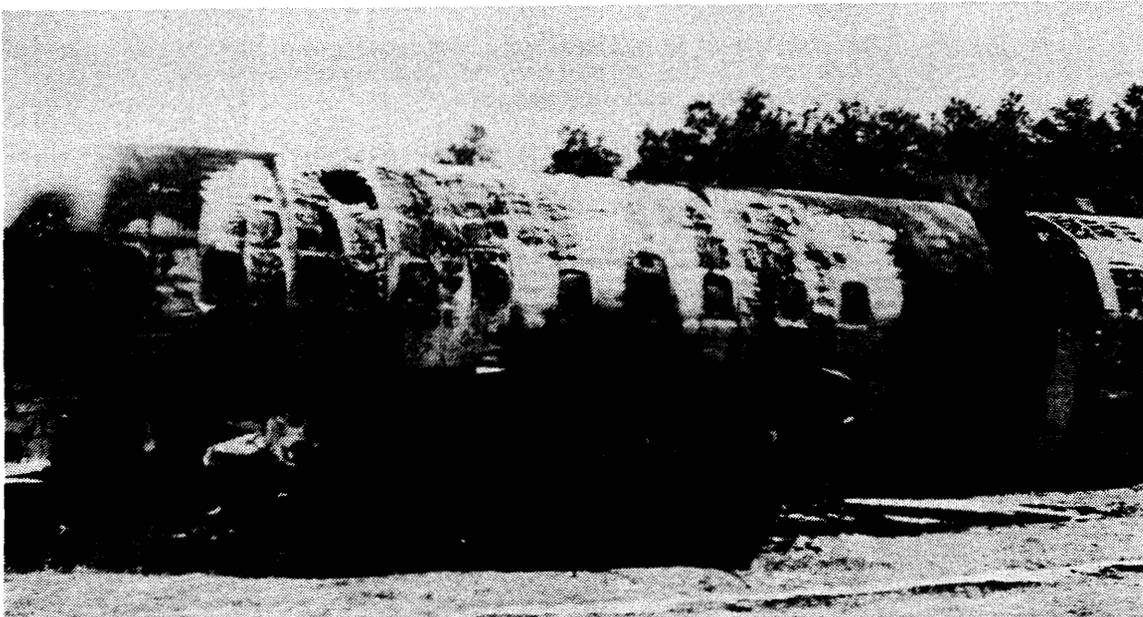
FIGURE 6. TEST 3 DC-8 CENTER SECTION FIRE DAMAGE

Skin Penetration. The skin aft of the wing (enclosing the wheel well) was completely melted away up to the top of the well (figures 6 and C-7). There was a small hole above the wheel well that went through the skin between the top of the wheel well and the cabin floor. Forward of the wing root the skin in the cheek area was melted through and the cargo liner was exposed. The liner was heavily charred but not penetrated. The window located directly above the trailing edge of the wing was completely consumed, allowing flame penetration into the cabin. The other windows exhibited varying degrees of damage but did not allow penetration. The skin both forward and aft of the wing above the melted sections was wrinkled and perforated. Both overwing exits were operable after the test. There was a 2- by 2-foot section above the trailing edge of the wing into the overhead section of the aircraft where the skin completely melted away.

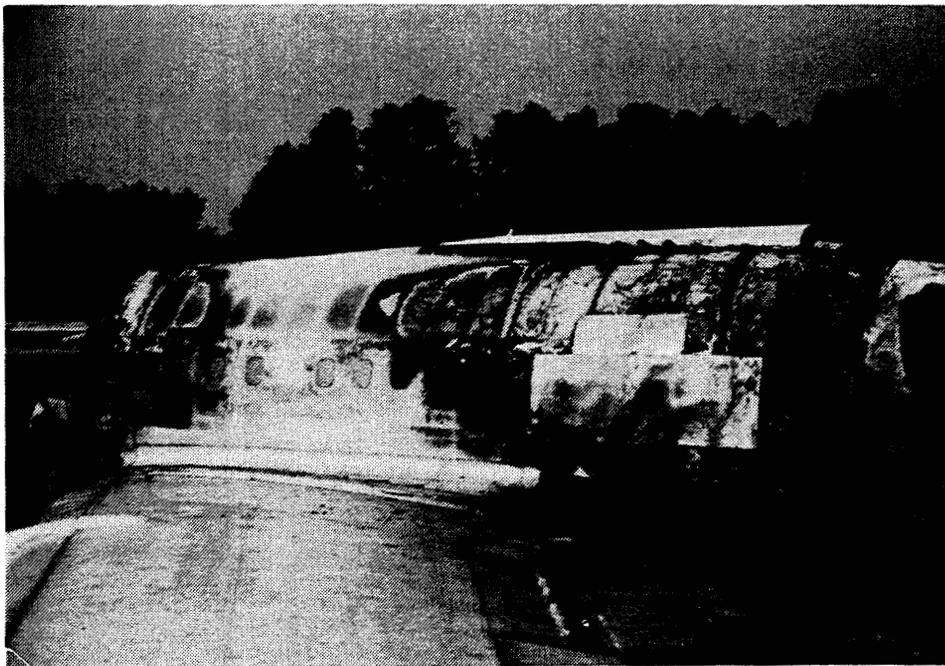
FIGURE 15. CV-880 PORT SIDE FIRE DAMAGE

Skin Penetration. The port side skin that was forward of the leading edge of the wing was completely burned away up to the top of the fuselage (figures 15 and F-7). The windows in this area (station 584) were completely burned through. The windows over the wing were charred but not penetrated. The skin aft of the wing was also burned away with damage extending forward to station 884. The exposed ribs at the aft end were buckled. The windows aft of the wing had their outer pressure panes completely burned away, but the inner fail-safe panes were

not penetrated. The insulation exposed by the melted skin on the fire side was charred but intact. The skin on the belly of the aircraft was heavily charred and buckled but not penetrated except forward and aft of the wing. The starboard side sustained damage similar to the port side (figures 16 and F-8). The skin aft of the wing was completely melted away exposing the insulation. The windows aft of the wing were burned through to the interior. The section forward of the wing also had the skin completely melted. The windows in this section had the pressure panes burned away with the fail-safe panes charred but not penetrated. The insulation throughout was heavily charred but intact.
