GENERAL MOTORS NORTH AMERICA  
Structure & Safety Integration

**Re: Petition for Determination of Inconsequential Noncompliance**

GM has determined that certain 2004 model year Saab 9-3 Sport Sedans and Convertibles may not comply with S4.2(b) of Federal Motor Vehicle Safety Standard No. 114 (FMVSS-114). Some of these vehicles were produced with an ignition key assembly that may contain a center spring plate switch that can bind in the closed position. This switch communicates to certain vehicle systems that the ignition key has been inserted or removed from the ignition switch. When this switch binds in the closed position, certain systems will read that the ignition key is still in the ignition switch, even after ignition key removal. One of the systems using the input from this switch is the electronic steering column lock. Manual transmission variants of the Saab 9-3 are equipped with this electronic locking steering column to meet the S4.2(b) requirement of FMVSS 114. If a subject vehicle has the aforementioned condition, the steering column will not lock upon ignition key removal.

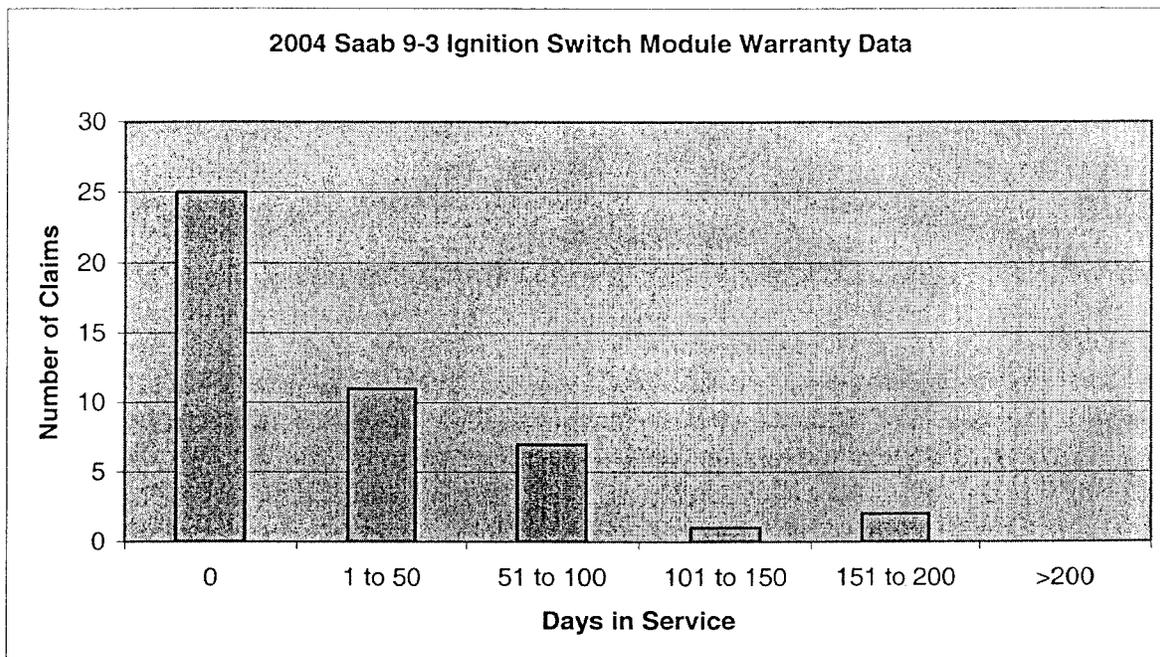
- *Failure Occurs Early and only a Small Percentage of Vehicles are Affected* - If this condition is present, it is most likely to occur very early in the vehicle's life. In an analysis performed by the component supplier (Delphi), it was estimated that of the components affected by this condition, 85% would fail within the first month and 99% would fail within six months. Most occurrences have been and will be caught prior to retail delivery. The following chart is based on warranty data from the Saab Cars USA, Inc. warranty system. Shown in this chart are the numbers of warranty claims for the subject condition against the number of days that the vehicle was in service when the repair was made. Zero (0) days indicate that the repair was performed prior to retail delivery.

It has been estimated by the supplier of the ignition switch assembly that as of the end of April 2004, a maximum of 15 additional vehicles might experience this condition. Saab warranty data shows that 4 warranty repairs have been performed since May 1, 2004. Therefore, based on this projection, a maximum of 11 additional units could be expected to be subject to this condition. We would expect any of these additional instances to occur over the next few months.
