FAA-04-19221-6

# Airworthiness Concern Sheet

| | <b>Reason for Airworthiness Concern:</b><br>The Federal Office for Civil Aviation (FOCA) of Switzerland has issued Airworthiness Directive (AD) HB 2004-330 to mandate Pilatus Service Bulletin PC-12 (SB) No. 32-017 dated August 3, 2004. |

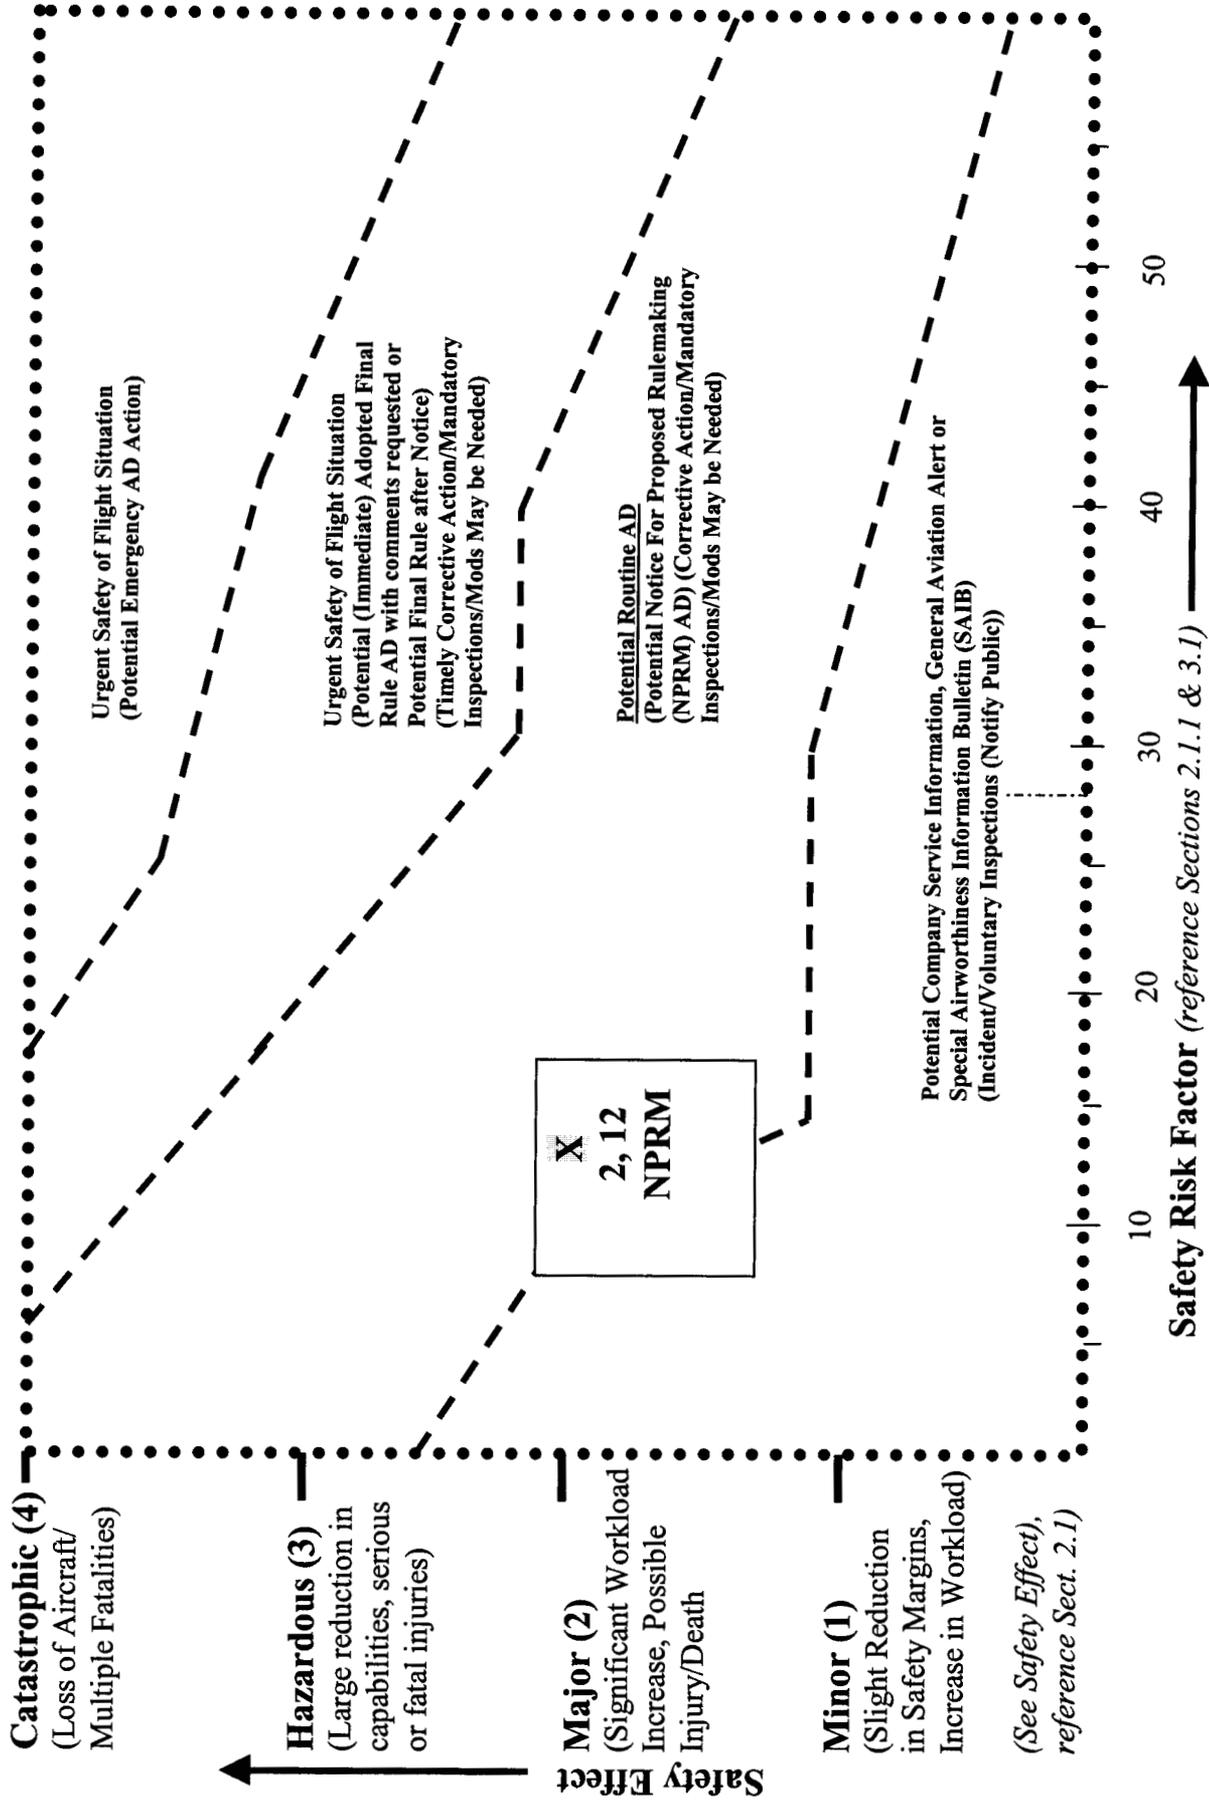
**Figure 1. Initial Risk Assessment Evaluation Chart (IRAEC)  
Pilatus PC-12 MLG actuator**

| (A) | <b>Safety Effect:</b> | Potential Outcome – Major | (2) |
| (B) | <b>Operational Use:</b> | Part 135/121 | (3) |
| (C) | <b>Percentage Use:</b> | Population < 25% | (1) |
| (D) | <b>Number of Occurrences:</b> | 1 to 3 | (1) |
| (E) | <b>Events vs. Population:</b> | 1% | (1) |
| (F) | <b>Time between events:</b> | Less than 1 year | (2) |
| (G) | <b>Aircraft type:</b> | Turboprop | (2) |

$$(2 \times 3 \times 1) + 1 + 1 + 2 + 2 = 12$$

**Safety Risk Factor = 12**
