# The Response of Aircraft Oxygen Generators Exposed to Elevated Temperatures

November 2002

DOT/FAA/AR-TN02/

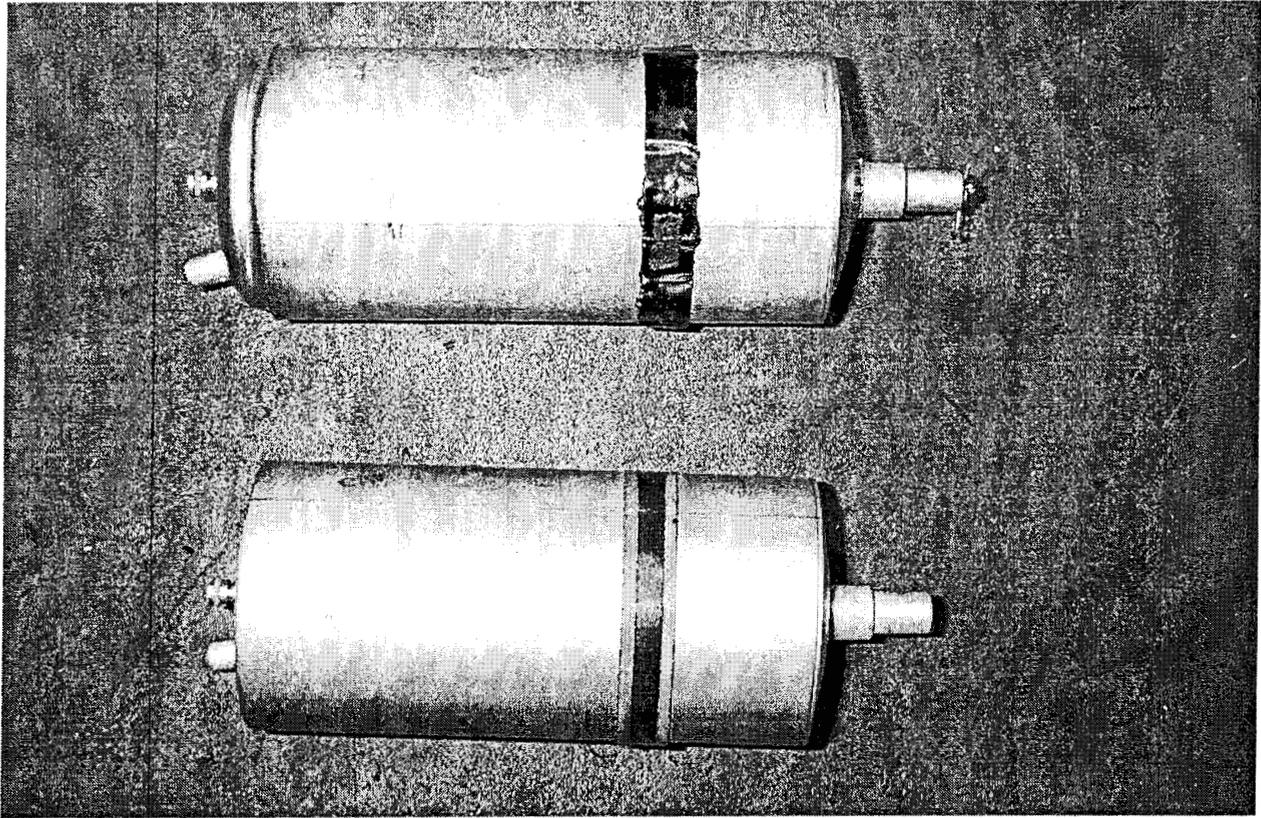
FIGURE 2. OUTWARDLY BULGED GENERATOR AND NORMAL GENERATOR

activated. Figure 2 shows the outwardly bulged generator from test 18 next to a normal generator. Table 1 summarizes the results of the testing.

1. Activated after 5 minutes but flow rate was much lower than normal.
2. Flow rate through normal outlet was much lower than normal. Oxygen also leaked out of primer cap end and generator body bulged outward due to internal pressure.

1. Exposure to furnace temperatures at or above 600°F was necessary to cause the self-activation of sodium chlorate oxygen generators.
2. Exposure to a furnace temperature of 500°F for 3 hours did not cause activation of the particular generator designs used in this test project.
3. Due to the uncertainty of the self-activation temperature of primer caps or electrically activated ignition squibs in other generator designs not tested in this project and the literature data stating that decomposition could occur as low as 482°F, it is recommended that generators not be exposed to ambient temperatures above 400°F.
