**Attention Rules Docket No: FAA-2000-7909 Improved Flammability Standards for Thermal/Acoustic Insulation Materials Used in Transport Category Airplanes**

**COMMENTS TO DOCKET NO. FAA-2000-7909 - Improved Flammability Standards for Thermal/Acoustic Insulation Materials Used in Transport Category Airplanes (NPRM)**

**REPORT ON FUSELAGE  
BURNTHROUGH RESEARCH  
ADDRESSING INSTALLATION ASPECTS**

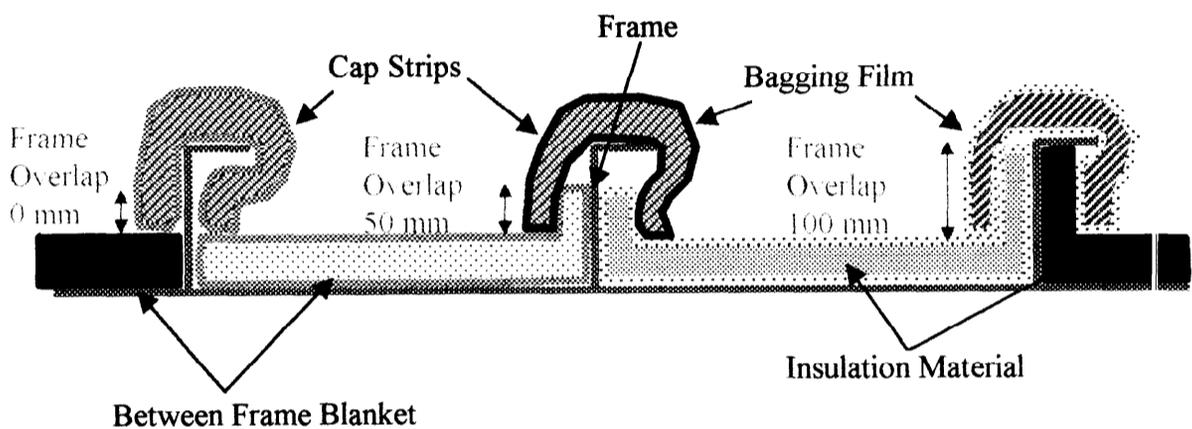
**Overlap at Frames:** The length of insulation material that abuts against fuselage frames as illustrated in Figure 1.

**Figure 1 Fuselage Panel and Thermal Acoustic Insulation Basic Configuration**

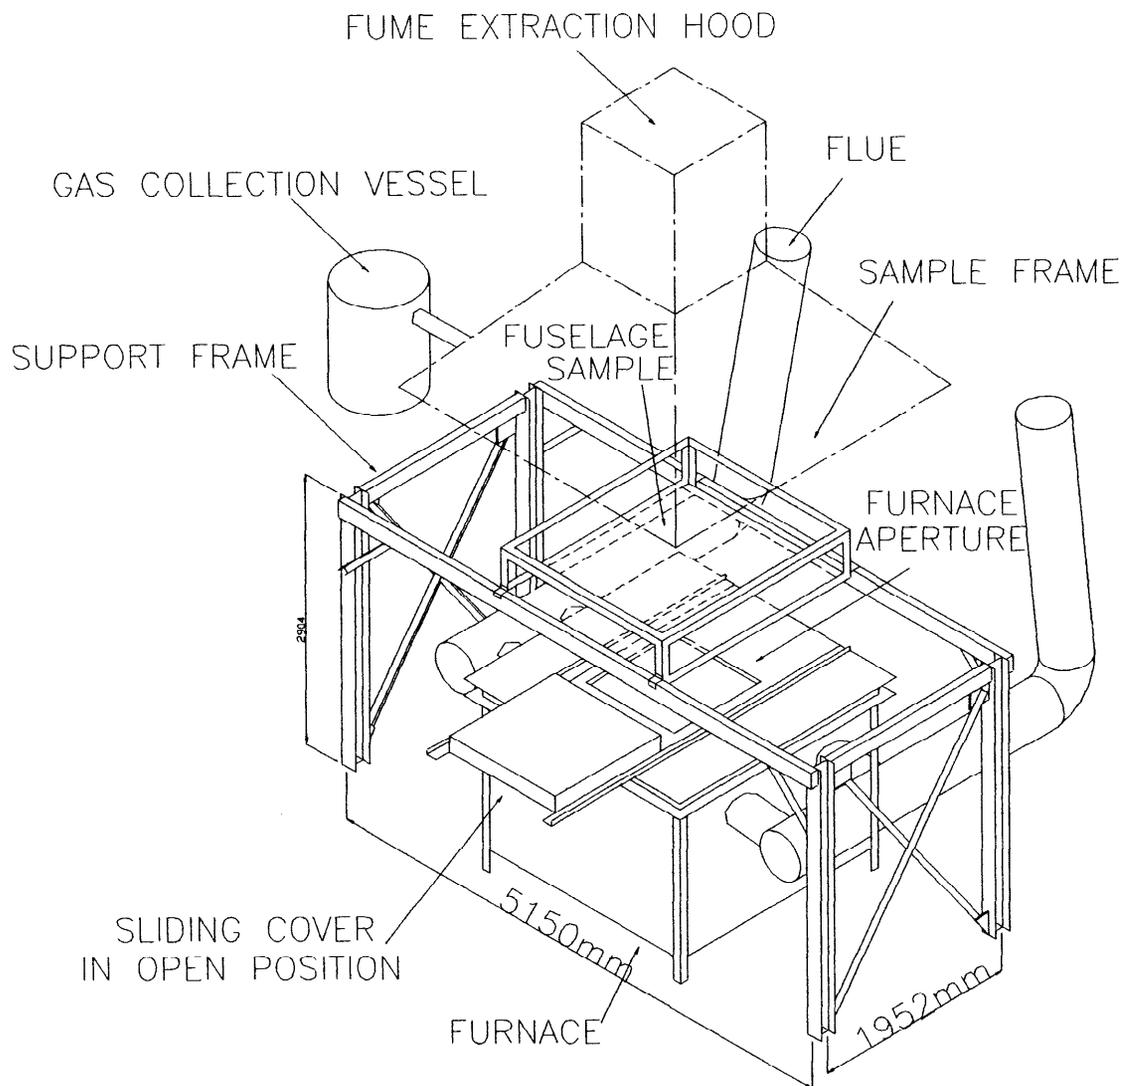
The burnthrough facility is a dedicated test furnace consisting of a mild steel frame and shell clad with 150 mm thick ceramic fibre insulation. Its internal dimensions are 2m x 2m x 1.5m high. The furnace is powered by four 300 kW propane burners which fire tangentially to ensure that energy is transferred efficiently to the furnace wall. The floor of the furnace is brick-lined to provide the required heat energy, both convective and radiative, in the correct proportions. The air and propane gas supplies are driven to the furnace by a fan and a pressurised gas supply, respectively.

The roof of the furnace incorporates a manually operated sliding lid which when rolled back reveals a 1 metre square aperture on the top of the furnace. The sliding lid section has a plug type sealing action onto a 25mm ceramic fibre gasket to ensure that no hot gases leak out during the furnace warm up period. The test piece is held in a frame 250 mm above this aperture and sliding lid. When the furnace is heated up to temperature and soaked, the insulated lid is rolled back, allowing instantaneous thermal assault to the test sample for the duration of the test. The results show that this method of storing energy and then releasing it provides repeatable test conditions.

The facility is also capable of monitoring smoke production. A light source and photoelectric cell are positioned opposite one another above the test sample. The amount of light detected by the cell is represented as a voltage. The voltage is directly proportional to the light intensity. The amount of smoke released is then indicated by the percentage reduction in light transmission. Full details of the facility and its commissioning are contained in CAA Paper 94002. A diagram of the facility is shown in Figure 3.

**Figure 3 Medium Scale Burnthrough Facility**

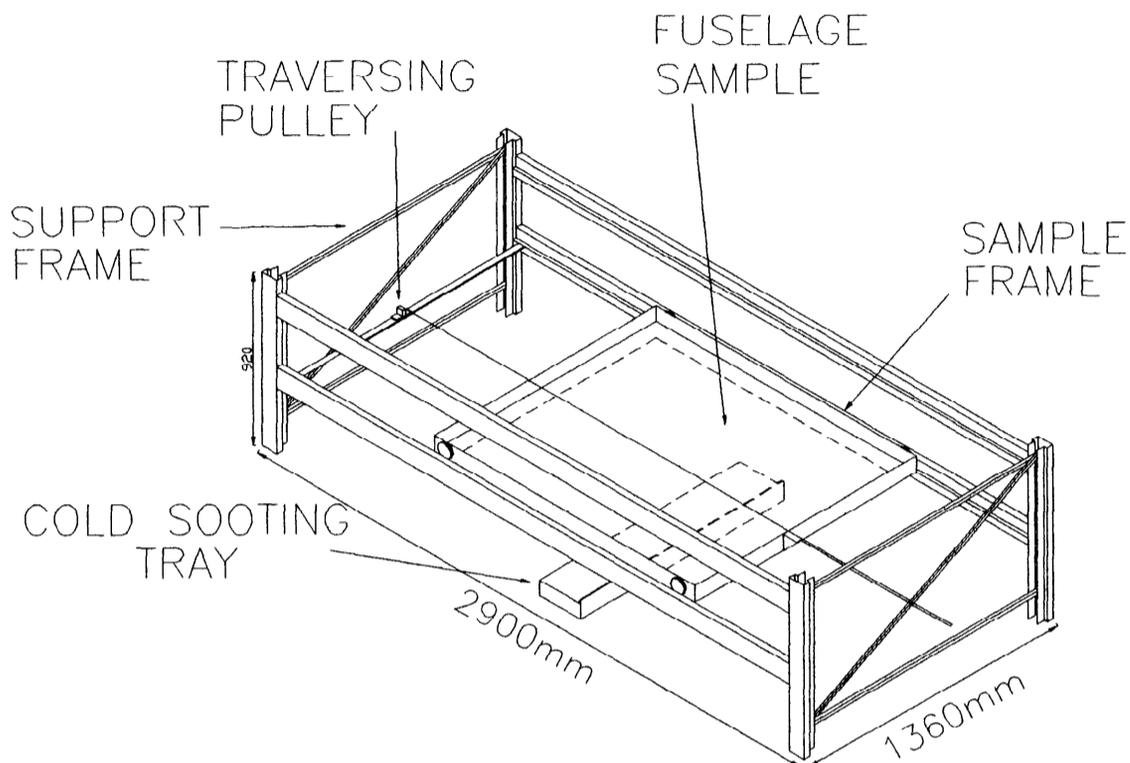
A tray is positioned centrally underneath the rig. The tray contains a strip of ceramic fibre material soaked in kerosene. A cover is positioned over the tray so that only a narrow strip of material protrudes. With the development of this cold sooting technique, materials can be pre-conditioned to an appropriate emissivity representative of a large-scale pool fire, before testing in the medium scale facility. Full details of the facility are contained in CAA Paper 94002 and a diagram of the facility is shown in Figure 4.

**Figure 4 Cold Sooting Facility**

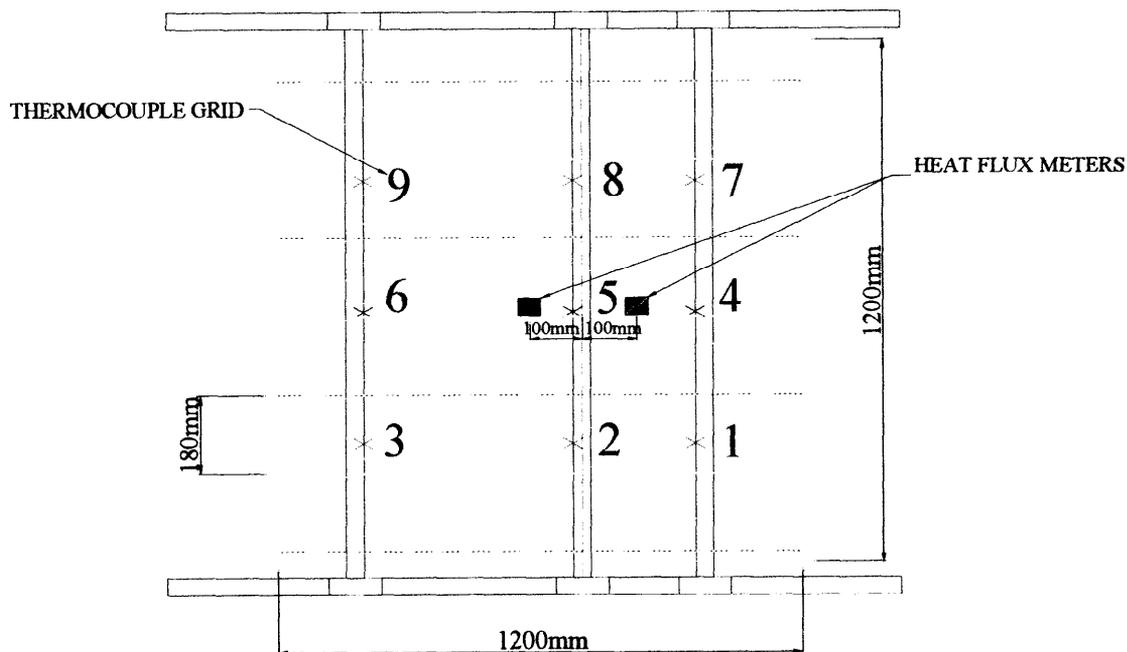
The original layout of thermocouple grid and heat flux measurement mounting platform utilised nine thermocouples and a single heat flux meter. This original configuration was modified during the test programme to allow for the addition of another heat flux meter. The revised configuration of the thermocouple grid and heat flux measurement sensors is shown in Figure 5.

The thermocouples used were metal-sheathed type k and were positioned at an approximate height of 100 mm from the hot face of the sample. The heat flux meters used were manufactured by the Vatell Corporation, model number Thermogauge 1000-1A FAA, and were positioned at a distance of approximately 100 mm from the centre of the test panel on either side of the central frame, approximately 250 mm above the hot face of the panel.

**Figure 5 Thermocouple Grid and Heat Flux Meter Position**

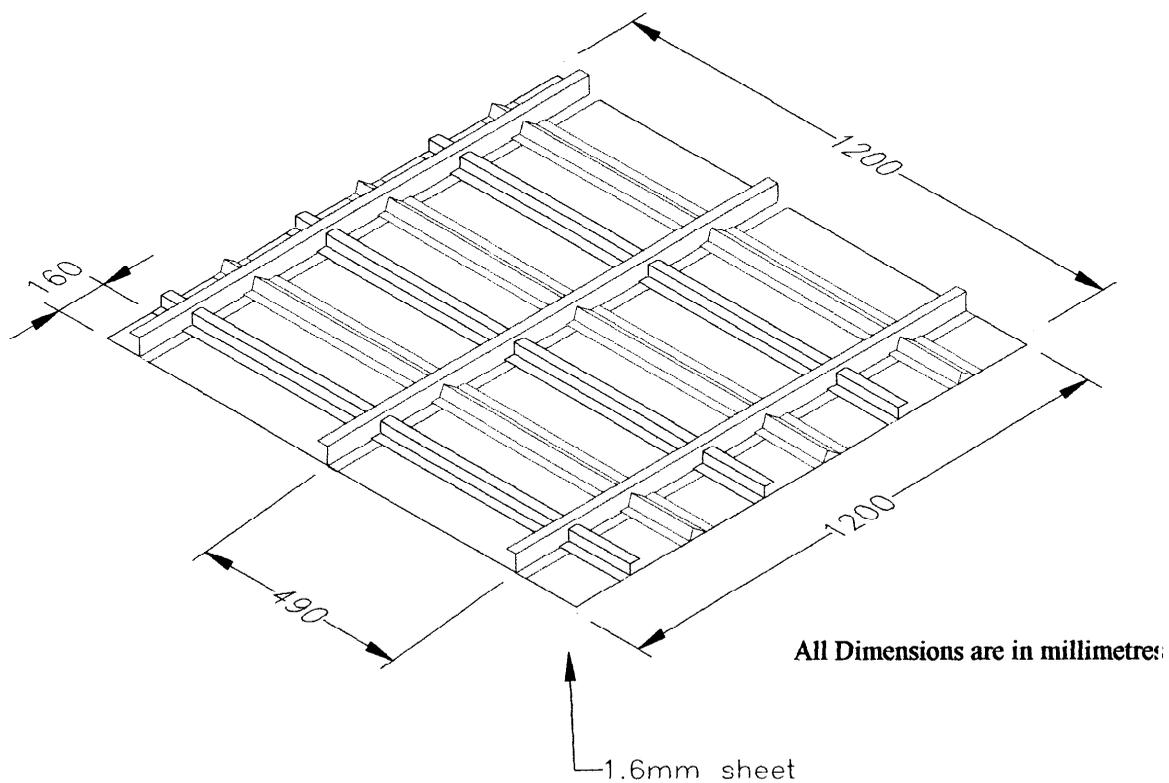
From studies of aircraft fuselages and as a result of discussions with the CAA and airframe manufacturers a stylised fuselage panel was constructed as shown in Figure 6, Figure 7, Figure 8 and Figure 9. Riveted onto a plain aluminium panel are a number of structural features typical of those employed in fuselage construction. These features comprise three frame members and a number of z section and top hat stringers running perpendicular to the frames. The size and positioning of these features are intended to be typical of those used on an aircraft.

No curvature was manufactured into the panel. Although there would be some curvature on an actual fuselage skin it was reasoned that given the size of the stylised panel any degree of curvature that was introduced, to represent more closely an actual fuselage, would be small enough that its omission would have a negligible effect on the test. The majority of the aluminium used in the construction of the stylised fuselage panel was typical aircraft grade aluminium, 2024-T3, and 1.6 mm thick. This was used in the plain aluminium sheet and the stylised frame members. The stylised stringers were constructed of commercial grade aluminium 0.8 mm thick.

**Figure 6 Isometric View of Stylised Fuselage Panel**

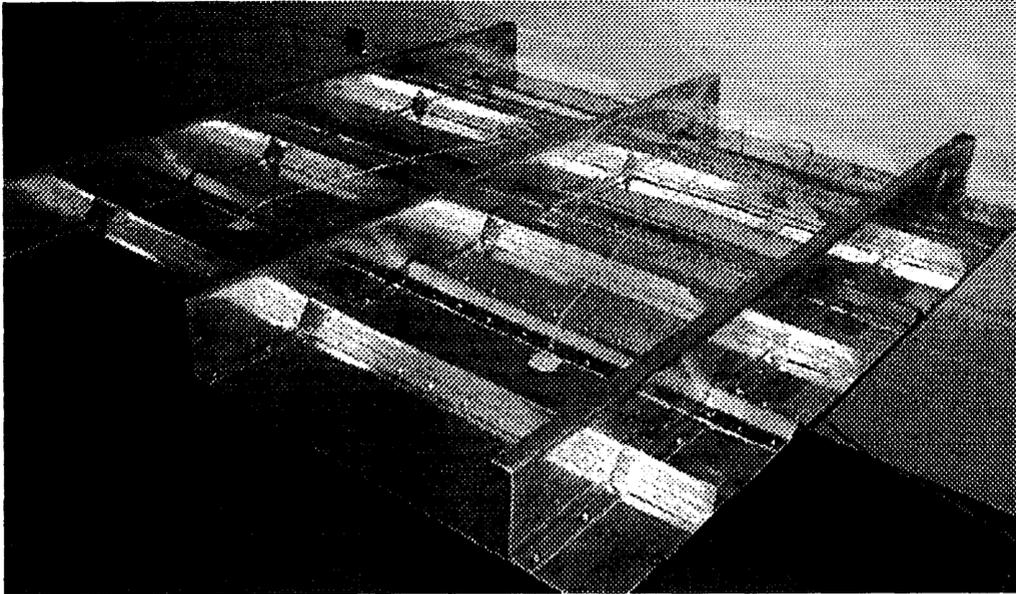
**Figure 7 View of Stylised Fuselage Panel**

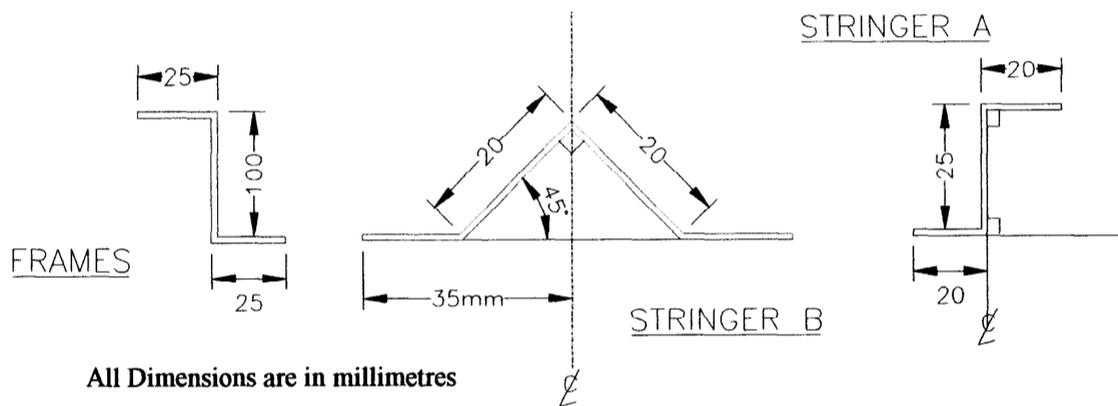
**Figure 8 Frame and Stringer Arrangement for Stylised Fuselage Panel**

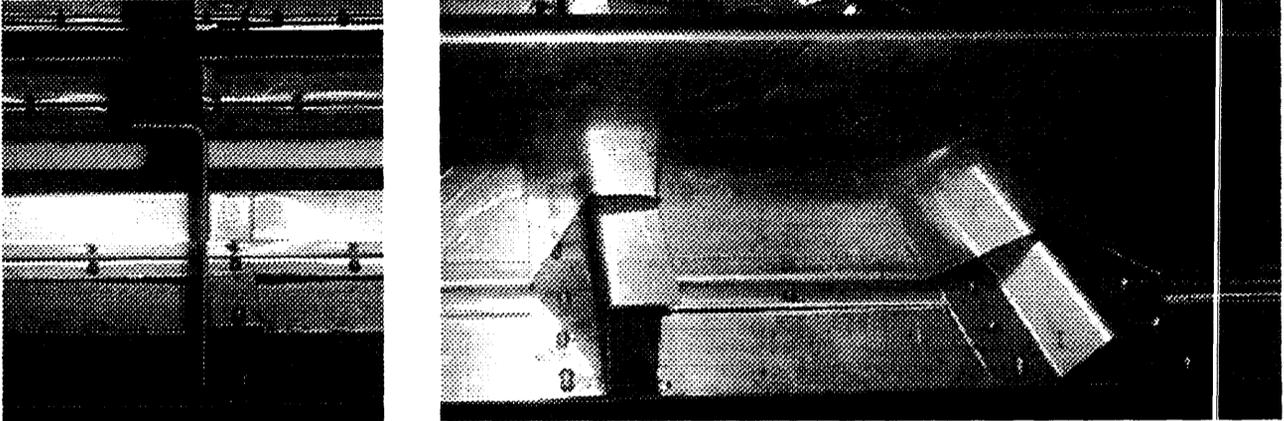
**Figure 9 Frame and Stringer Arrangement for Stylised Fuselage Panel**

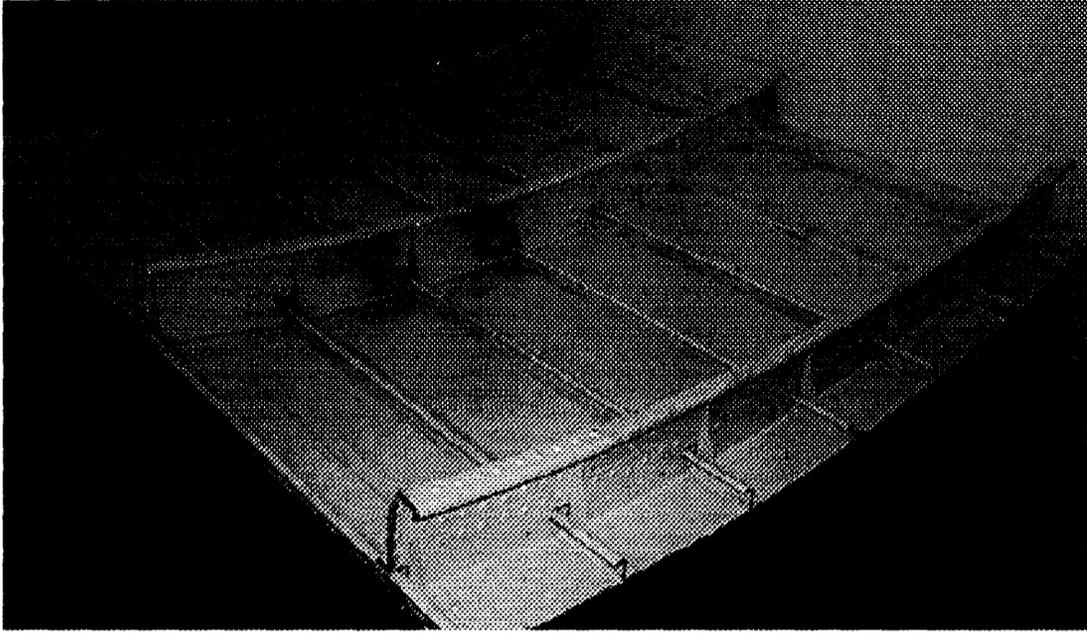
The aircraft panels used for the burnthrough tests were taken from cut-outs from an in-service aircraft that had undergone conversion to a freight aircraft. In an attempt to ensure consistency for each test all of the panels used were thoroughly cleaned before use and where possible the panels were chosen so that the configurations of frames and stringers were similar to the configuration of the stylised panel and each other. A typical aircraft panel is shown in Figure 10 and Figure 11.

**Figure 10 View of Actual Aircraft Panel**

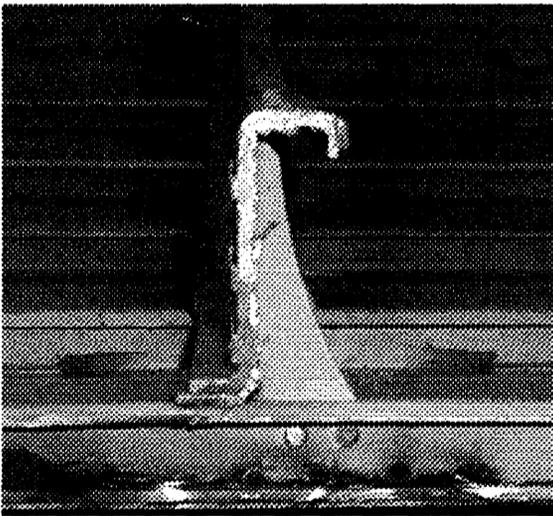
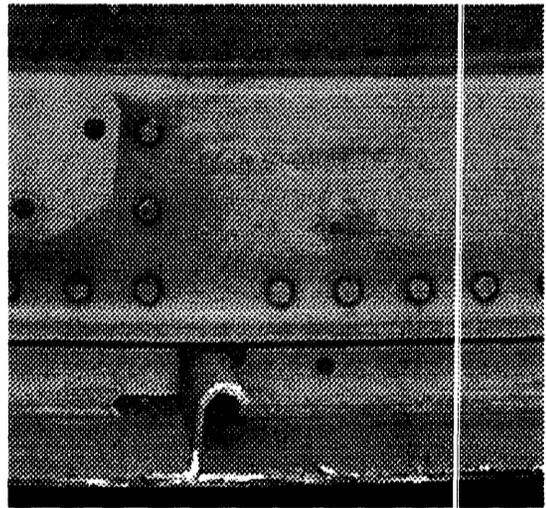
**Figure 11 Frame and Stringer Details on Actual Aircraft panel**

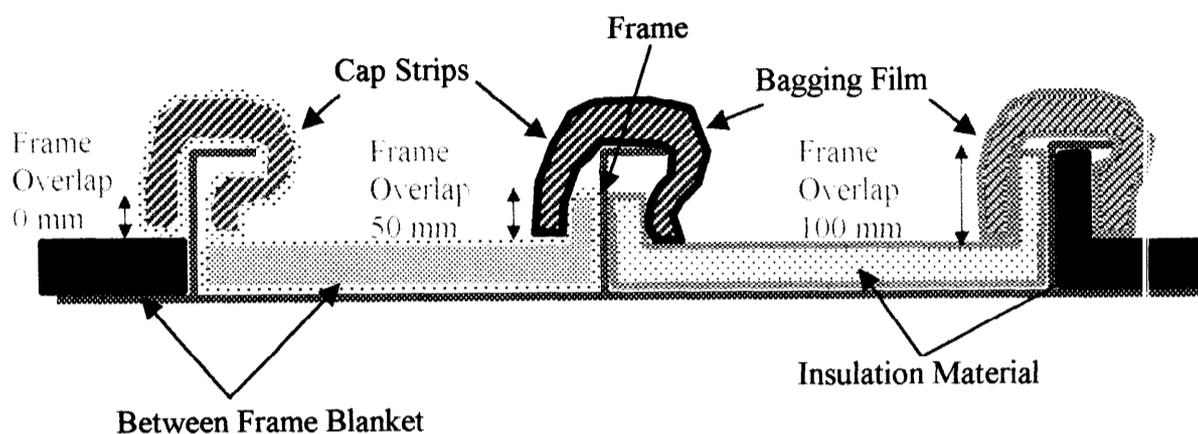
Although at this stage of the test programme a number of different configurations have been tested, the thermal acoustic insulation configuration used as the baseline is shown in Figure 12. This configuration comprises four between-frame blankets of two sizes, which cover the majority of the sample and three cap strips, which cover the frames.

**Figure 12 Thermal Acoustic Insulation Basic Configuration**

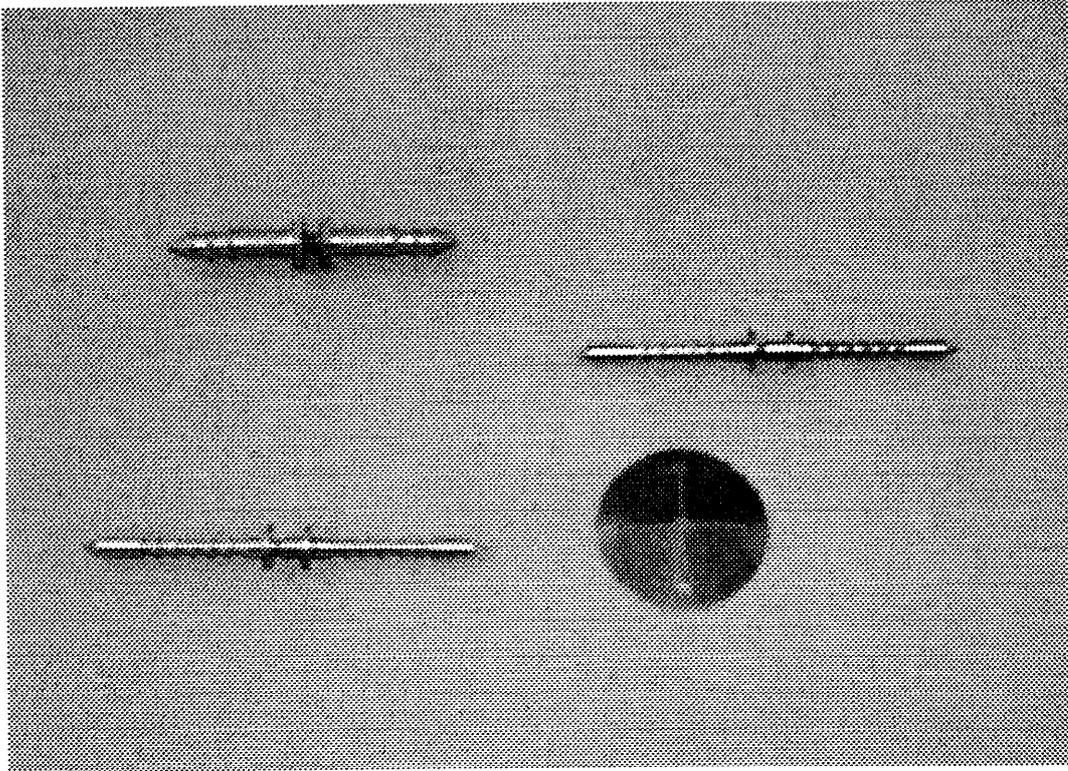
**Figure 14 Metallic Through Frame Fixing Component and Washer**

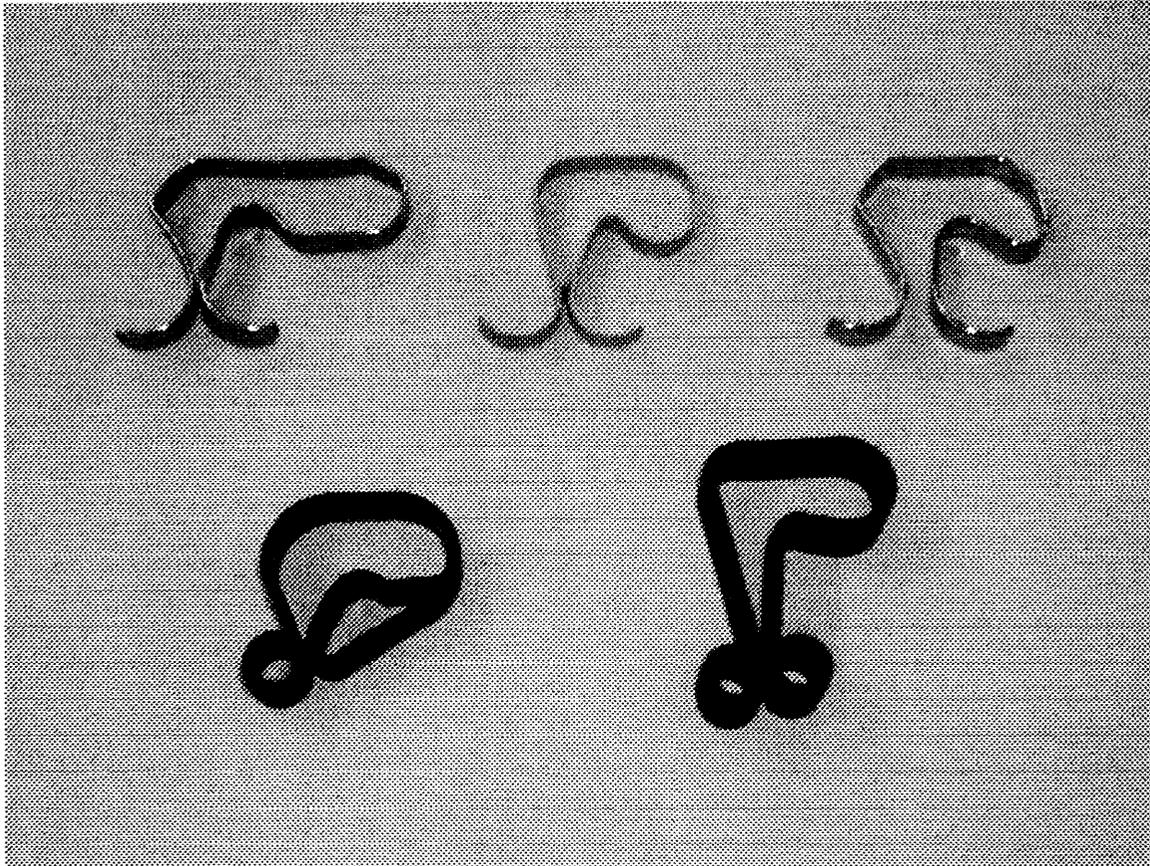
Over frame fixing clips are an attachment method by which a spring metallic or plastic component is located over the aircraft frame and mechanically holds the cap strip and the between frame blanket together at the frame. Typical over frame fixing clips are shown in Figure 15.

**Figure 15 Metallic & Plastic Over Frame Clips**

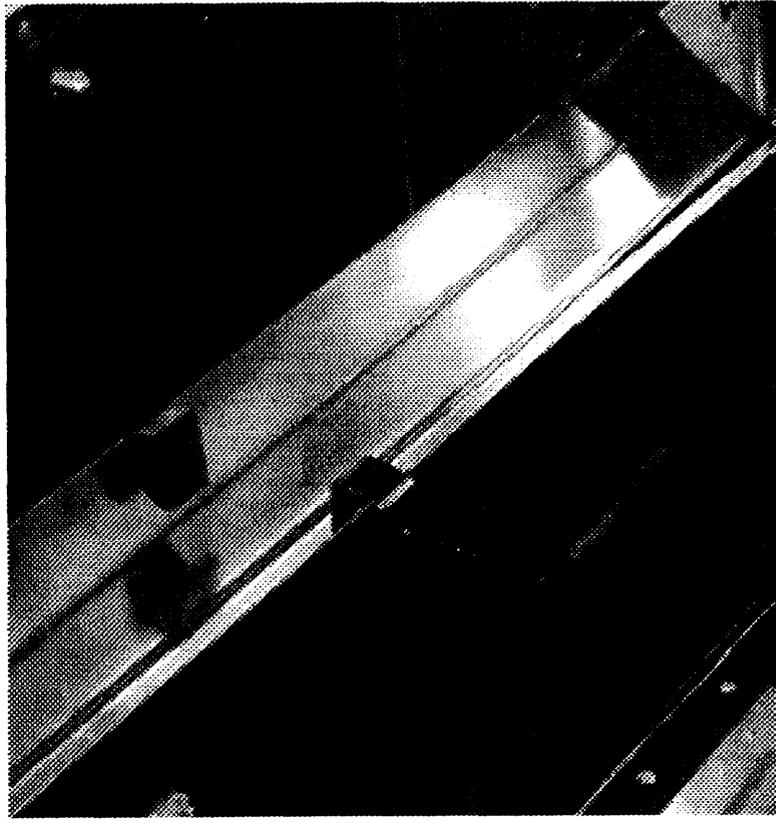
A typical stringer pin as located on the fuselage stringer and with insulation installed is shown in Figure 16 and Figure 17.

**Figure 16 Stringer Pin/Clip Attachments to Stringer**

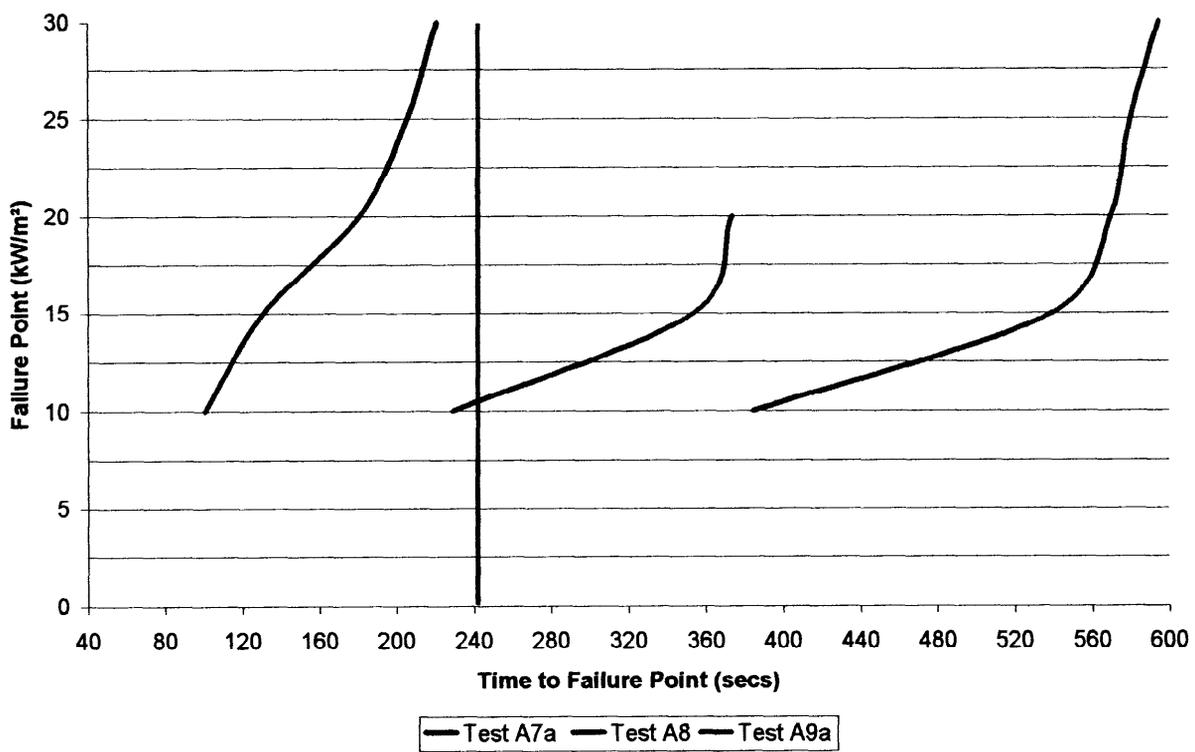
- ii) Figure 18 and Figure 19 illustrate the heat flux histories for seven tests. The target burnthrough time of at least 240 seconds is shown on both figures. It may be seen that tests A7a, B3, B4 and B8 did not meet the target burnthrough times (irrespective of the heat flux failure criteria). Tests A8, A9a and B9 were considered to have met the 240-second target burnthrough time for the insulation material. It may be seen that for all three of these successful tests, that the heat flux readings tend to rise rapidly in the range 15 to 20 kW/m<sup>2</sup>. The choice of 20 kW/m<sup>2</sup> as the failure criterion therefore has the advantage that small variations in the heat flux reading produce small changes in the derived burnthrough time. At lower heat flux levels small variations in the recorded values could result in larger variations in the derived burnthrough time.

**Figure 18 Phase 1 Failure Point Analysis**

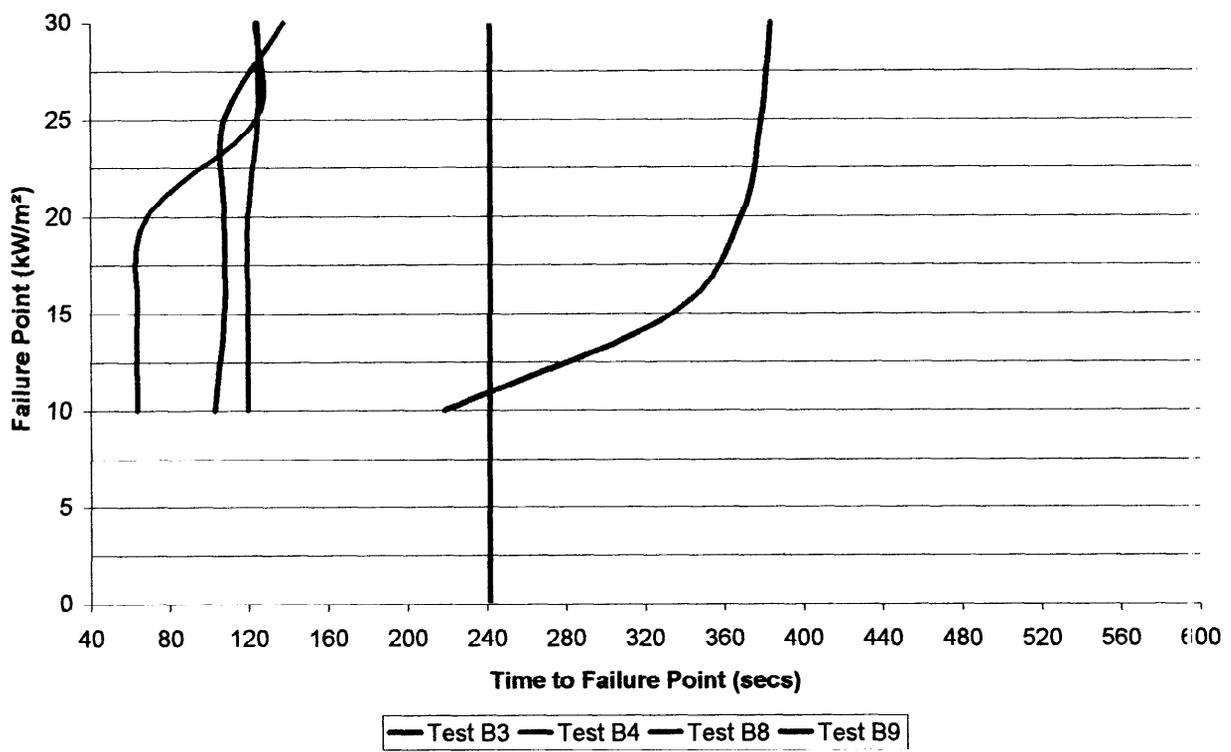
**Figure 19 Phase 2 Failure Point Analysis**

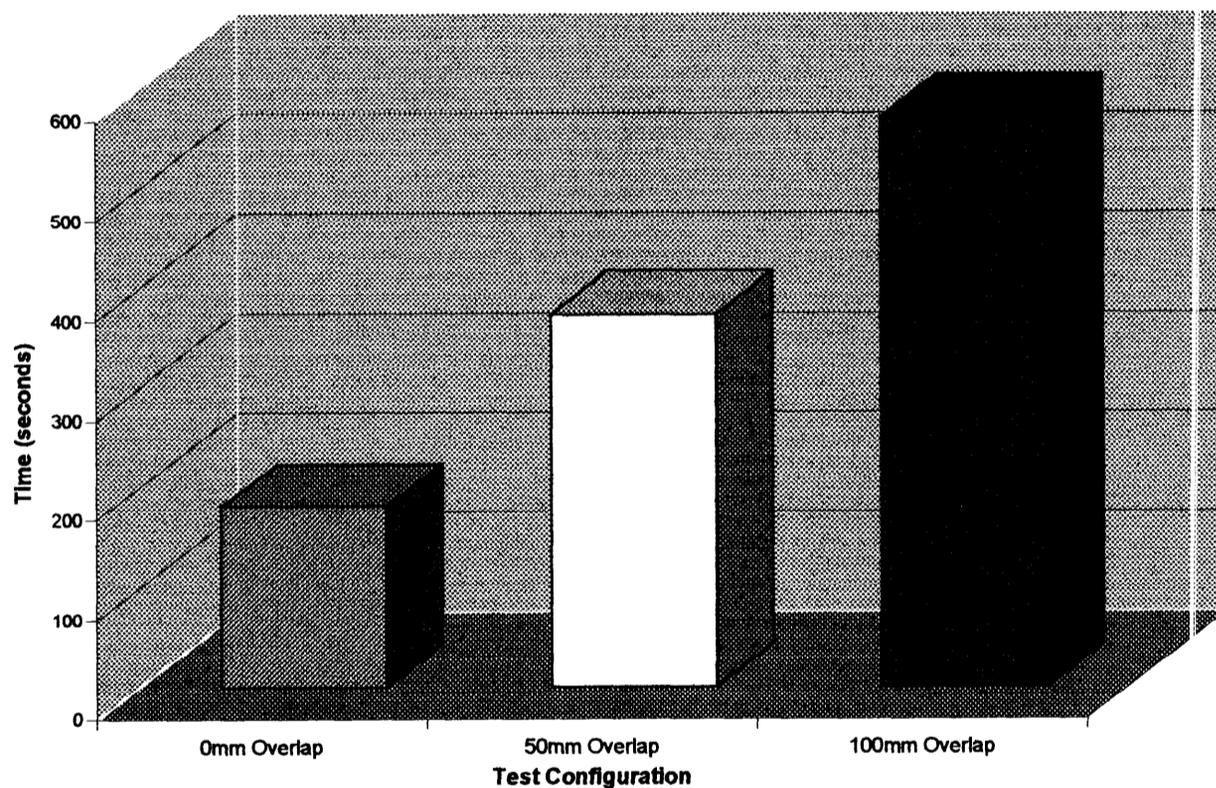
Tests A7a, A8 and A9a illustrate the pronounced effect that bag overlap can have on burnthrough times. All three tests were carried out using the stylised fuselage panel. The insulation system used was Orcobloc encapsulated in Orcofilm KN-80 and was attached to the frame using steel fixing pins and washers.

**Figure 20 Frame Overlap Failure Point Analysis**

The results from these three tests are shown in Figure 20. Each value shown on the graph represents the time taken to reach a heat flux level of  $20 \text{ kW/m}^2$ .

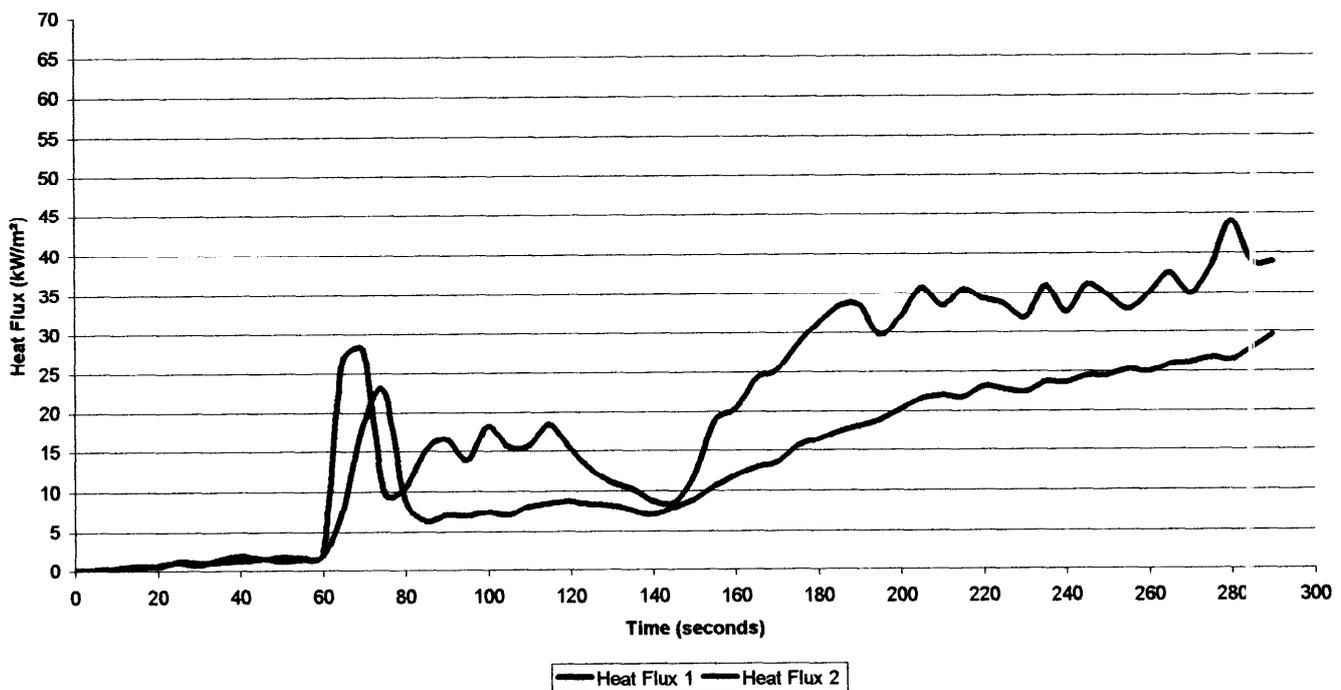
A test was conducted on an insulation system with no capping strip present to determine the necessity for this aspect of the installation. The results of the test, D6-4, are shown in Figure 21.

This test was carried out using an aircraft fuselage panel that had been treated with corrosion inhibitors. The insulation bags were attached to the frame using aluminium through frame pins positioned at 50 mm up the frame and at a pitch of 350 mm. The frame overlap was 50 mm. The test resulted in rapid burnthrough with the 20 kW/m<sup>2</sup> level of heat flux being achieved in approximately 65 seconds from the start of the test.

Figure 21 Heat Flux Profile for Test D6-4

A test was conducted on an insulation system with no capping strip present using an aircraft fuselage panel that had been treated with corrosion inhibitors. Rapid burnthrough occurred with the 20 kW/m<sup>2</sup> level of heat flux being achieved in approximately 65 seconds.

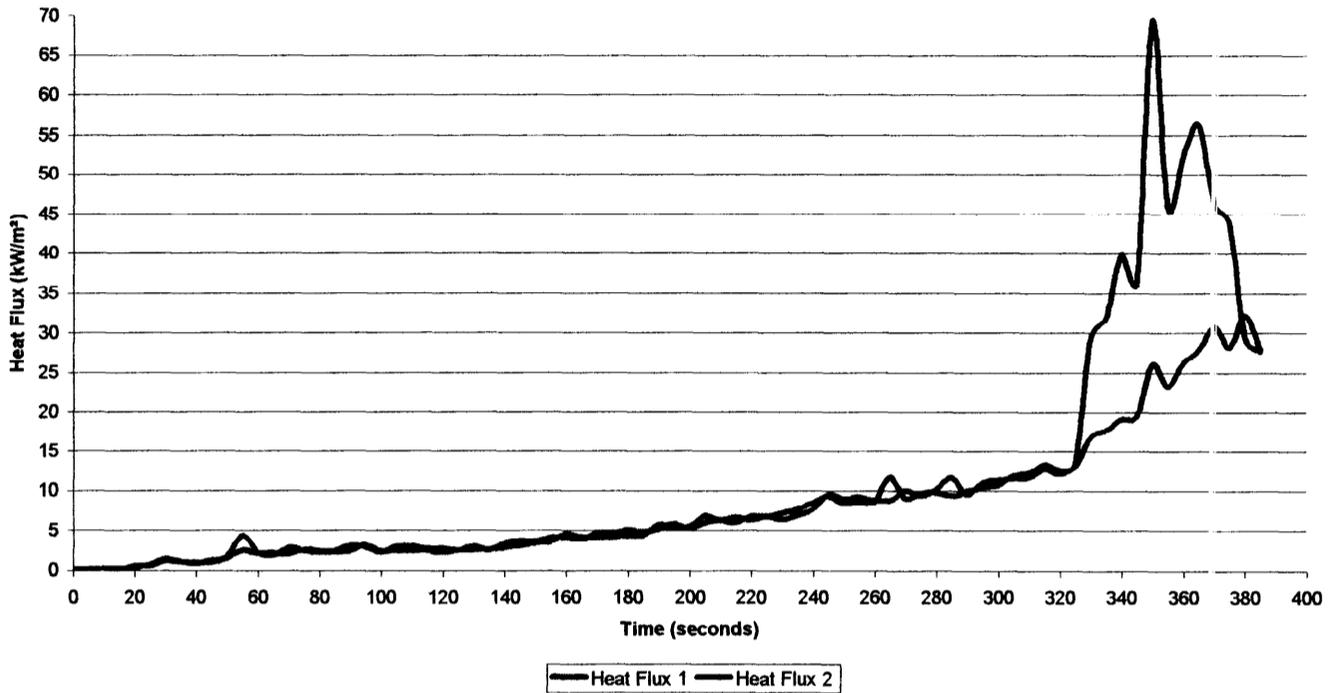
A similarly configured test was then carried out with the addition of cap strips, test D6-5. The cap strips were made of fibreglass batting encapsulated in a PVF based bagging film. As with test D6-4 the insulation bags were attached to the frame using aluminium through frame pins positioned at 50 mm up the frame and at a pitch of 350 mm. The overlap at the frame was 50 mm. The heat flux profile for test D6-5 is shown in Figure 22.

**Figure 22 Heat Flux Profile for Test D6-5**

The test resulted in a heat flux level of 20 kW/m<sup>2</sup> being achieved after approximately 330 seconds from the start of the test.

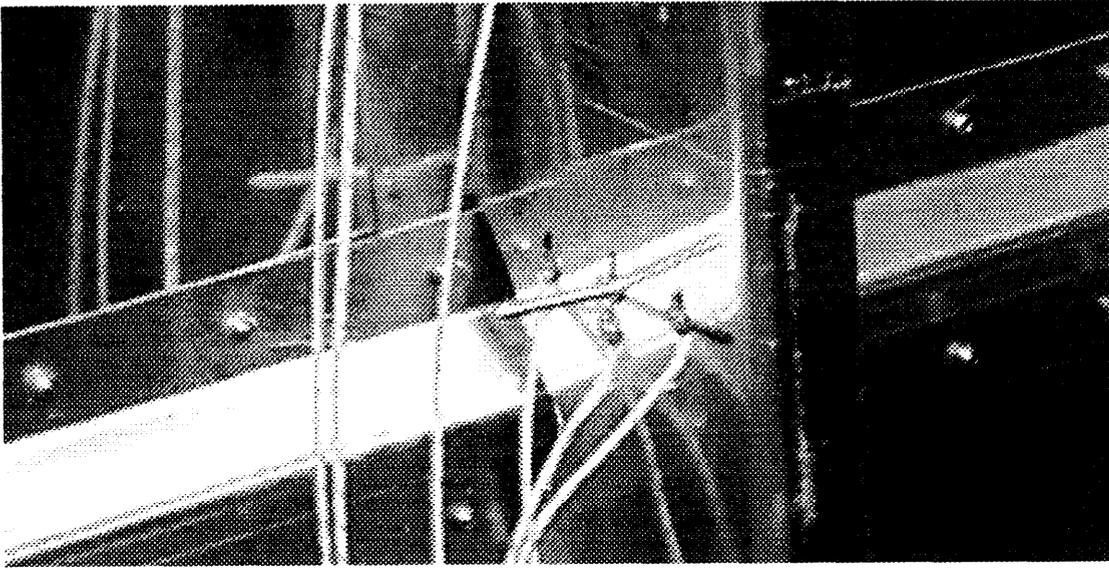
The insulation system used for the tests was again Orcobloc insulation encapsulated in Orcofilm KN-80 bagging film. In Section 4.2.1 the importance of frame overlap was discussed. For the tests described in this Section of the report 100 mm of frame overlap was used since this resulted in improved burnthrough results in comparison with smaller overlaps. A number of steel and aluminium through frame fixings were used for these tests and pitches along the frame of approximately 170 mm, 260 mm, and 350 mm, were tested. The vertical location of the through frame fixings in relation to the skin of the panel was also varied with values of 25 mm and 50 mm being selected. Figure 23 shows one of the through frame fixings as located on the test panel.

**Figure 23 Aluminium Through Frame Pin positioned 50 mm up the Frame**

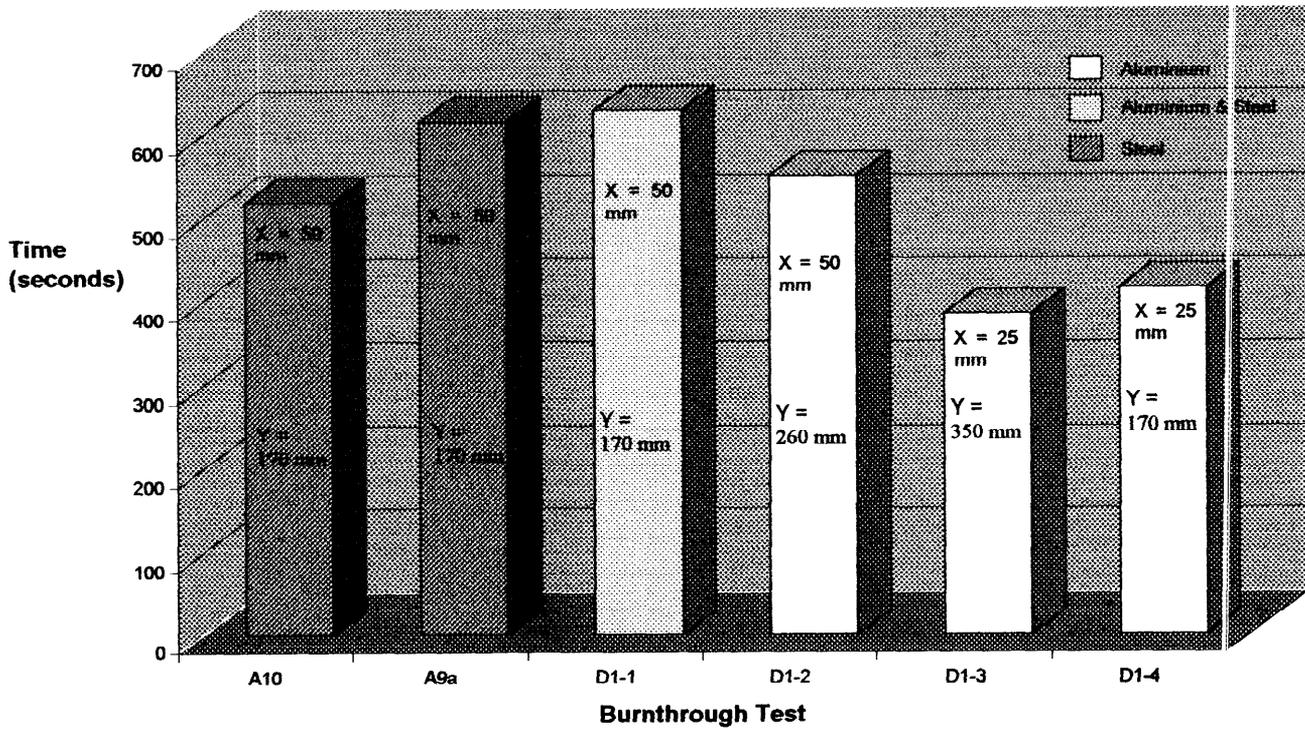
The results of the testing directed at through frame fixings presented in Figure 24 relate to the complete system and hence include the burnthrough time for the aluminium stylised fuselage panel. The Figure shows the time taken for a heat flux level of 20 kW/m<sup>2</sup> to be reached i.e. the burnthrough failure criterion. The system failure times are in the approximate range 380-600 seconds. All results are in excess of the 300-second complete system failure criterion.

**Figure 24 Time to Reach Failure Point of 20 kW/m<sup>2</sup> for Tests using Through Frame Fixing Pins & Washers**

**NB: Y = Pitch of through frame fixing along the frame  
X = Vertical location of through frame fixing in relation to the skin of the panel**

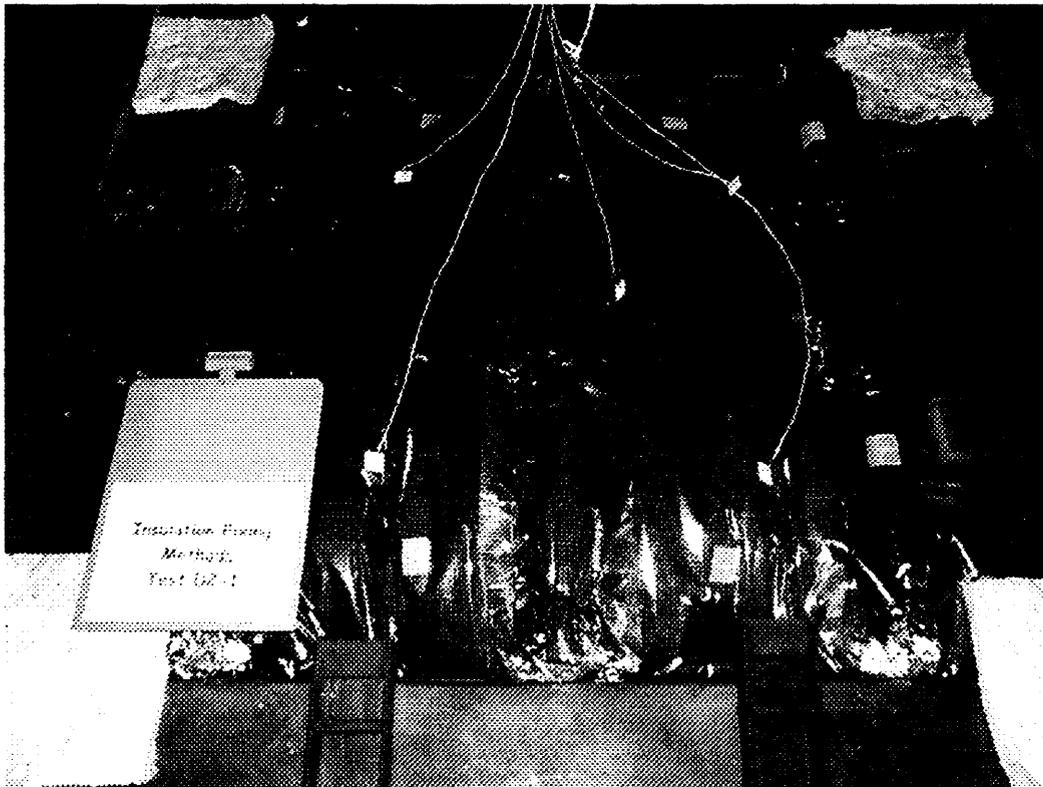
**Figure 25 Test D2-1 Plastic Over Frame Clips on a 14" pitch**

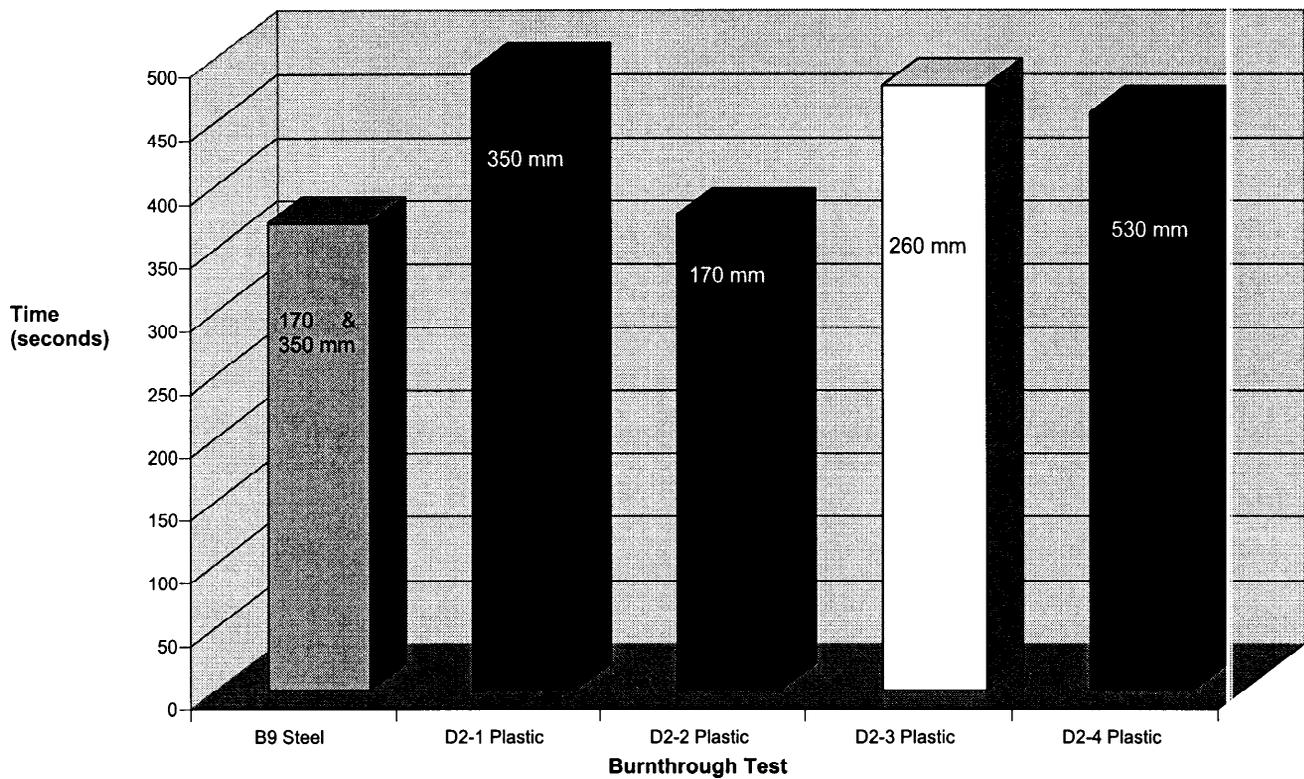
A number of tests were carried out to determine the <sup>effect</sup> that these over frame fixing clips could have on burnthrough time for an insulation system installed onto a stylised fuselage panel. The focus of the initial tests was on determining the importance of pitch of the fixing clips and their material of construction. The insulation system used for the tests was again Orcobloc insulation encapsulated in Orcofilm KN-80 bagging film. In Section 4.2.1 the importance of frame overlap was discussed and for each of these tests the frame overlap was 100 mm. Steel and plastic clips were used and pitches of approximately 170 mm, 260 mm, 350 mm, and 530 mm. Details of the typical construction of these samples are shown in Figure 25 and Figure 26. The condition of one of the plastic over frame fixings after a test is also shown in Figure 27. A summary of the results of these tests is shown in Figure 28.

**Figure 28 Time to Reach Failure Point of 20 kW/m<sup>2</sup> for tests involving over frame clips**

**NB: The values at the top of each column indicate the pitch of the fixings along the frame**

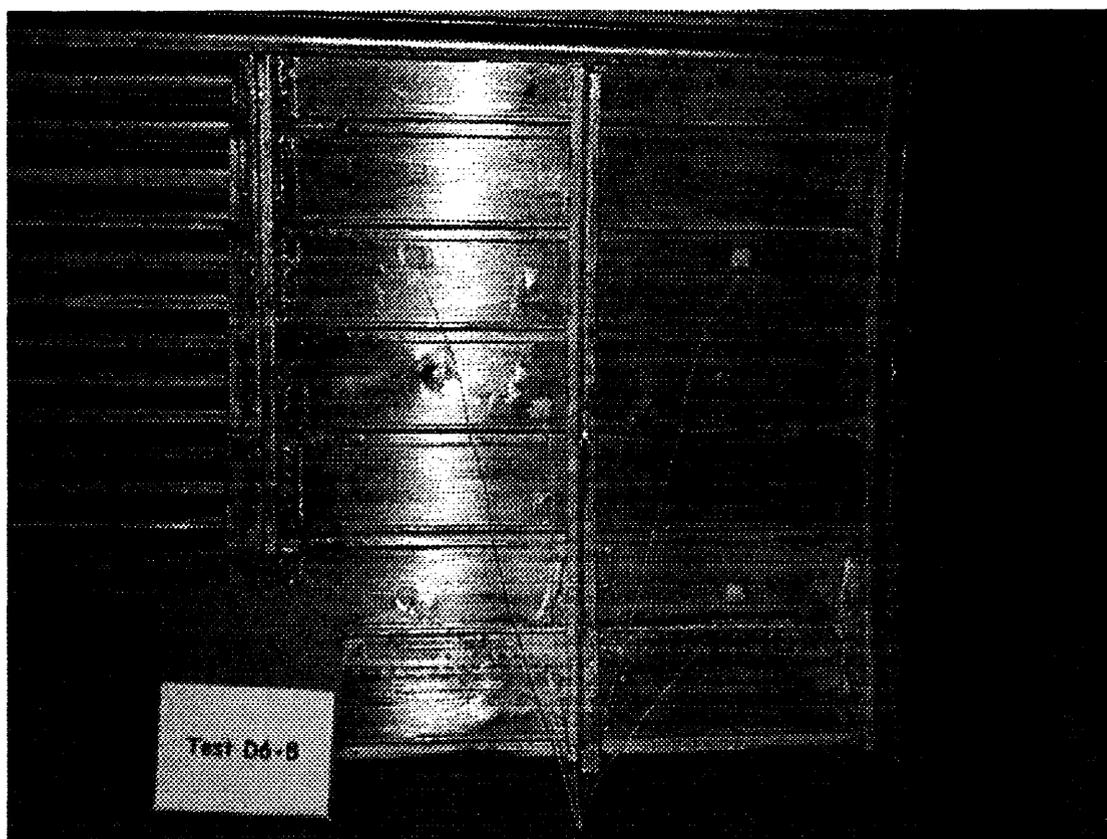
As discussed in section 4.1.2 using the stylised panel a minimum acceptable standard of installation characteristics could be derived. However, it was considered expedient to verify this minimum acceptable standard on an actual aircraft panel. Section 4.1.2 also discussed the effect the presence of corrosion inhibitors and the protective coatings applied to aircraft structures may have on the burnthrough time of a fuselage and insulation system. Therefore two tests, D6-7 and D6-8, were conducted on an actual aircraft panel using over frame fixings as the method of insulation system attachment. For test D6-8 corrosion inhibiting compounds were also applied to the actual aircraft panel as indicated in Figure 29.

**Figure 29 Test D6-8 Fuselage Panel Coated with Corrosion Inhibitors**
