**Attention Rules Docket No: FAA-2000-7909 Improved Flammability Standards for Thermal/Acoustic Insulation Materials Used in Transport Category Airplanes**

**COMMENTS TO DOCKET NO. FAA-2000-7909 - Improved Flammability Standards for Thermal/Acoustic Insulation Materials Used in Transport Category Airplanes (NPRM)**

**REPORT ON FUSELAGE  
BURNTHROUGH RESEARCH  
ADDRESSING INSTALLATION ASPECTS**

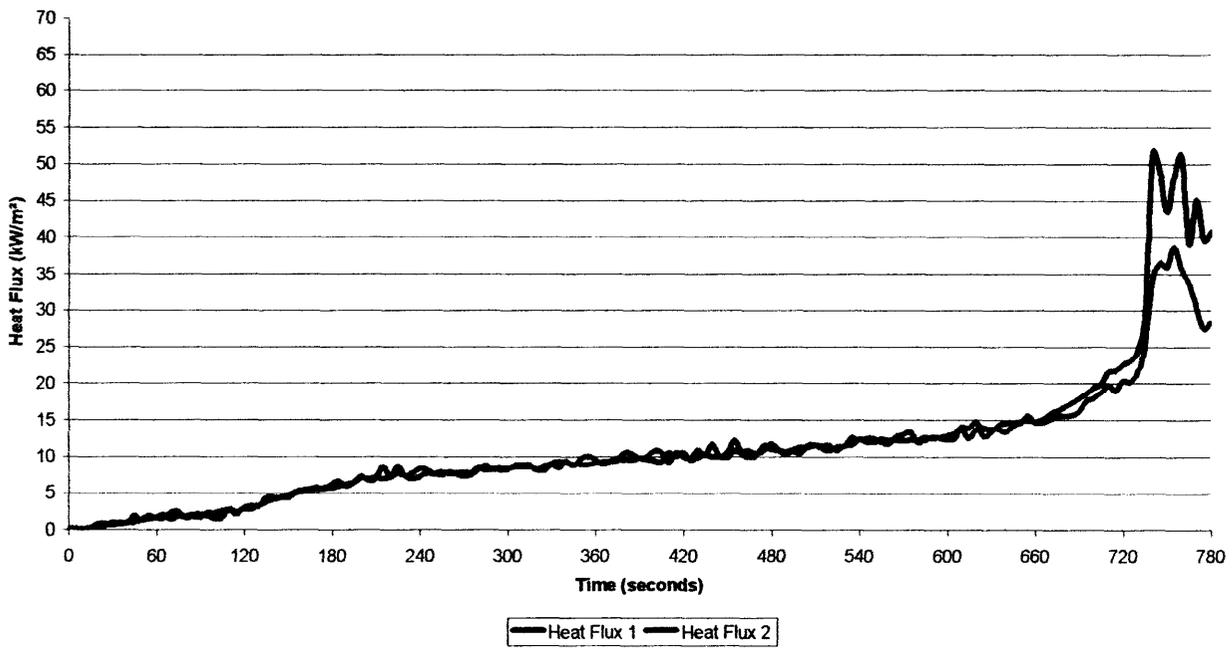
The two tests were conducted using Orcobloc insulation batting encapsulated in Orcofilm KN-80 bagging film and the overlap of insulation at the frame with the capping strip was 100 mm. The heat flux profiles are shown in Figure 30 and Figure 31.

**Figure 30 Heat Flux Profile for Test D6-7**

For both tests the burnthrough time of the system was again well in excess of the failure criterion- test D6-8 did not fail until approximately 900 seconds. The burnthrough times for the actual fuselage panel tests are higher than those for the equivalent tests using the stylised fuselage panel.

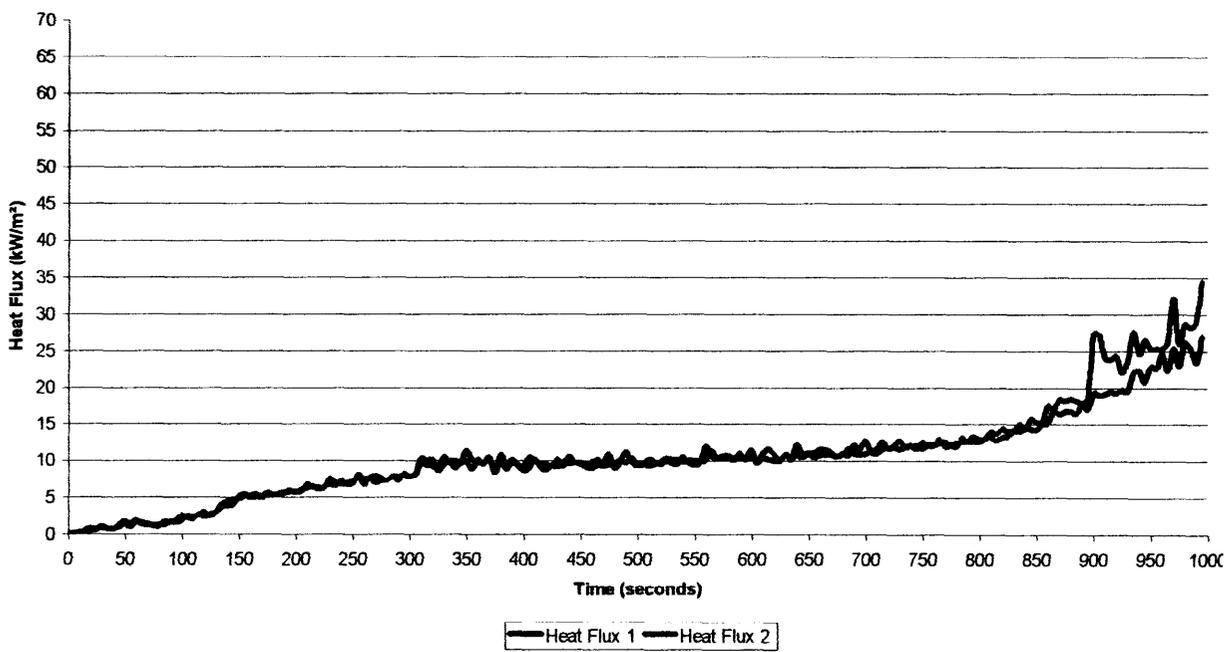
**Figure 31 Heat Flux Profile for Test D6-8**

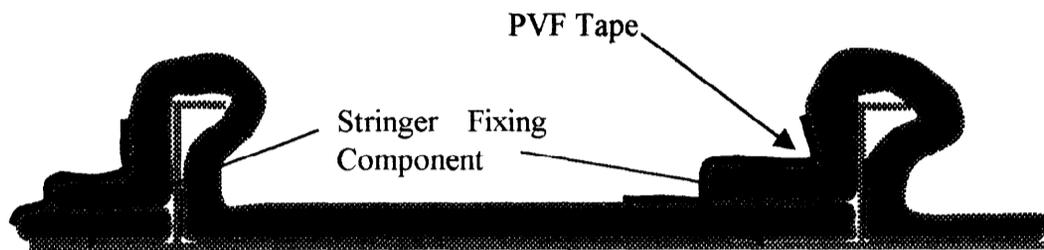
One of the first tests conducted in the current burnthrough programme investigating insulation installation aspects was on a configuration representative of one currently used on board aircraft. A sketch of the test sample configuration is shown in Figure 32 and photographs showing the installation are provided in Figure 33 and Figure 34. The insulation blankets were attached to the stylised fuselage panel and to each other using plastic stringer fixings as shown. These were positioned every 350 mm, parallel to the frames and along the length of the panel. The insulation blankets were overlapped by 100 mm and along this overlap a strip of PVF tape was positioned along the length of the blankets.

Figure 32 Test B8 Orcobloc in KN-80 (100 mm Overlap)

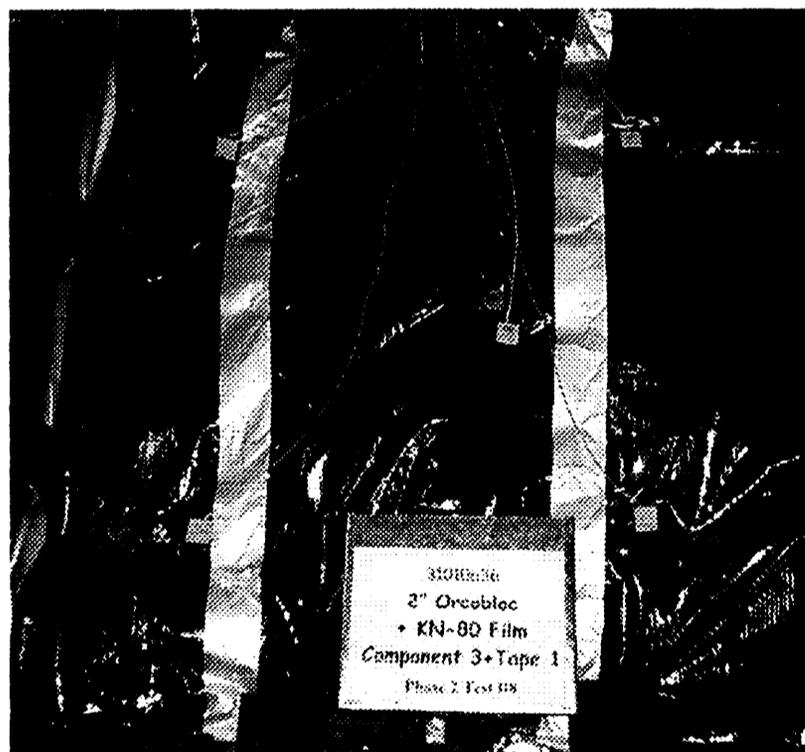
Figure 33 Test B8 Pre-Test

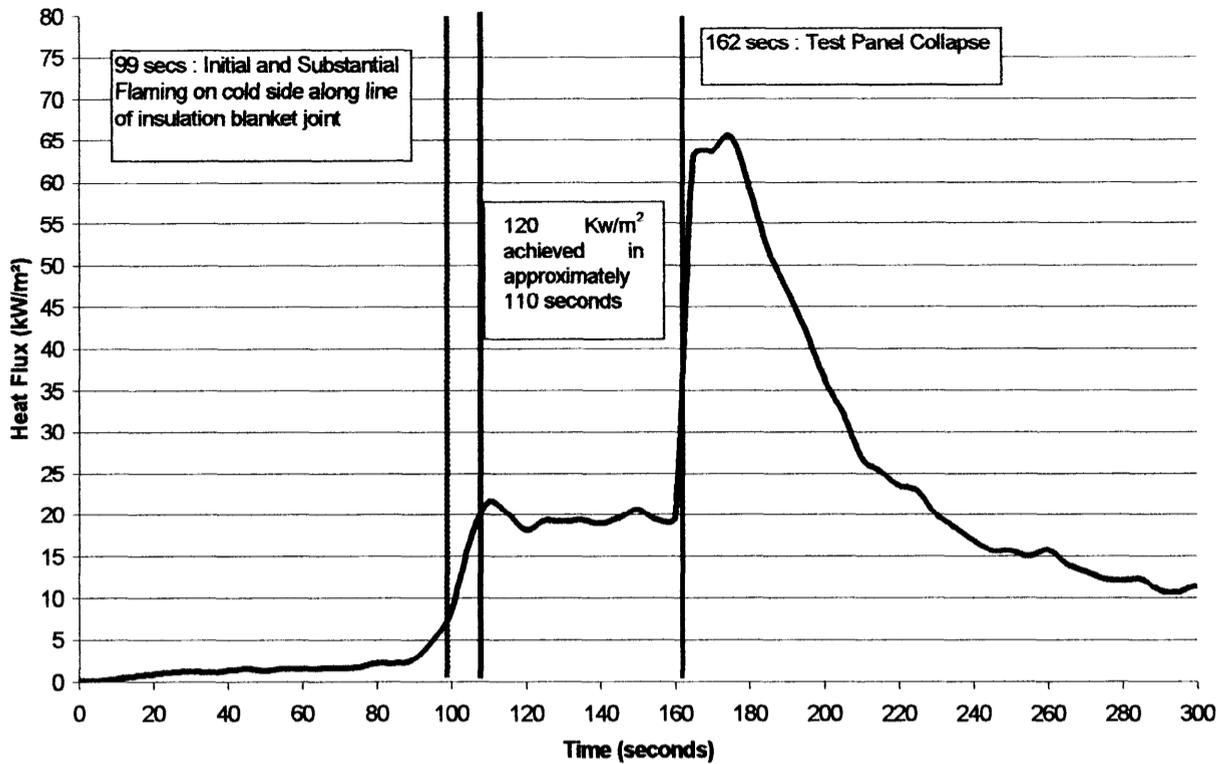
This test resulted in a rapid burnthrough with the 20 kW/m<sup>2</sup> level of heat flux being achieved in approximately 110 seconds as shown in Figure 35. This result indicated that this method of attaching an insulation system to the aircraft fuselage was not capable of providing significant burnthrough protection even by using insulation materials that have been shown to be burnthrough resistant.

**Figure 35 Heat Flux Profile for Test B8**

In test B8 the combination of stringer fixing pins/clips and PVF tape was found to be unacceptable.

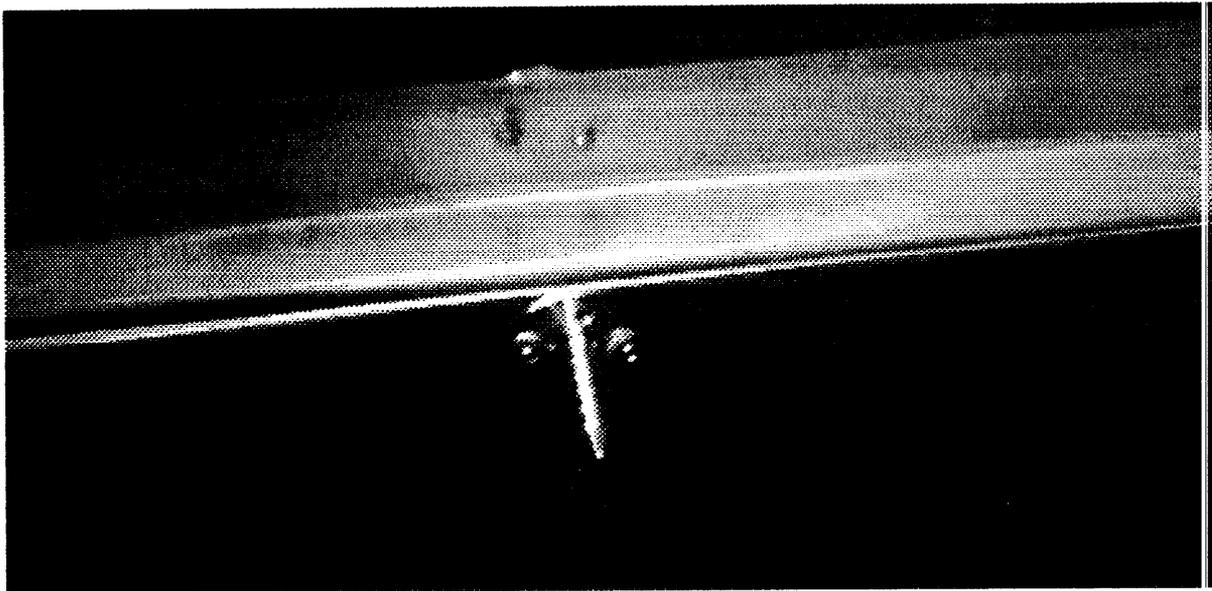
Test D5-1 was conducted using a stylised fuselage panel and the Orcobloc insulation material and Orcofilm KN-80 bagging film combination. The insulation bags were attached to the frame using steel over frame clips, positioned over the frame at a pitch of approximately 250 mm. The frame blanket extended a distance of 100 mm up the frame. In one of the frame bays a number of aluminium stringer pins were riveted on to the stringer sections as shown in Figure 36. The insulation was pushed onto these stringer pins and then held in place using washers as shown in Figure 37.

**Figure 36 Test D5-1 Close Up of Aluminium Stringer Pin attached to Stringer**

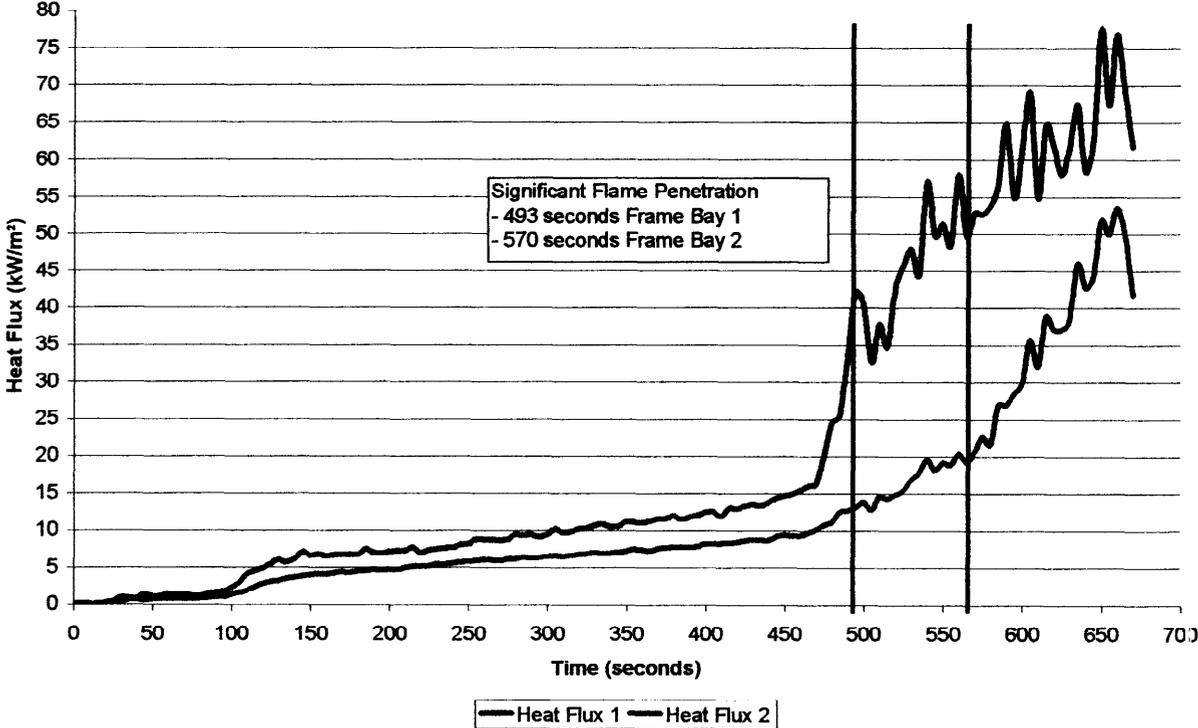
The test resulted in the failure heat flux of 20 kW/m<sup>2</sup> being achieved after approximately 475 seconds with no appreciable difference between the frame bay containing the stringer fixing clips and the one without any. Results of the test are shown in Figure 38.

Figure 38 Heat Flux Profile for Test D5-1
