Subject: Docket submission of Technical Report "Development of the SID-IIs FRG"

# **Development of the SID-II's FRG**

**Heather Rhule**

**November 2003**

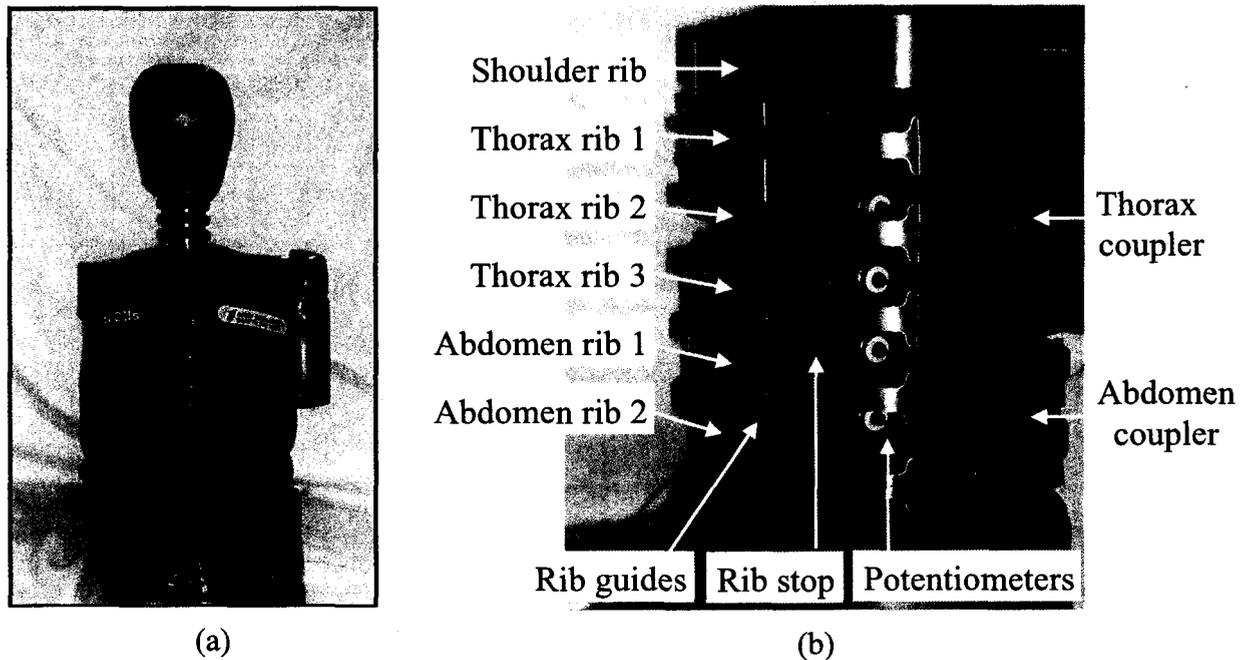
Figure 1. Original SID-II's Dummy seated with jacket on (a); shoulder, thorax and abdomen (b).

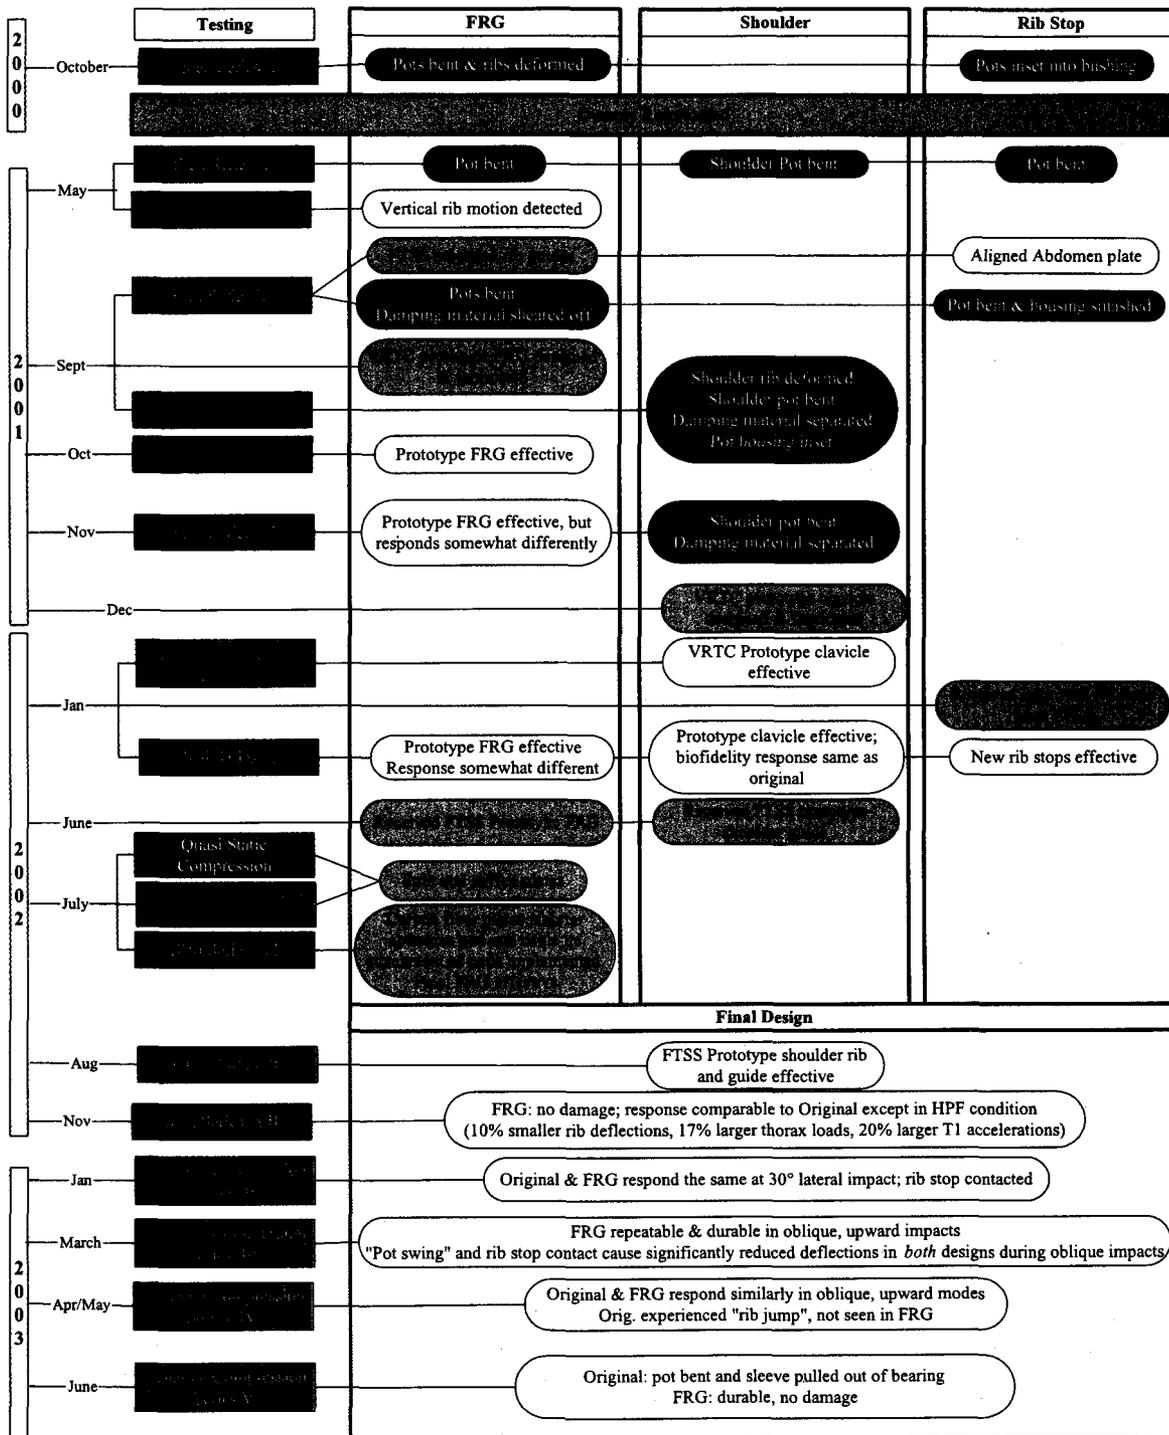
Figure 2. Timeline of Critical Events in the Evaluation of the Original SID-IIIs

Figure 2 is a timeline showing the critical events during the design change phase including testing, results, and modifications. The timeline begins chronologically at the top of the Figure and ends at the bottom. The columns of the Figure are, from left to right, the years and months of the evaluation, the testing conducted, and three columns of test results (including modifications to the dummy). The Testing descriptions are color-coded to identify similar test types. Within the Test Results section of Figure 2, the modification types are organized into columns for FRG, Shoulder and Rib Stops. When the design was final in August 2002, the three columns for FRG, Shoulder and Rib Stops were merged into one column of Test Results (Final Design), as shown in Figure 2. Red and yellow events in the Test Results section indicate damage and design changes, respectively. The timeline ends in June 2003, when the evaluation of the modifications to the dummy was complete and the current design of the dummy, referred to as the FRG, was ready for a full evaluation.

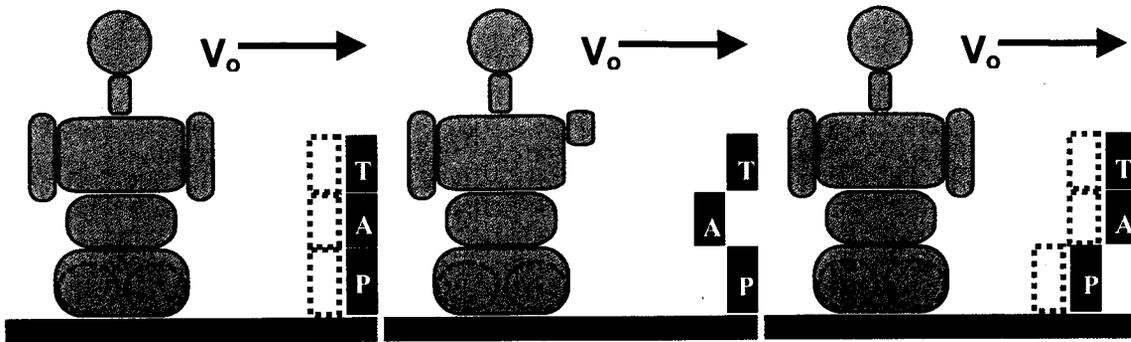
**Figure 3a.** Test condition schematics, from left to right: padded or rigid flat wall; rigid abdomen offset; padded or rigid pelvis offset

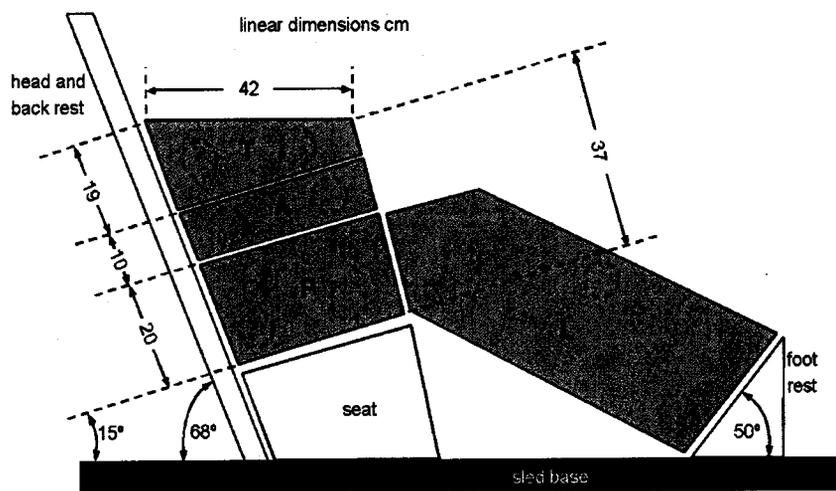
**Figure 3b.** Impact wall configuration for mid-size male showing thorax (T), abdomen (A), pelvis (P) and leg (L) plates.

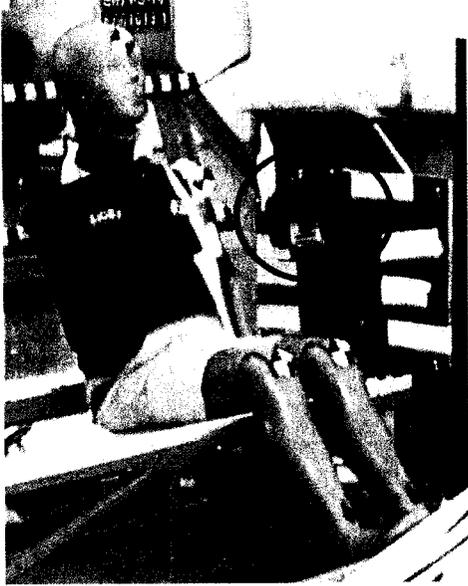
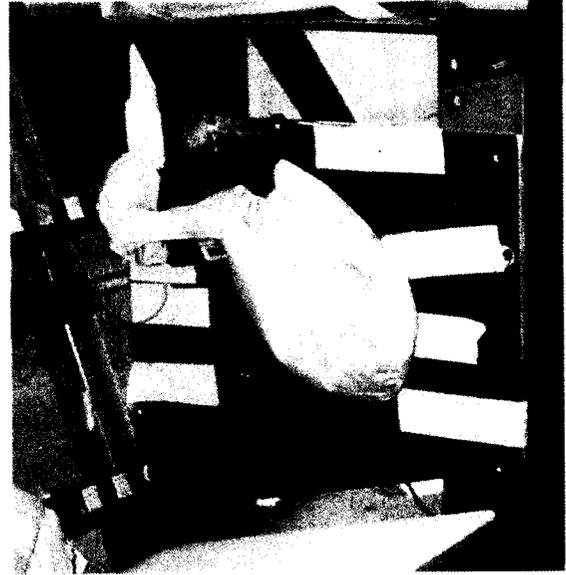
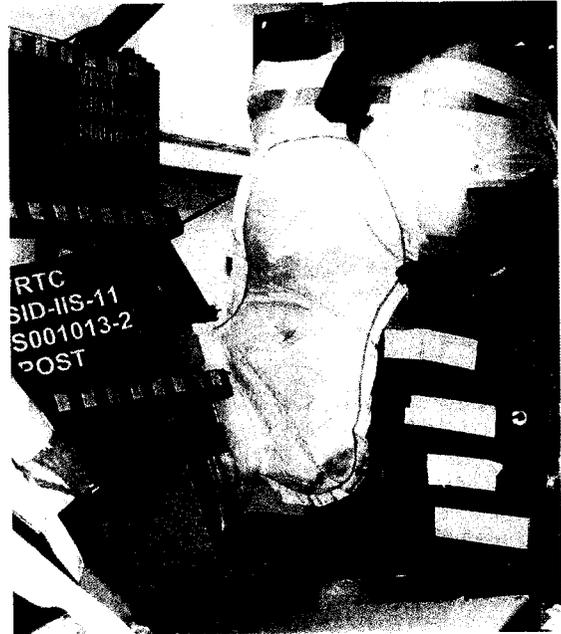
**Figure 4.** High-speed Flat Wall Airbag Tests: Test 258 setup with Cadillac door-mounted passenger side airbag (a); Post-test photo after Test 258 showing deployed airbag (b); Test 259 setup with Maxima seat-mounted side airbag (c); Post-test photo after Test 259 showing deployed airbag (d).

A shoulder plate was added to the sled wall in the first test in order to engage the shoulder. As an alternate test condition for evaluating the SID-IIs at 8.9 m/s, an air bag was installed in a flat wall in order to provide some cushion and enable the dummy's interaction with an air bag to be studied. In order to position the air bags relative to the dummy realistically, the dummy was positioned in the vehicles and measurements were taken for duplication on the sled. In Test 258, a 1999 Cadillac Deville passenger side airbag was used. In Test 259, a Nissan Maxima side airbag was used. Figure 4 shows the test setups with the air bag modules circled in green (4a, 4c) and the deployed air bags (4b, 4d) for Tests 258 and 259.

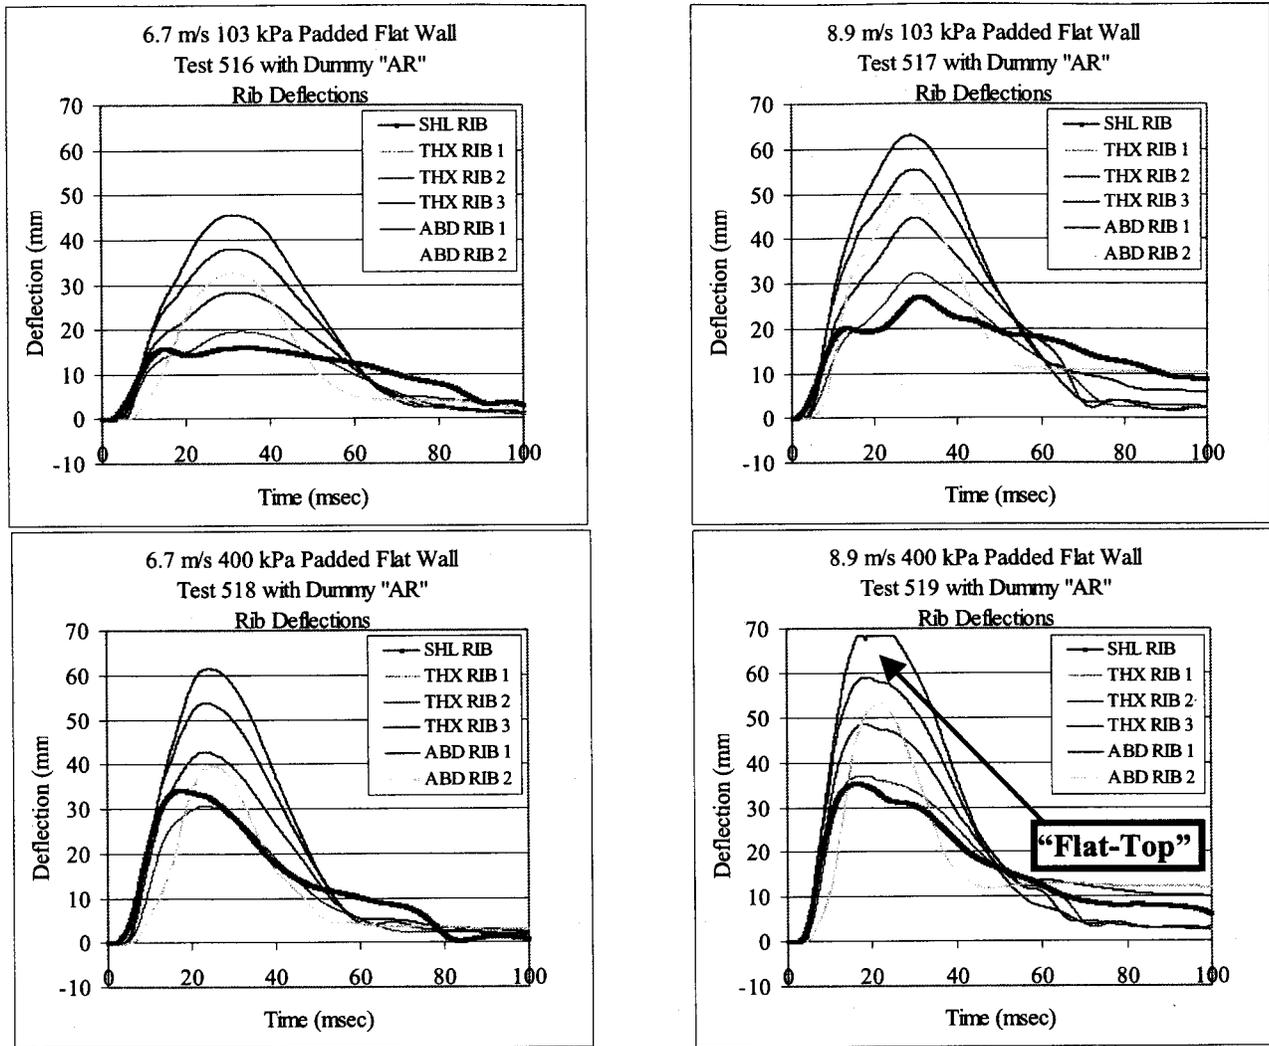
Figure 7. Sled Series II Flat Padded Wall rib deflections showing effects of impact speed and wall padding.

Although no damage occurred in the flat-wall tests, the data traces in Figure 7 show that the rib deflections gradually increased with increased severity of the test conditions. The peak deflection in all flat-wall tests occurred in the first abdominal rib, likely due to the bottom of the “half-arm” intruding into the abdomen (Figure 8). In the HPF test with 400kPa foam, the first abdominal rib potentiometer reached its maximum stroke capacity of 69 mm, resulting in a “flat-top” in the data trace.

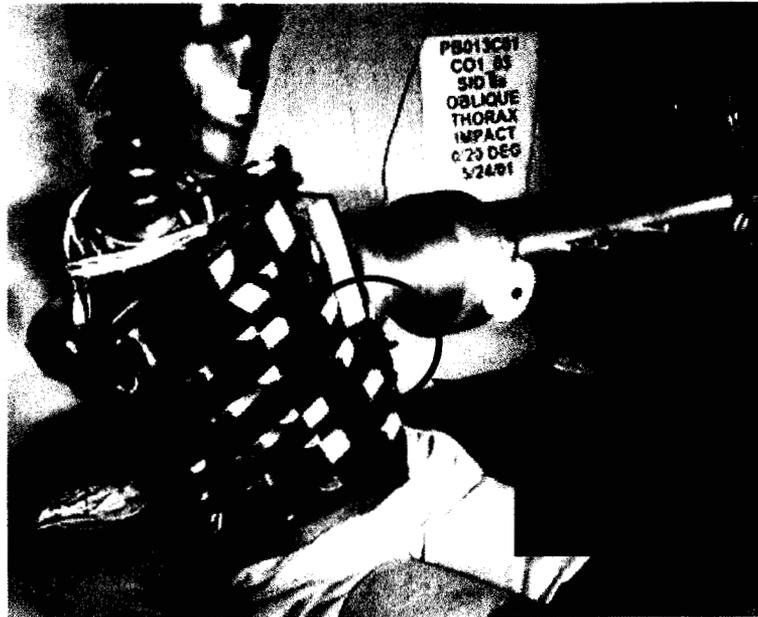
Figure 12. Large pendulum face gets caught inside abdomen rib 1 during Test 3 of Upward Pendulum Test Series I.

Damage to the dummy occurred in Test 3 as the edge of the large probe face became caught in the ribcage and pulled abdomen rib 1 outward laterally (Figure 12). The pot housing of abdomen rib 1 cracked and broke, which was clearly due to a test anomaly since the dummy would normally wear a jacket during a crash test. The jacket would not allow anything to get caught in the ribcage and pull the rib and pot outward. Although no damage occurred in Test 7, high-speed video showed thorax rib 2 bow out beyond the rib guide, move vertically, and catch on the rib guide (Figure 13a). This indicated that some vertical motion of the ribs was possible, without any damage. It also illustrated that the potential for damage to the potentiometer shaft existed when rib deflection and vertical forces occur. The deflection traces for thorax ribs 1, 2, and 3 during Test 7 are plotted in Figure 13b.

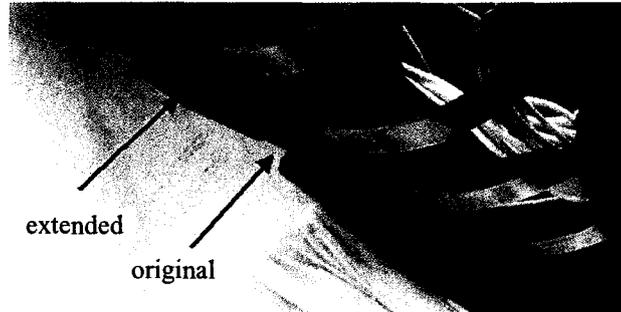
Figure 14. Extended rib guides shown with original rib guide for visual illustration.

FTSS was notified of the vertical movement of the ribs and resulting damage that occurred in sled tests. As a first attempt at fixing the problem, FTSS added spacers behind each rib guide to extend the guides outward  $\frac{3}{8}$ " (Figure 14). Also, a guide was added in the front and rear between thoracic ribs 2 and 3 because there were no guides at those locations in the dummy. With these changes to the dummy, referred to as design configuration B, further testing (Sled Series III) was conducted with the dummy's jacket removed so that rib motion could be viewed.

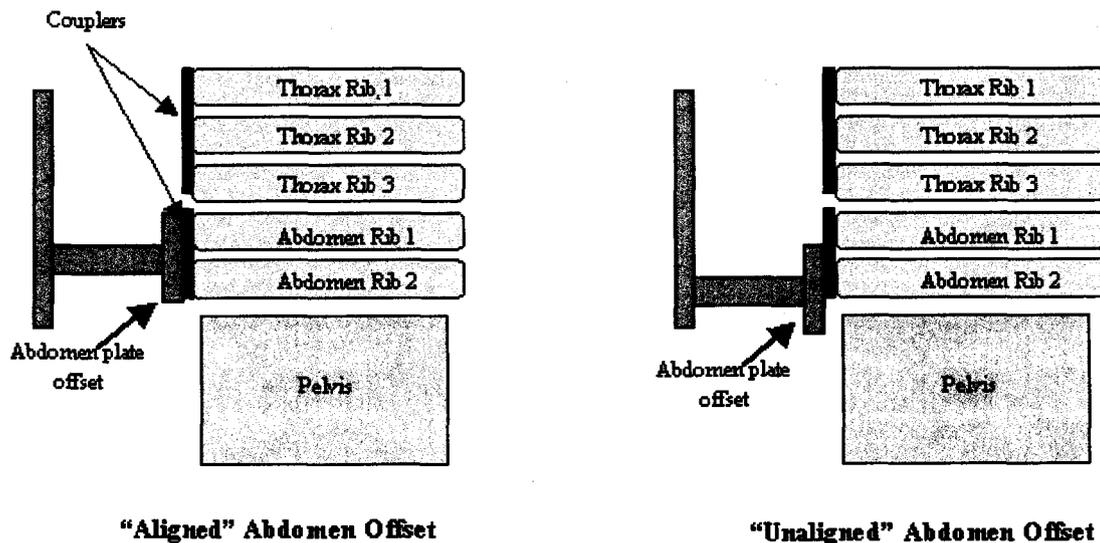
Figure 15. Schematic showing Aligned and Unaligned Abdomen Offset test configurations

In Test 644, the pot housing of abdomen rib 1 crushed and its shaft bent. Since this test was an Aligned configuration (Figure 15), the energy from the impact was absorbed by the two abdominal ribs, which resulted in substantial rib displacement. In the Unaligned condition, the pelvis engaged the offset abdomen plate, which may have limited the amount of deflection experienced by the abdomen ribs. In the Aligned condition, the pelvis did not contact the plate and both abdomen ribs experienced extreme deflection causing the rib stops to become engaged. The rib stops of the original design were not sufficient to protect the instrumentation from crushing or bending. Further discussion of the rib stops and Test 644 is included in Section 5, Rib Stop Modifications.

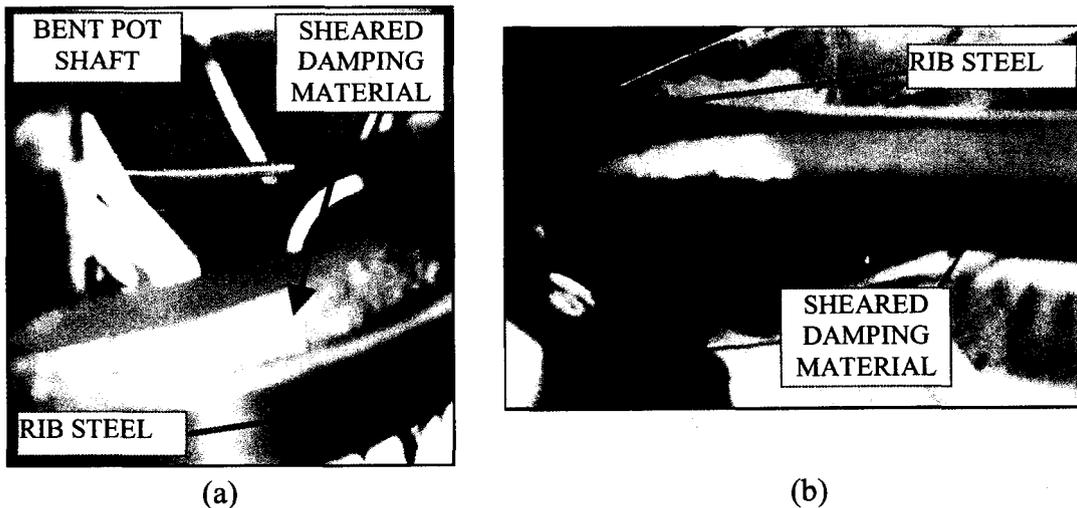
**Figure 16.** Bent abdomen rib 1 potentiometer shaft (a) and separated damping material (a), (b) after Rigid Abdomen Offset Test 642 with extended rib guides.

In the first test of Sled Series III with design B (Test 642), abdomen rib pot 1 bent severely and the damping material sheared off the rib steel, as shown in Figure 16. Motion analysis revealed that the rib jumped the guide and moved vertically, causing the damage. It appeared that the  $\frac{3}{8}$ " extension was not enough to maintain the ribs in a horizontal plane, so an additional  $\frac{1}{2}$ " spacer was added behind abdominal rib guide 1 for the next test. The rib and pot were replaced. (This is referred to as design B+). The same damage was observed in Test 643: abdomen rib pot 1 bent severely and damping material sheared off the rib steel. Motion analysis showed that the rib did not jump the guide but that the rib deflected enough for the rib steel to move beyond the extra long guide. However, the rib damping material did not clear the guide, resulting in the sheared-off damping material. Deflection traces for the thorax and abdomen ribs in these two tests are shown in Figure 17.

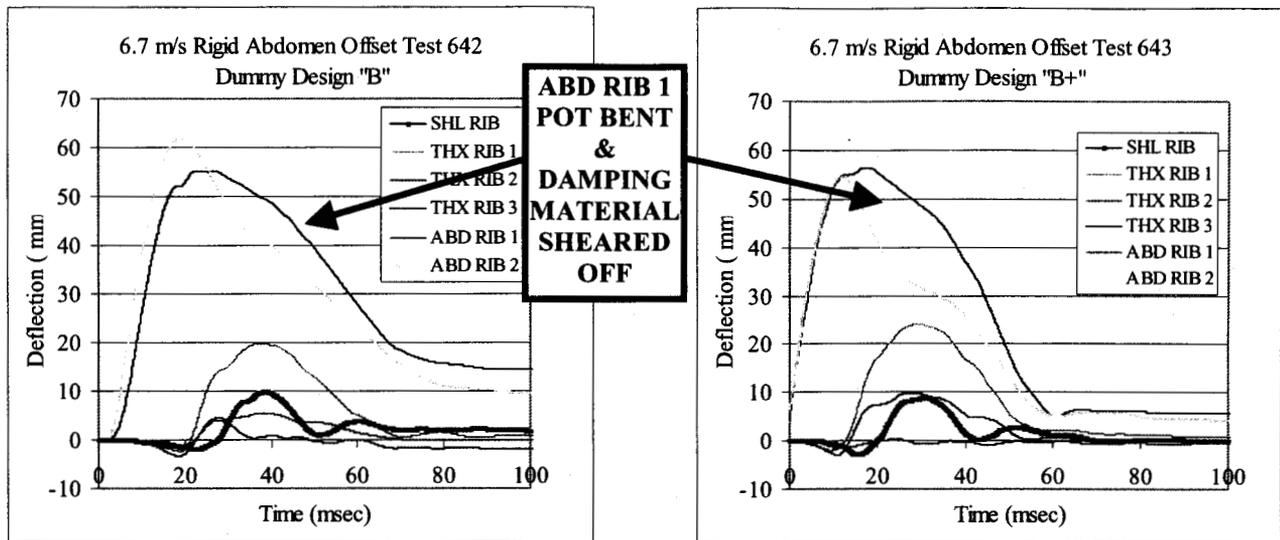
**Figure 17.** Rib deflections during LRA Tests 642 and 643 with  $\frac{3}{8}$ " and  $\frac{7}{8}$ " extended rib guides, respectively. Note that in both tests abdomen rib 1 pot bent and damping material sheared off.

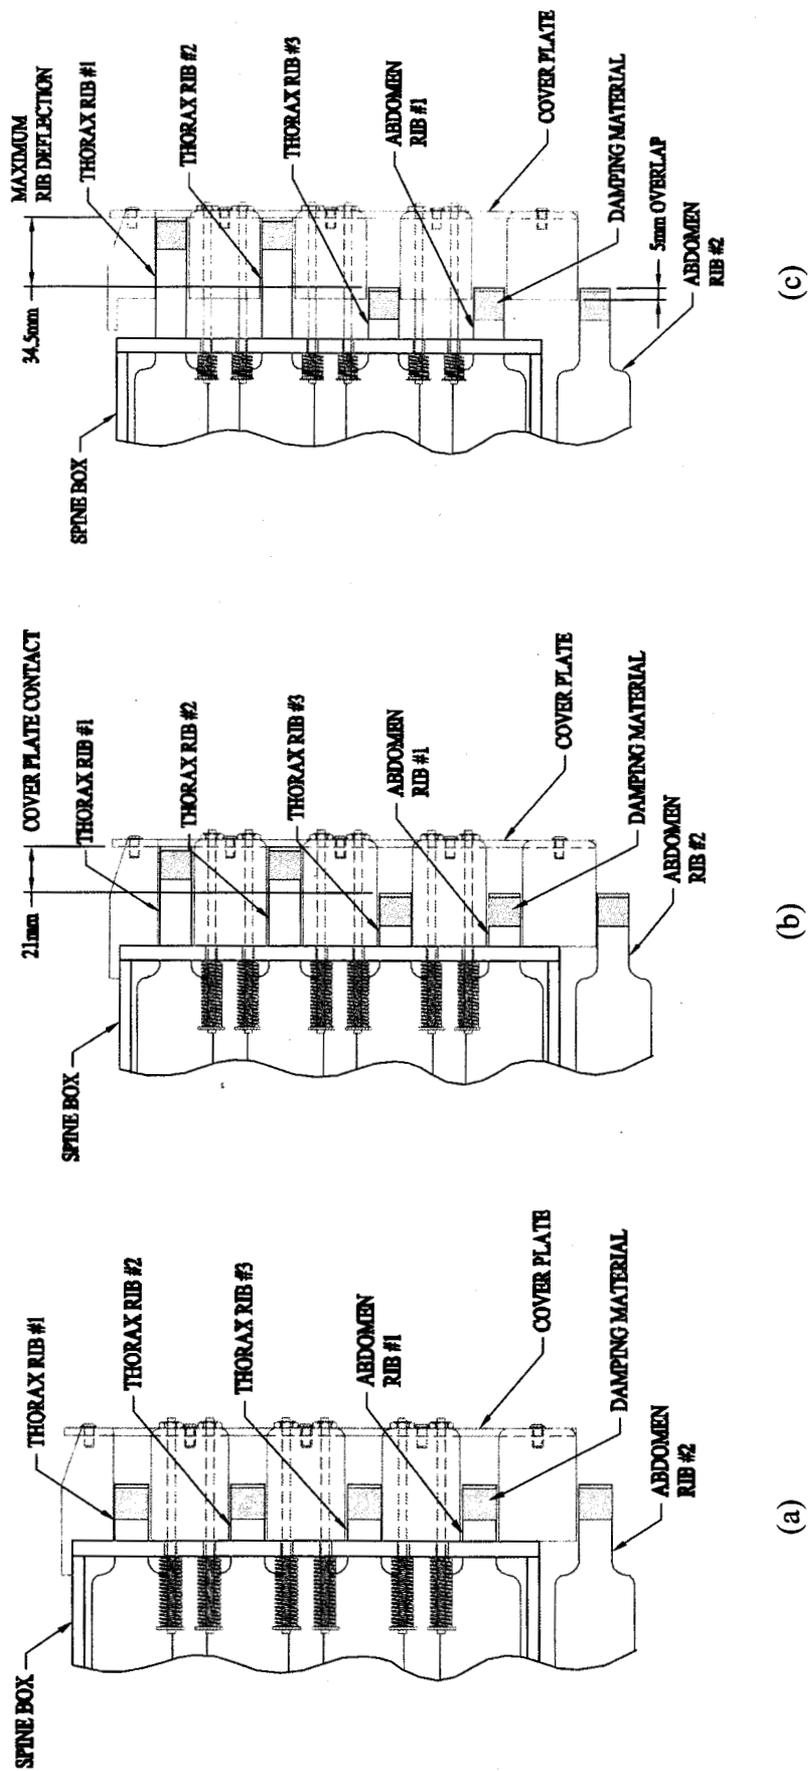
**Figure 22.** Schematics showing FRG system (a) at rest; (b) as thorax ribs 1 and 2 contact cover plate; and (c) at maximum deflection of thorax ribs 1 and 2. Note that in (c), 5mm of overlap exist between the non-deflected ribs and the floating rib guides for a maximum rib deflection of 69mm, indicating that rib under-ride is not possible.

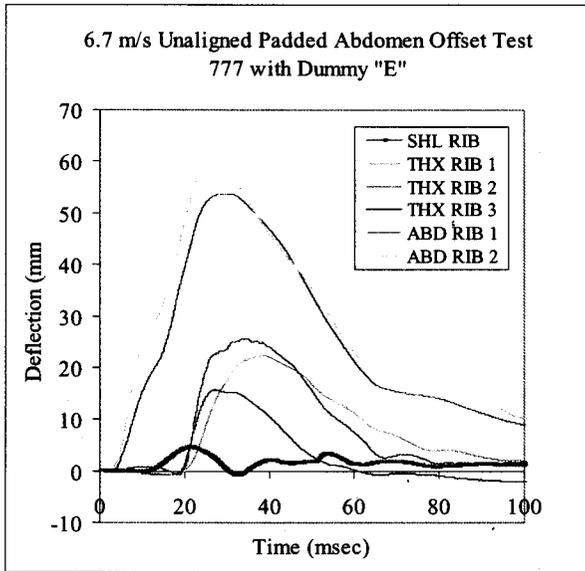
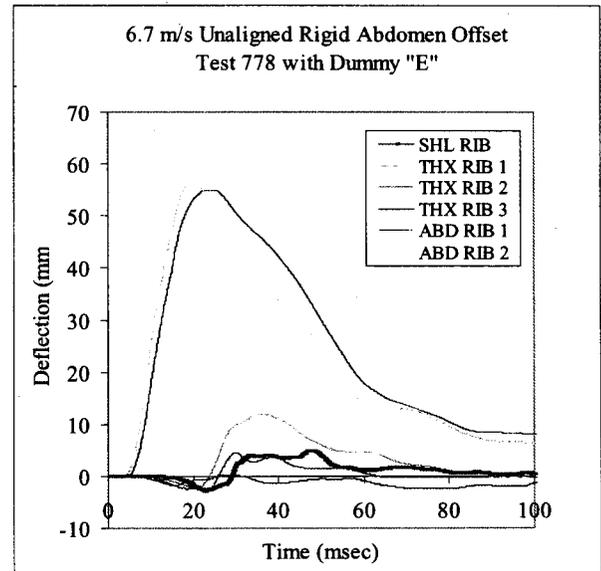
**Figure 25a.** Rib deflection data traces during Padded and Rigid Unaligned Abdomen Offset Tests 777 (a) and 778 (b), respectively. Note that no damage occurred in these two tests with dummy E.

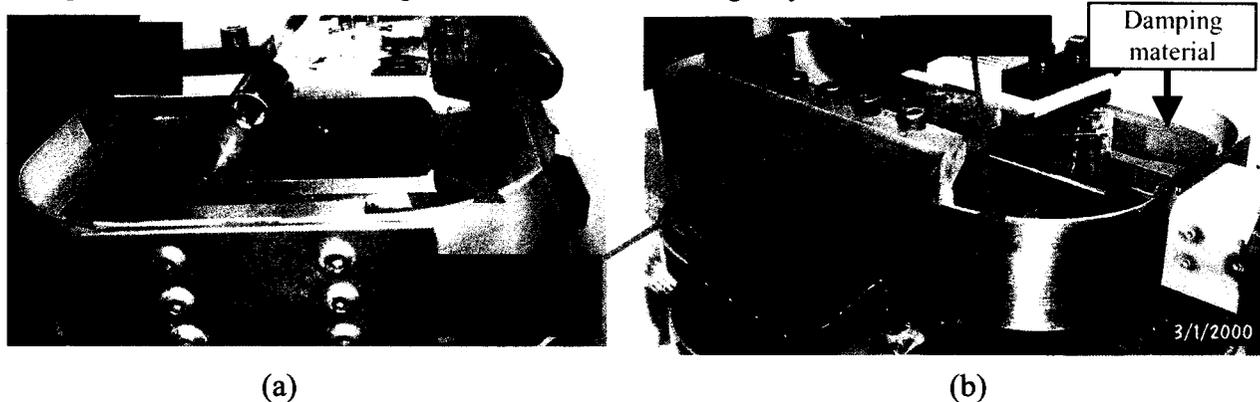
**Figure 26.** Side view (a) and oblique frontal view (b) of the original shoulder rib, damping material and shoulder rib guide.

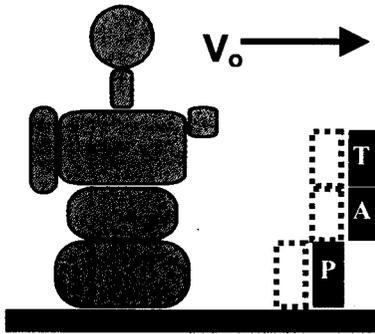
Figure 27. LPP test setup schematic.

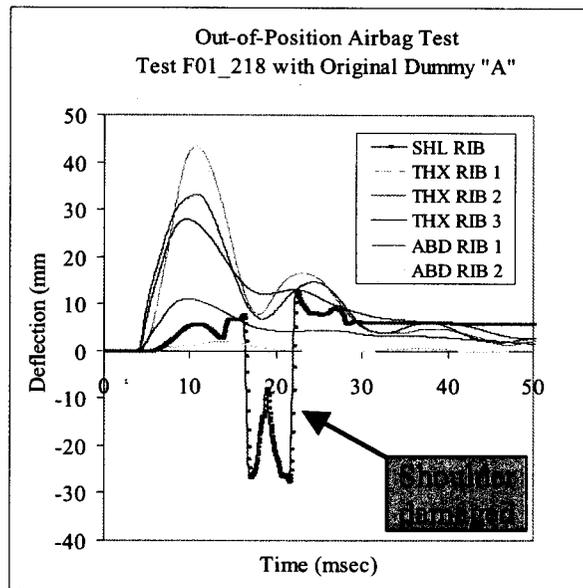
**Figure 32.** Rib deflection traces during OOP airbag test F01\_218 with the original dummy design. Note that the shoulder sustained severe damage.

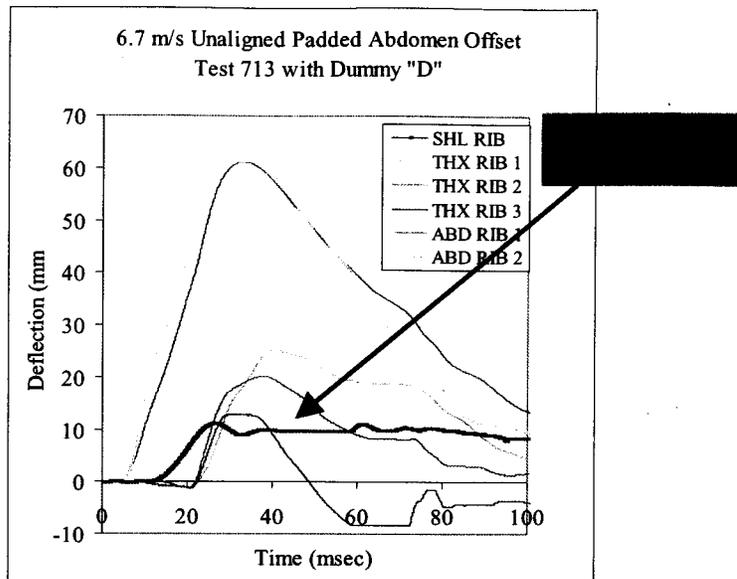
**Figure 35.** Rib deflection data traces during Test 713 showing unusual activity in the shoulder rib and thorax rib 3

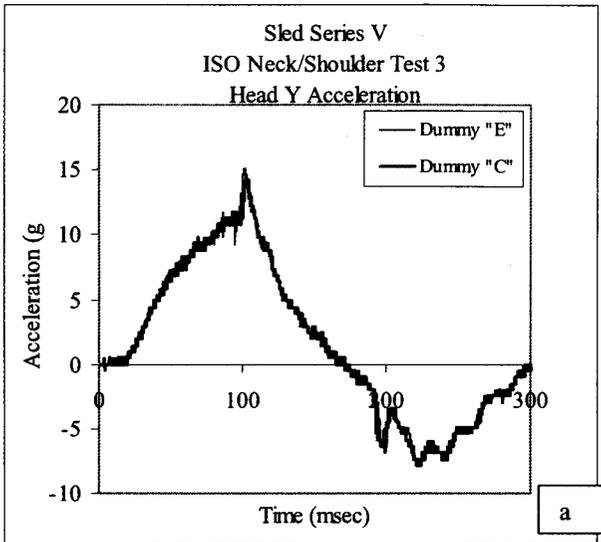
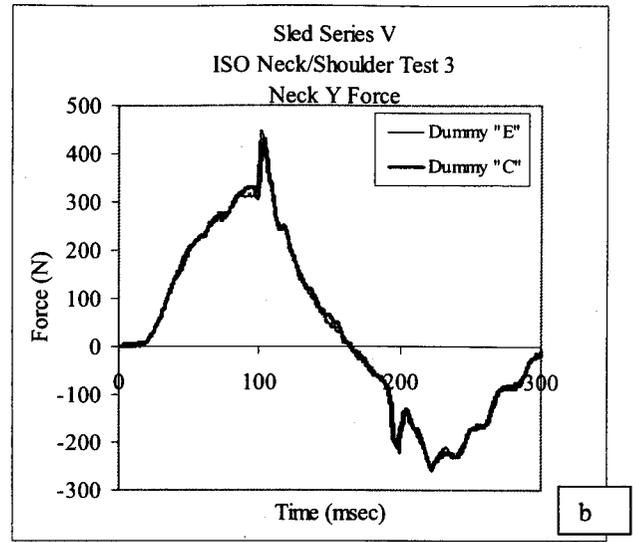
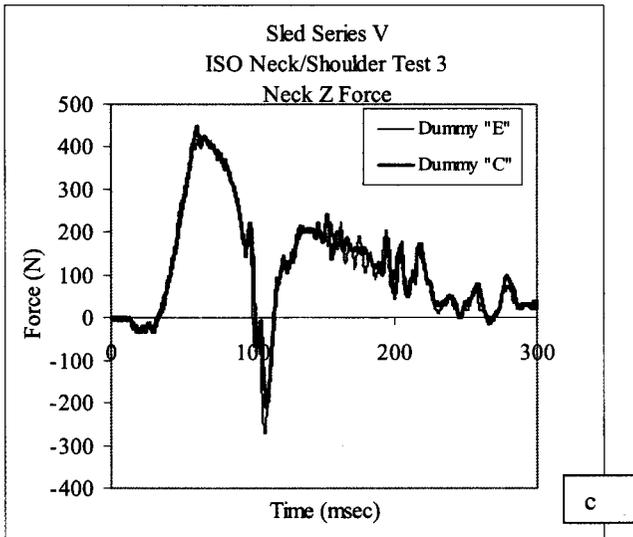
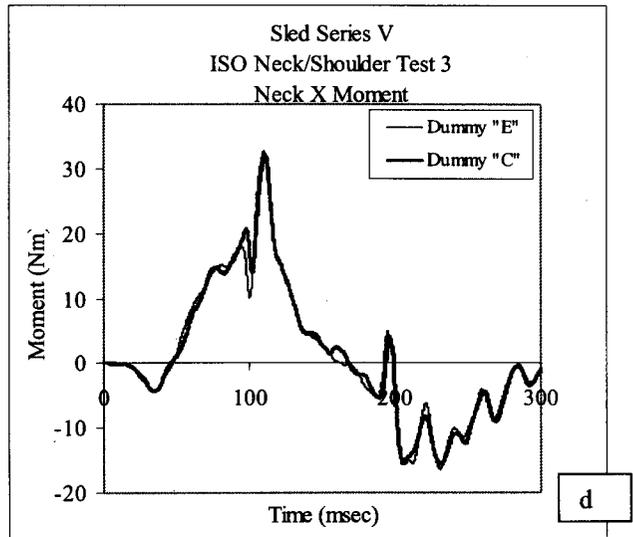
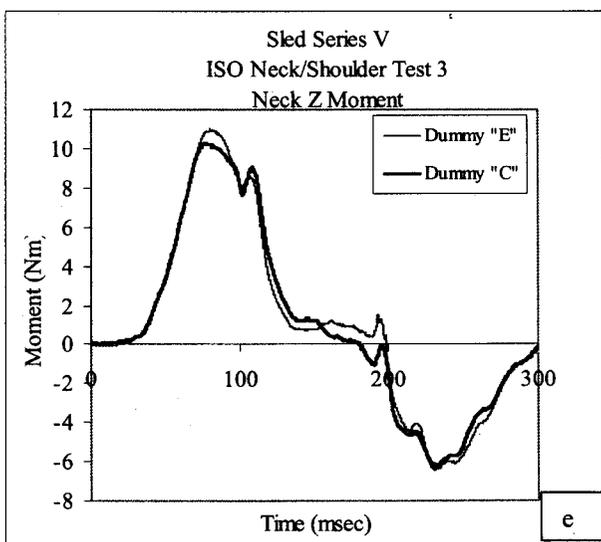
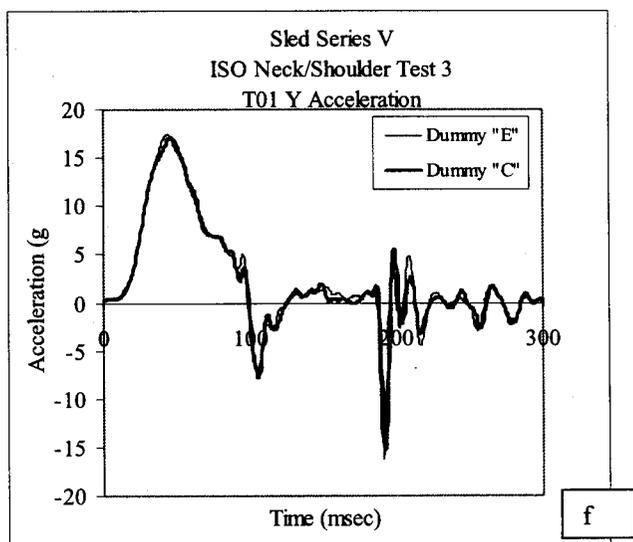
Figure 39. Data traces from ISO Neck/Shoulder Test 3 showing comparison between dummies C and E.

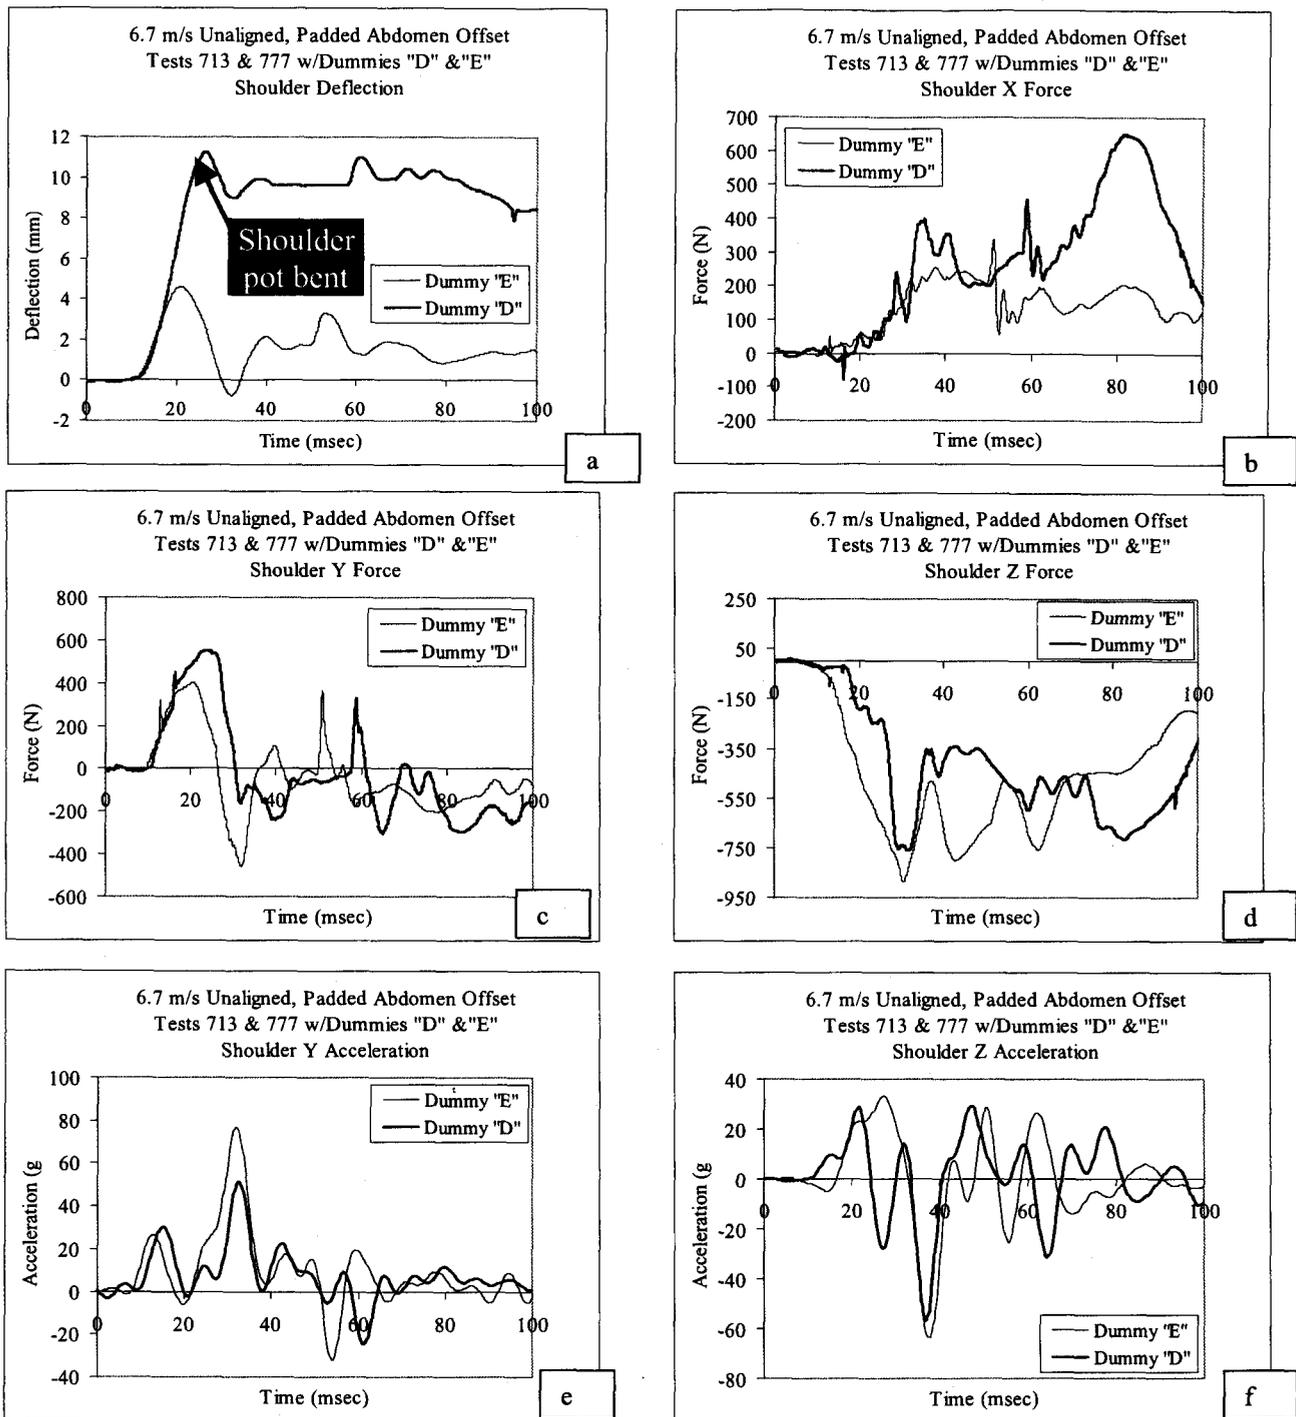
**Figure 40.** Comparison data traces from the shoulder region of dummies D and E from Tests 713 and 777, respectively, in the Unaligned, Padded Abdomen Offset condition. Note that in Test 713 the shoulder rib lodged up over the neck bracket, bending the shoulder pot and separating its damping material from the rib steel. No damage occurred in Test 777.

Analysis of high-speed video during the three tests showed that similar kinematics occurred, where the arm and shoulder of the dummy slid over the top of the thorax plate, and as the dummy rotated around the abdomen offset, the thorax plate loaded the shoulder vertically. Figure 40 shows comparison data traces from the shoulder region of dummies D and E from the Unaligned, Padded (2" 103kPa) Abdomen Offset tests (Tests 713 and 777, respectively). In the vertical (Z) direction, dummy E experienced comparable amounts of force and acceleration, if not more, than dummy D, indicating that the two dummies' shoulders were subjected to similar conditions. Since the dummy with the clavicle guide (E) did not sustain any damage from this test, it appears to be superior over the original shoulder guide at restraining vertical motion of the shoulder rib, and causing damage. No damage occurred during Test 778, either, confirming the success of the clavicle guide.

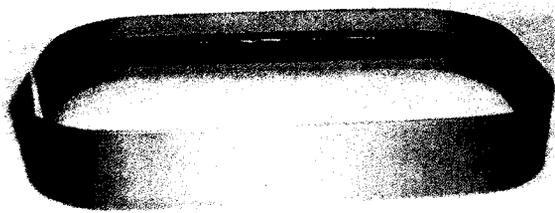
**Figure 42.** Shoulder rib assembly of original SID-IIs

As the damping material of the shoulder rib assembly of the original dummy was adhered to the center of the rib steel with roughly 1/2 inch depth, its attachment was not optimal for preventing it from being sheared off (Figure 42). To improve this condition, FTSS modified the shoulder rib assembly by adhering a thinner piece of damping material along the full width of the rib steel (Figure 43). Further evaluation of the FTSS prototype shoulder and rib guide was performed and is included in Section 7, FTSS FRG Prototype Evaluation.

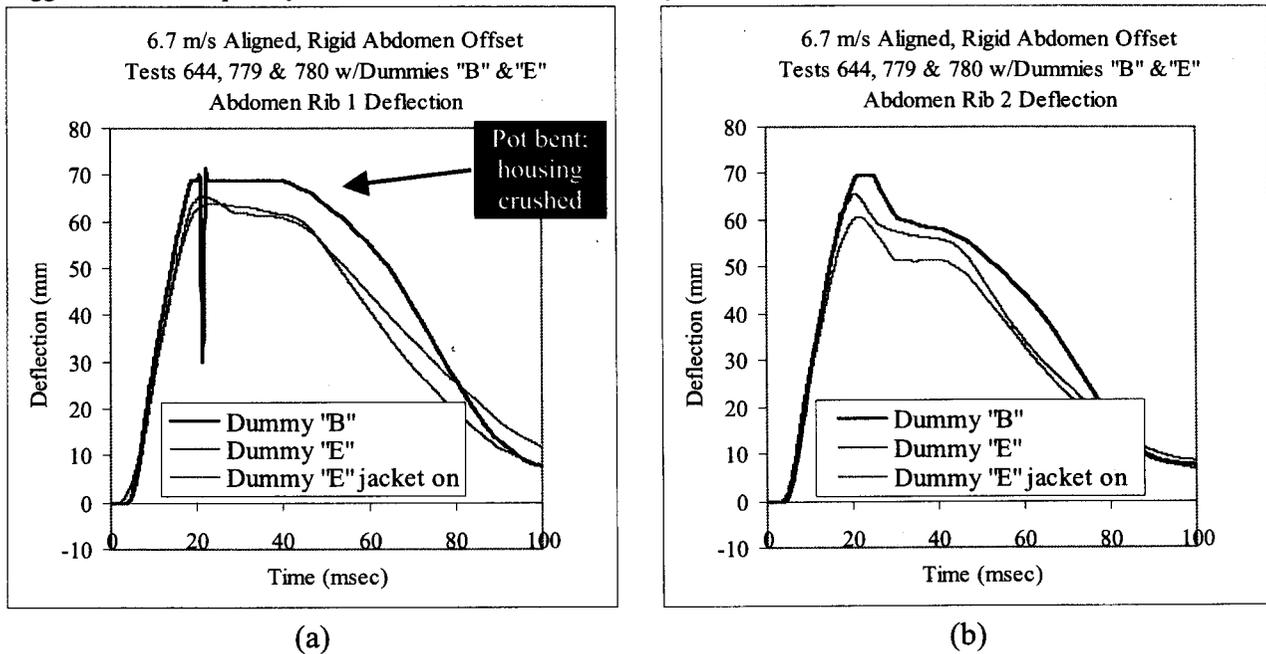
**Figure 49.** Abdomen rib 1 (a) and abdomen rib 2 (b) deflection data traces from Tests 644, 779 and 780 with dummies B and E showing effect of prototypes, including FRG, shoulder "clavicle", and new rib stops. Note that no damage occurred with dummy E in Tests 779 and 780.

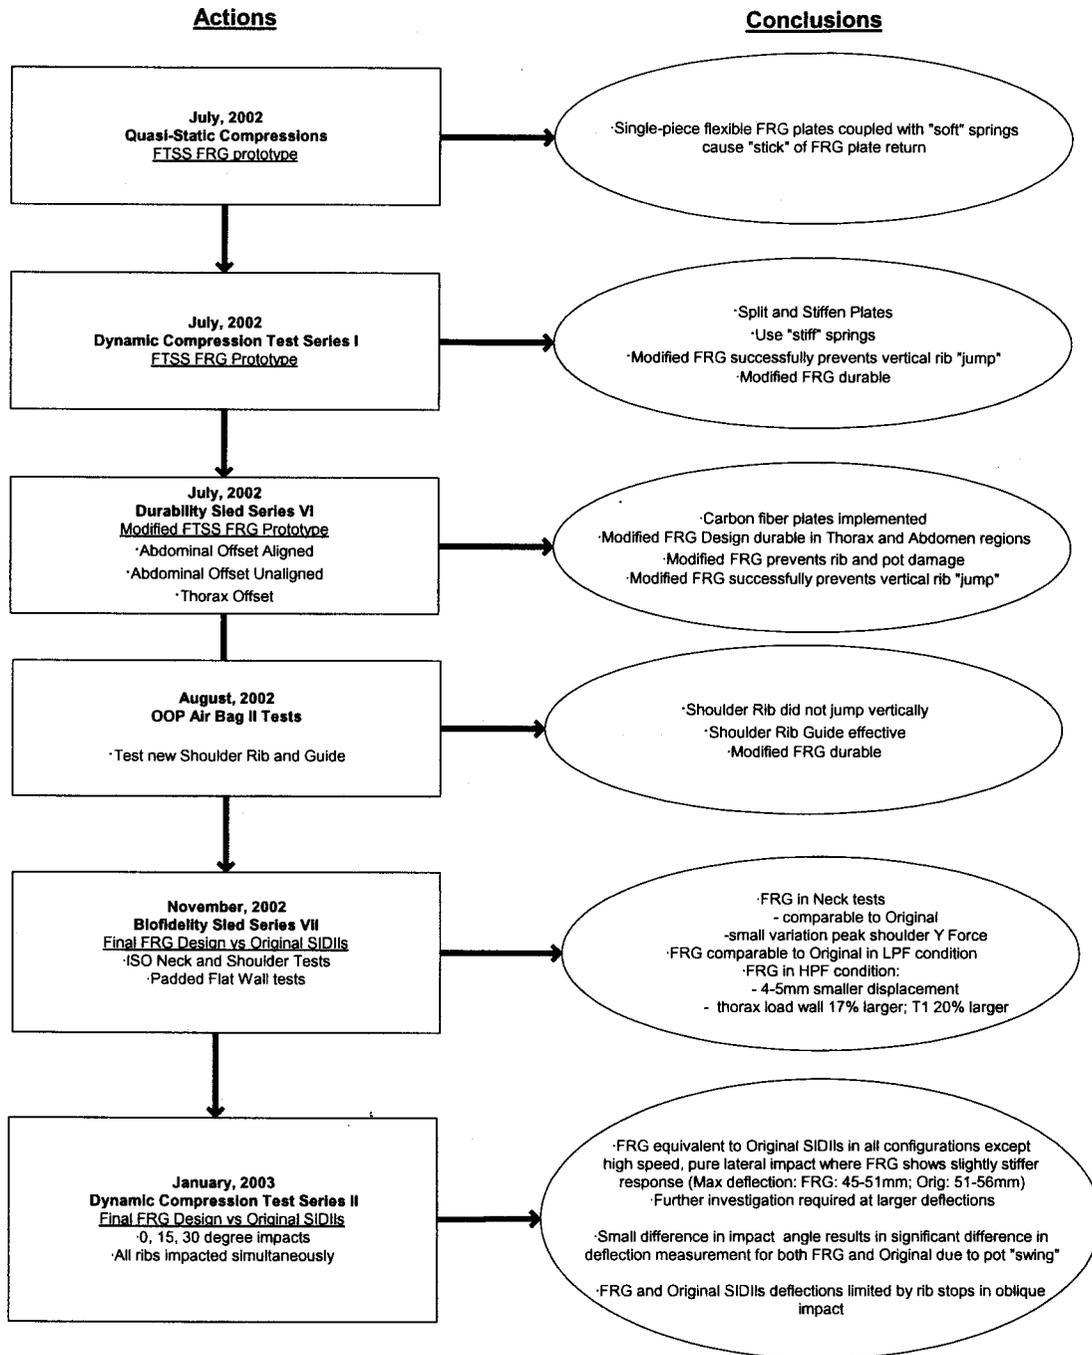
Figure 51. Flowchart of evaluation testing and outcome of the FTSS SID-IIs FRG

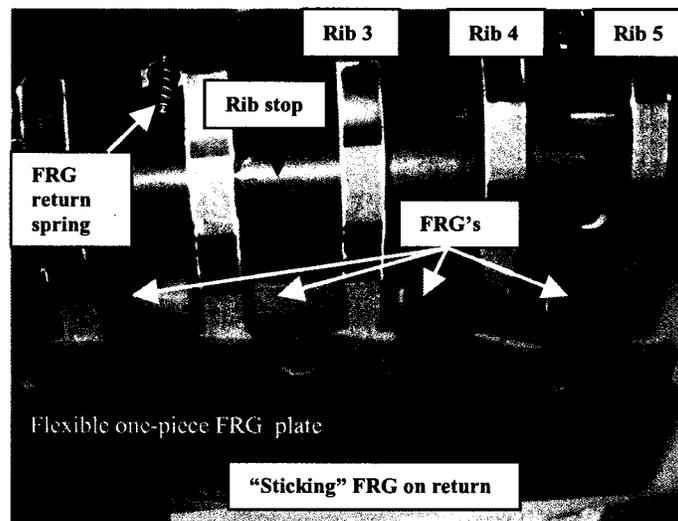
**Figure 53. Flexible one-piece FRG plate binding on rib return during quasi-static tests**

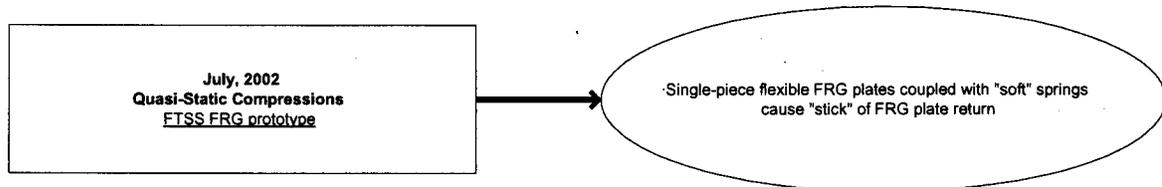
**Figure 54. Summary of July 2002 quasi-static compression tests**

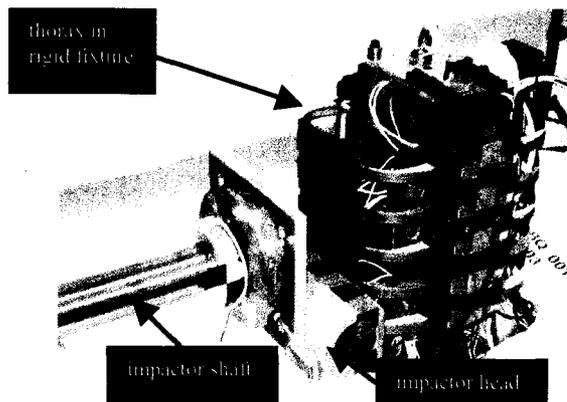
**Figure 55.** Example of dynamic compression test setup used throughout FRG prototype evaluation testing

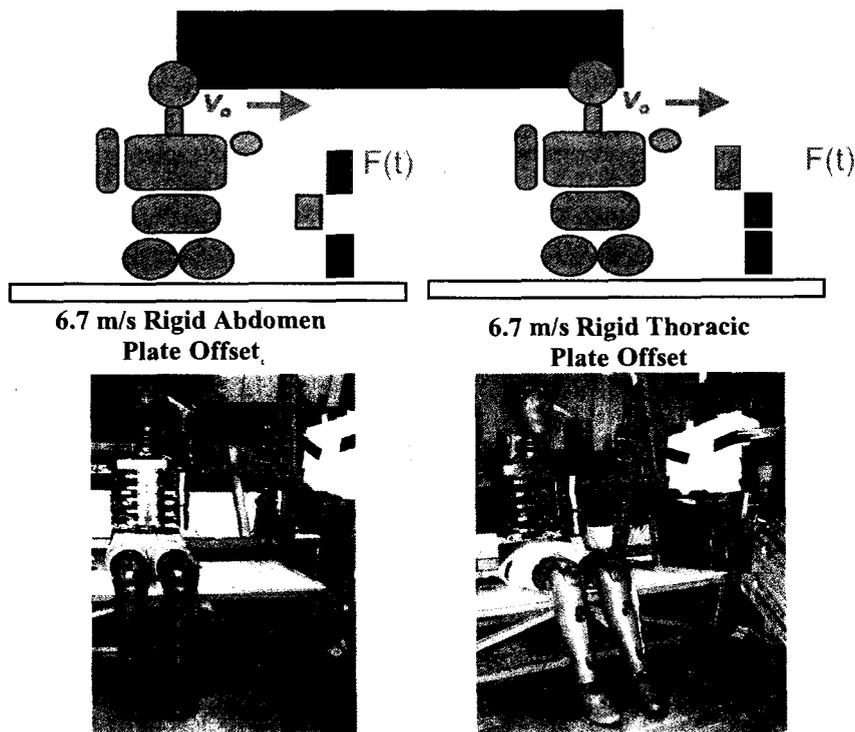
Figure 59. Setup for FRG Durability Sled Series VI
