Subject: Docket submission of Technical Report "Development of the SID-IIs FRG"

# **Development of the SID-II's FRG**

**Heather Rhule**

**November 2003**

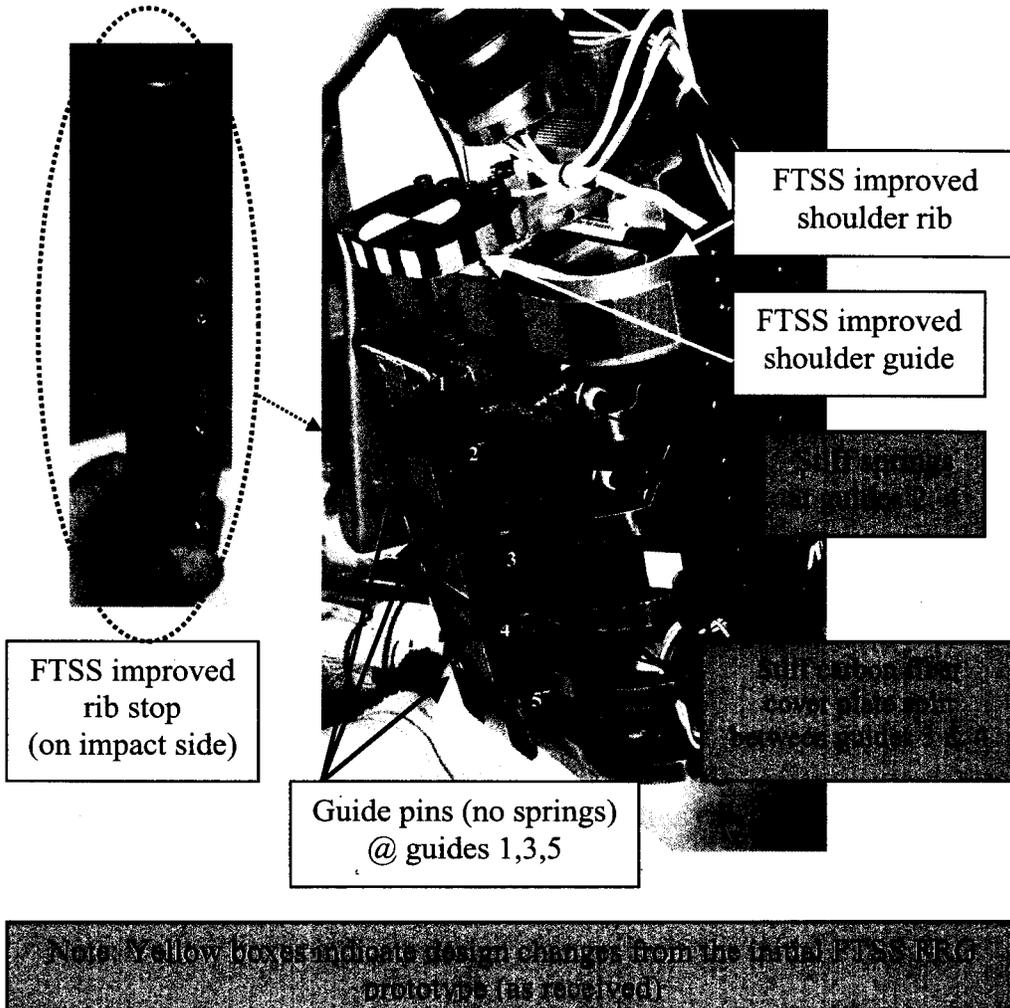
**Figure 61a.** Modified FTSS FRG Dummy in final configuration after VRTC testing

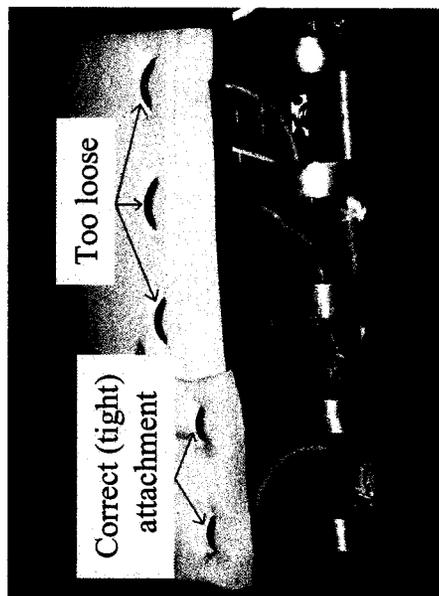
**Figure 61b.** VRTC’s new thorax and abdomen pad attachment method using cable ties. Note that abdomen pad in this figure does not reflect the ¼” cut from the top of the abdomen pad.

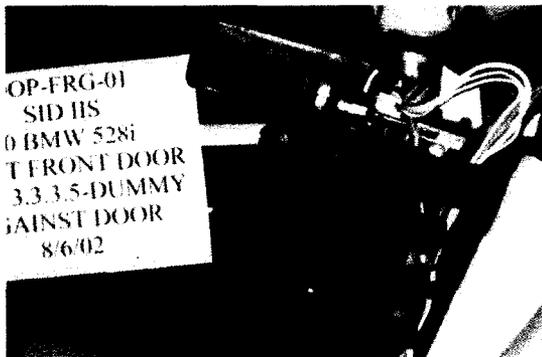
**Figure 63.** FRG SID-II's OOP Test 1

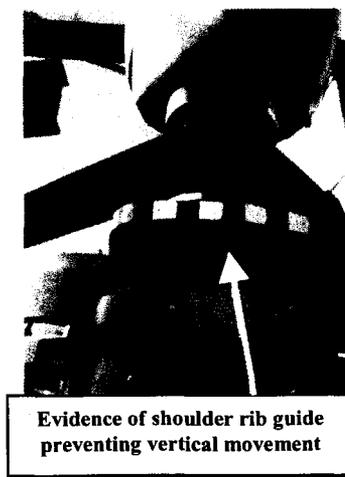
**Figure 65.** Shoulder guide after the OOP test

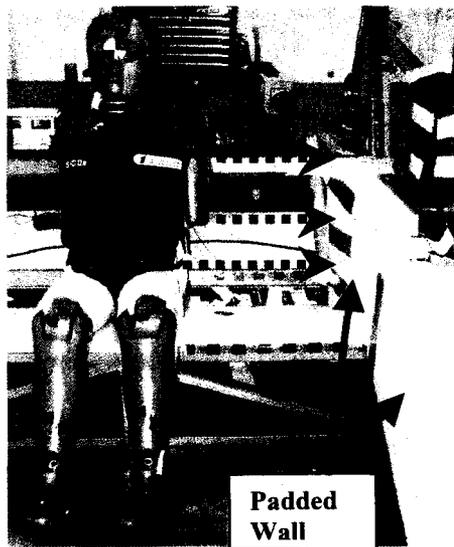
Figure 68. Flat, padded wall test setup

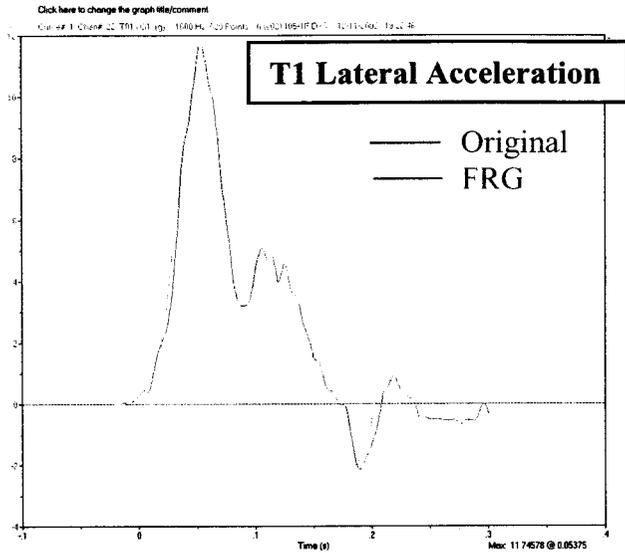
**Figure 69.** T1 lateral acceleration of the Original and FRG SID-IIs dummies in Neck Test 1/Shoulder Test 2

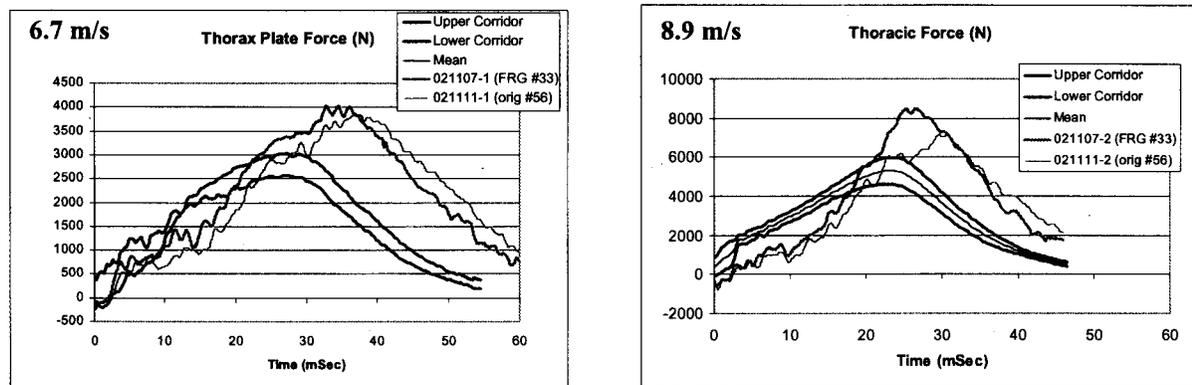
Figure 77. Thoracic plate force response and biofidelity corridors for 6.7m/s and 8.9m/s padded flat wall tests

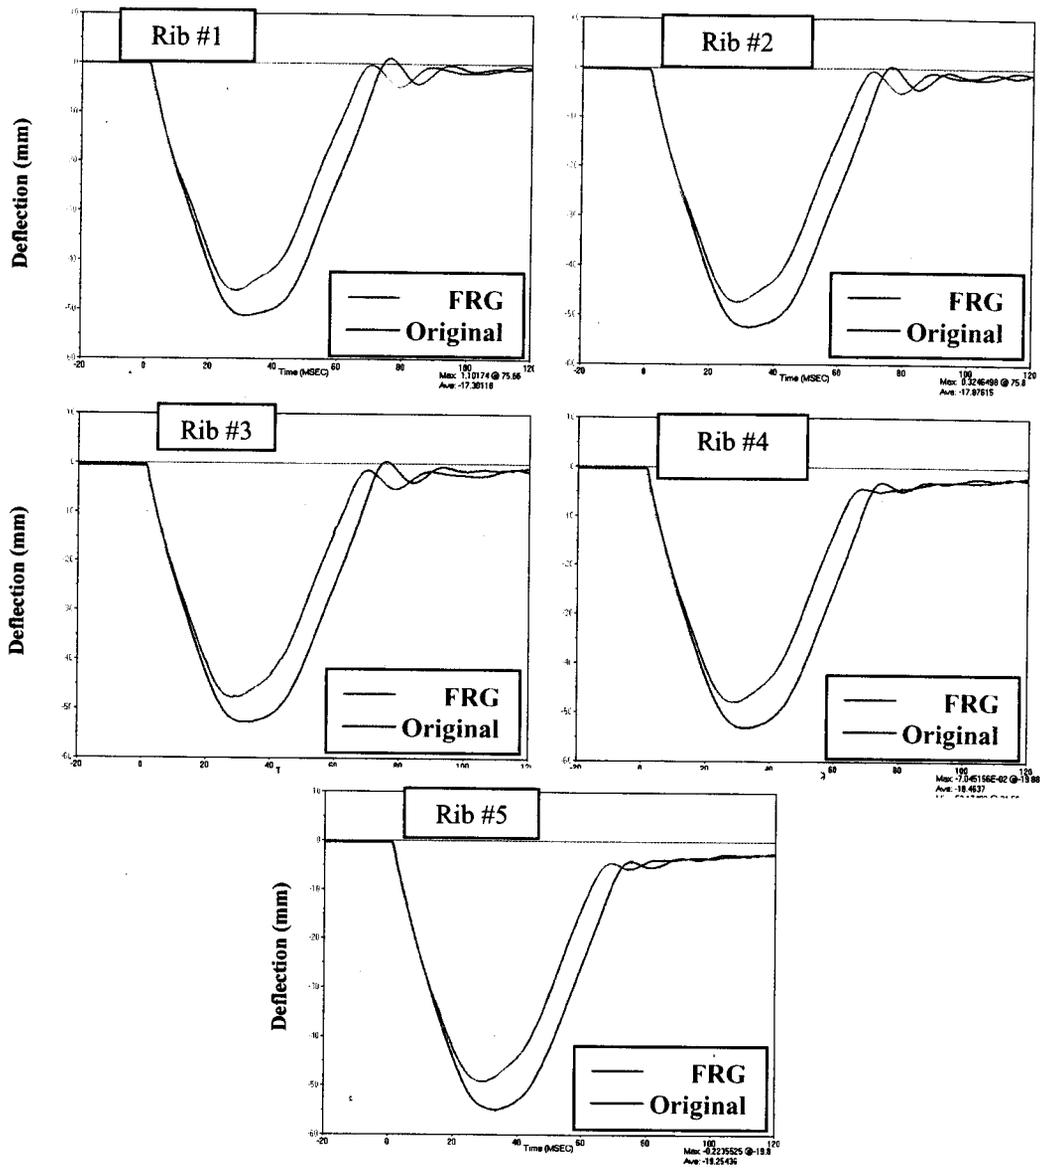
Figure 88. Comparison overlays between the FRG (Test 27) and Original (Test 26) SID-IIs in 6.6 mph, 0° impacts

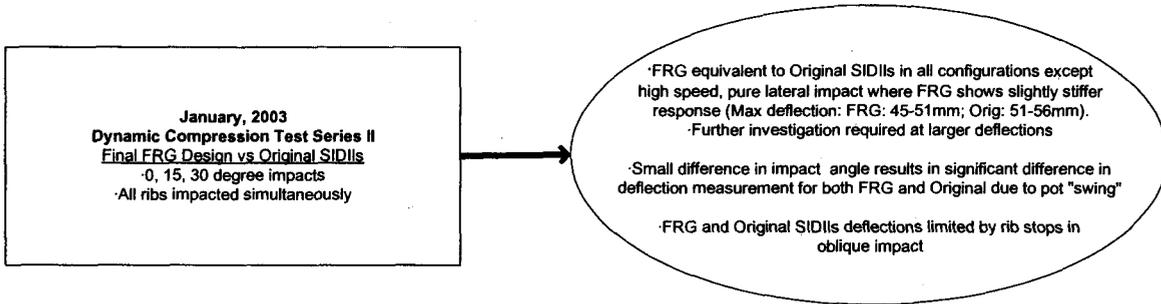
Figure 96. Summary of Dynamic Compression Test Series II

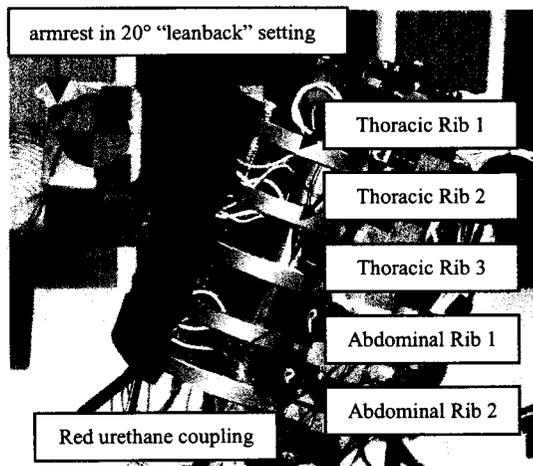
**Figure 98.** Setup for “leanback” impacts conducted in Dynamic Compression Test Series III (setup is for a 20° oblique, 20° upward, 20° “leanback”, impact of upper ribs)

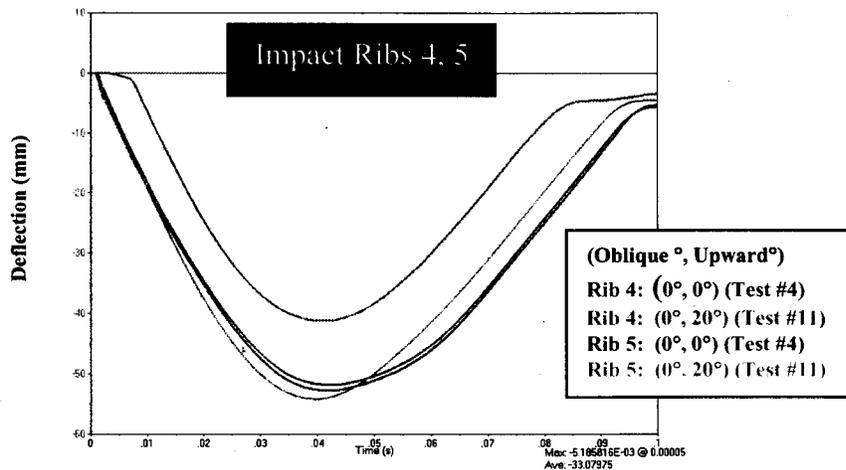
**Figure 102.** Plot overlay showing influence of upward angle on deflections (note that Rib 5 is the “primary contact” rib in the Rib 4, 5 impact)

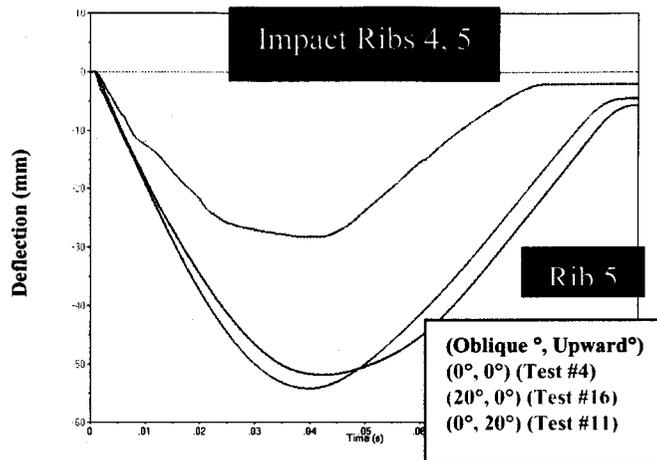
**Figure 103.** Plot overlay showing influence of oblique angle on deflections (note that Rib 5 is the “primary contact” rib in the Rib 4, 5 impact)

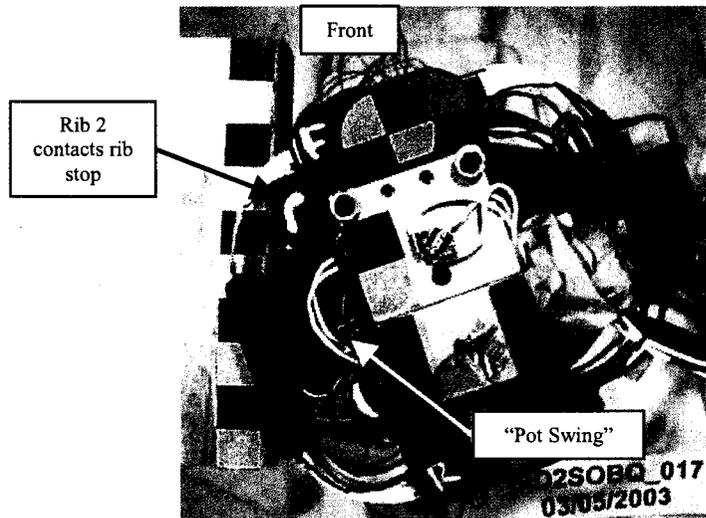
**Figure 104.** Illustration of “pot swing” and rib stop contact which limit deflection in oblique impacts in Dynamic Compression Series III (Test 17)

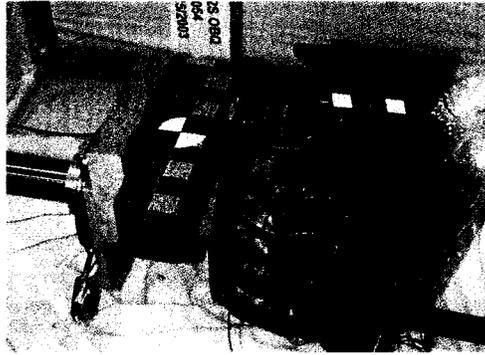
**Figure 108.** Original SID-IIs setup in 15° oblique, 10° upward configuration

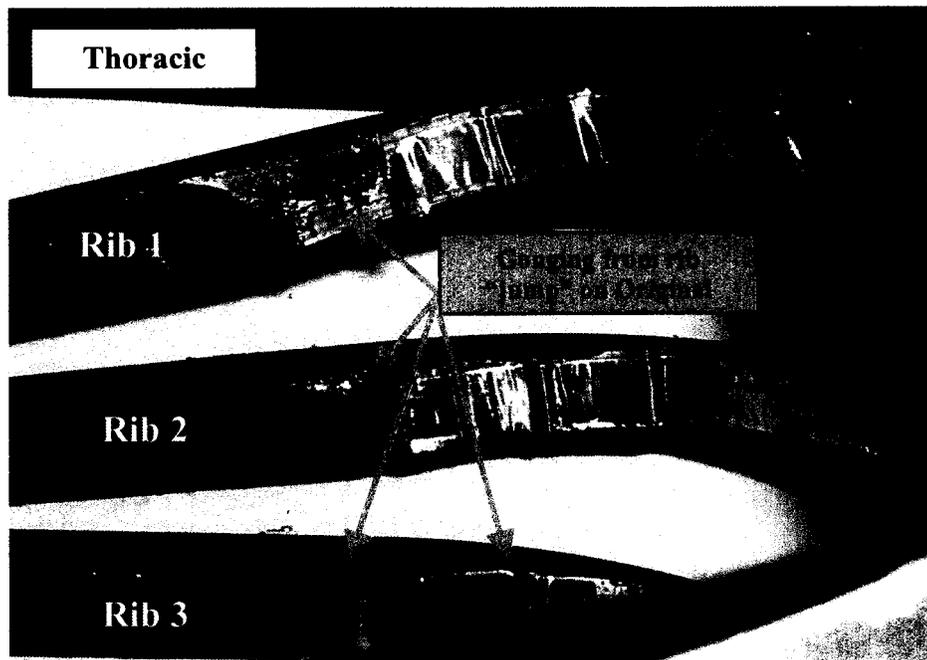
**Figure 109.** Gouging from rib jump on Original SID-IIs during Dynamic Compression Series IV

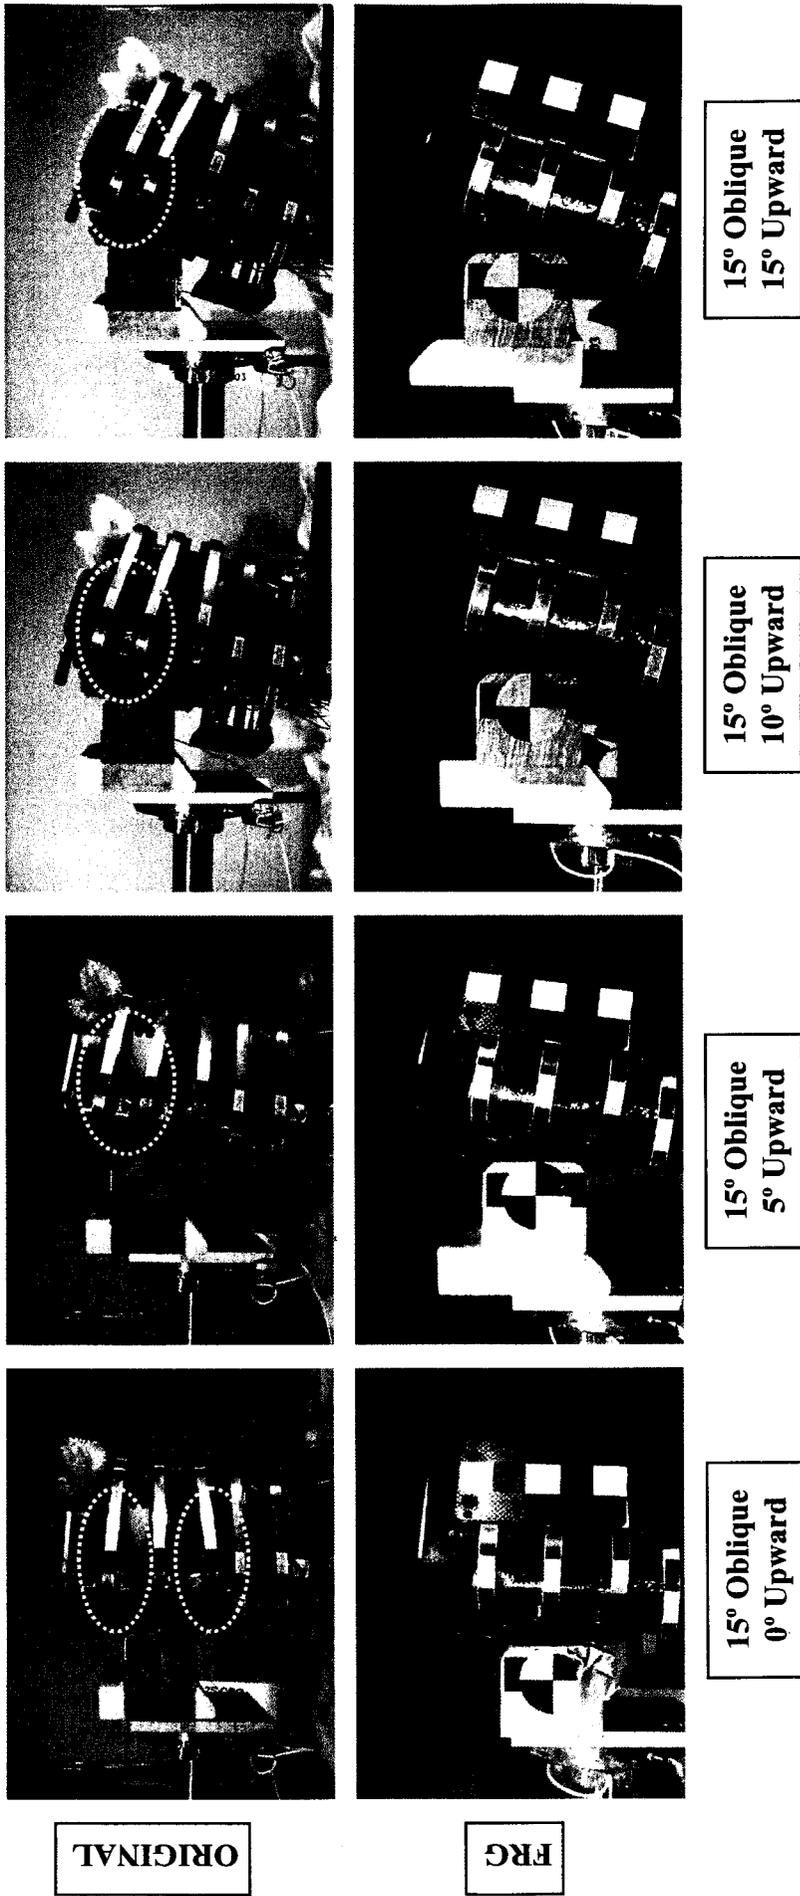
**Figure 110.** Comparison between the Original (top row) and FRG (bottom row) SID-IIs thorax responses for oblique, upward, impact configurations from Dynamic Compression Test Series IV (circled areas denote "rib jump")

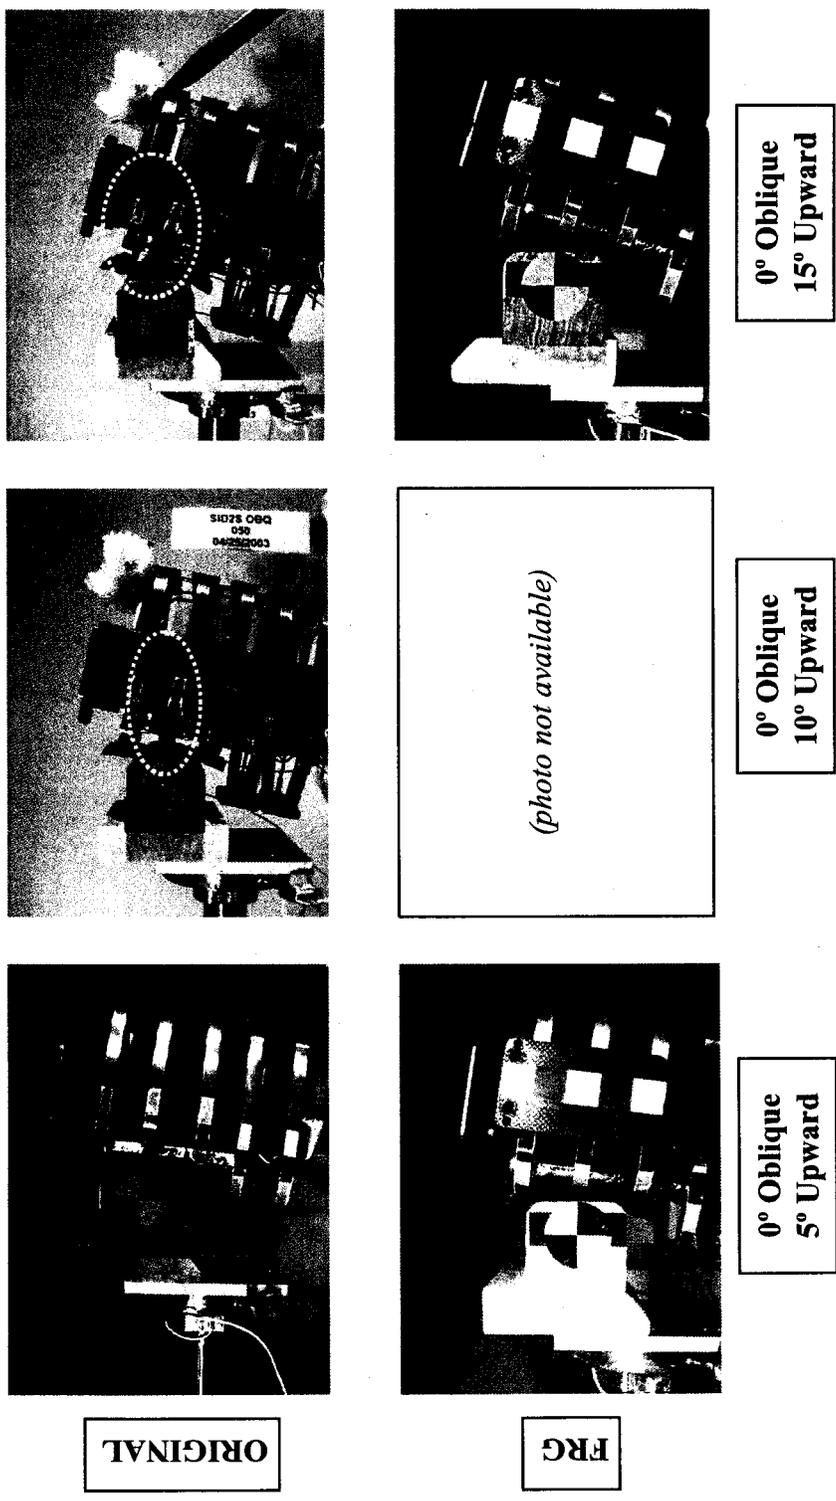
Figure 111. Comparison between the Original (top row) and FRG (bottom row) SID-II's thorax responses for upward impact configurations from Dynamic Compression Test Series IV (circled areas denote "rib jump")

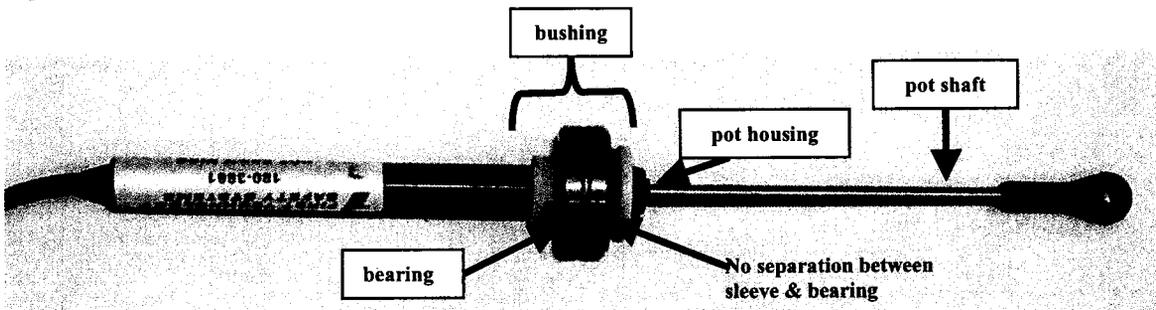
**Figure 121.** SID-IIs potentiometer assembly with bushing sleeve intact in metal bearing

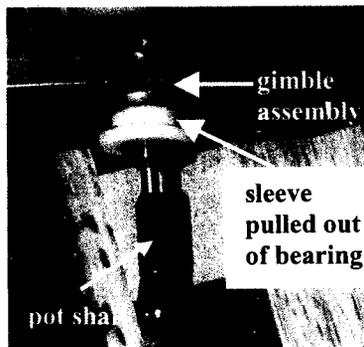
**Figure 122.** Bushing sleeve separation from metal bearing

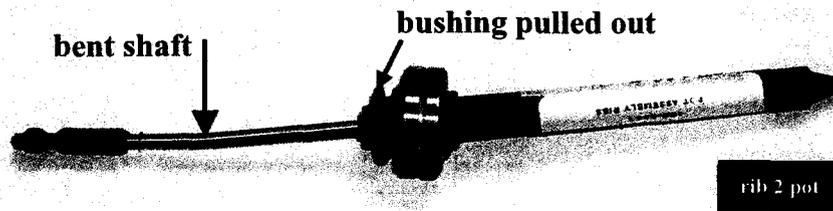
Figure 123. Damage to potentiometer shaft and bushing during Test 89

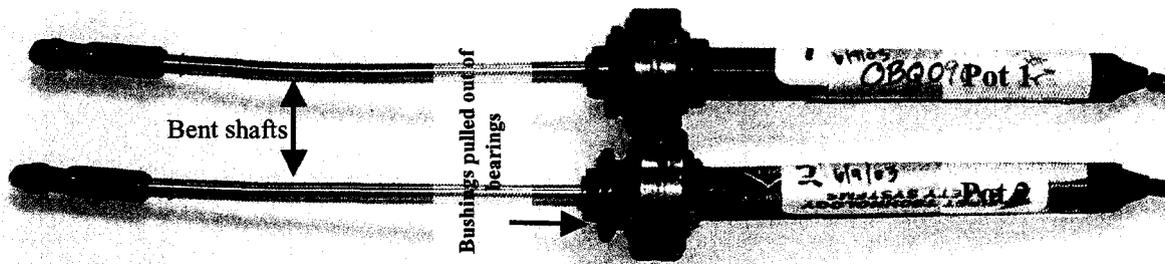
Figure 124. Potentiometers 1 and 2 showing pot bending damage and bushing pull-out after Test 90

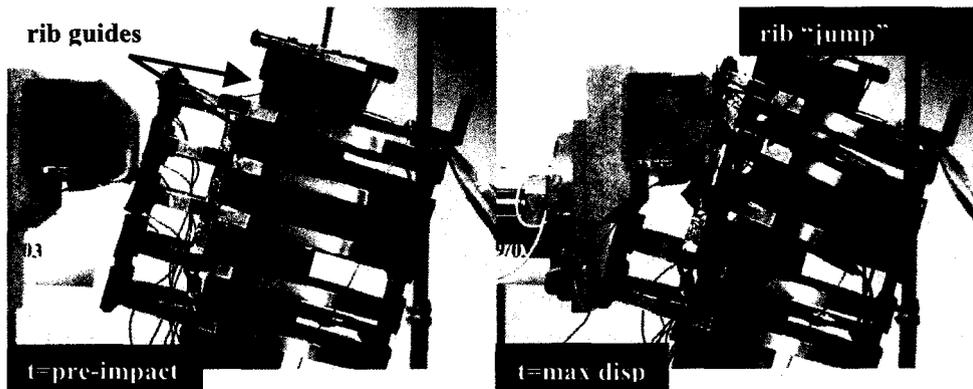
Figure 125. Vertical displacement (“jumping”) of ribs beyond rib guides which led to potentiometer damage on the Original SID-IIs (Test 90)

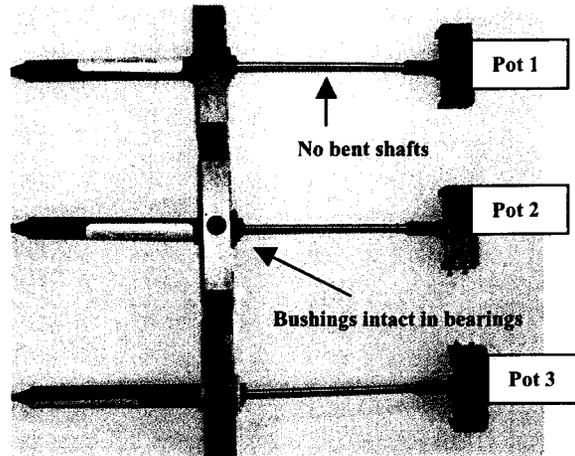
Figure 126. No damage to pots in FRG Tests 91 and 92

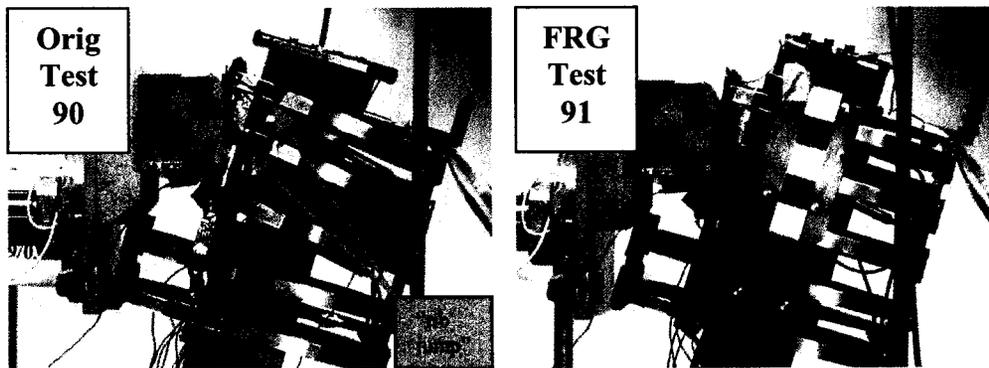
Figure 127. Comparison between Original and FRG SID-IIs in 0° oblique, 15° upward impact at 6.4 mph. Evidence of "rib jumping", which damaged pots in the Original dummy, is absent in the FRG.
