1. Report No. DOT/FAA/CT-90-10		2. Government Accession No.		3. Recipient's Catalog No.	
4. Title and Subtitle FUSELAGE BURNTHROUGH FROM LARGE EXTERIOR FUEL FIRES				5. Report Date July 1994

6. Performing Organization Code ACD-240	
7. Author(s) Harry Webster				8. Performing Organization Report No. DOT/FAA/CT-90-10	
9. Performing Organization Name and Address Federal Aviation Administration Technical Center Atlantic City International Airport, NJ 08405				10. Work Unit No. (TRAVIS)

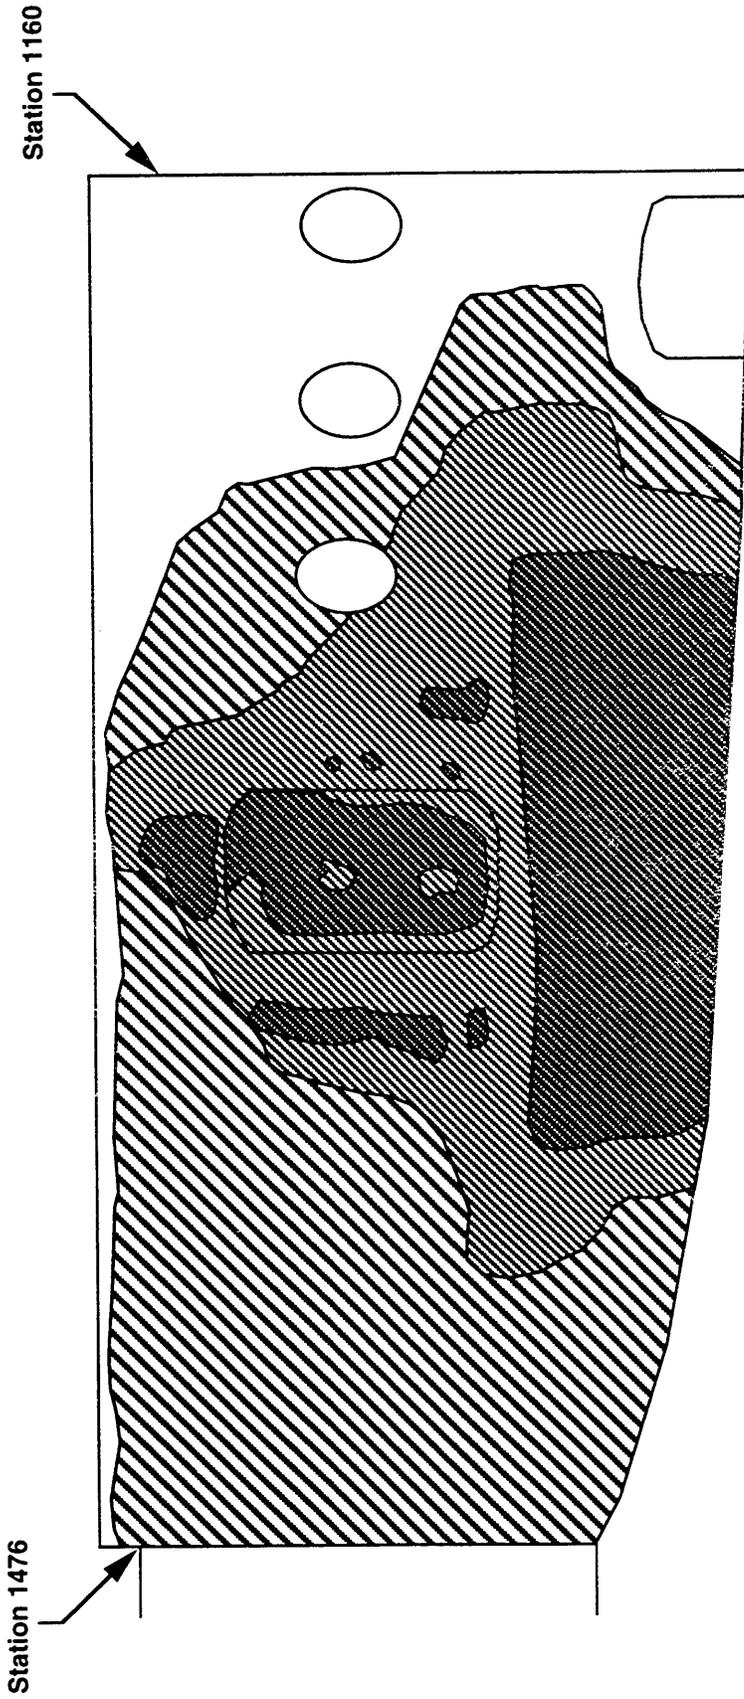
FIGURE A-8. TEST 1 EXTERIOR FIRE DAMAGE, AFT SECTION FUSELAGE STARBOARD SIDE

Skin Penetration. The aluminum skin melted away in an area below the floor and centered about the aft service door (figure A-8). The damage extended approximately 6 feet forward and 5 feet aft of the door. The skin was buckled approximately 30 inches on all sides of the melted area. The titanium doubler strips were undamaged. The skin above the door was melted in a triangular shape extending 12 inches on either side of the doorway and 30 inches above the door.

Fiber Glass Insulation. The insulation exposed by the melted skin was charred and extended downward 30 inches from the floor level but was mostly intact. The insulation had fallen away in the cheek area, approximately 3 feet forward of the aft service door, exposing the cargo compartment liner to the fire. The cargo liner was cracked and scorched in this area. Where the insulation remained in place there was no fire damage to the interior of the aircraft.

FIRE PATHS. The smoke and fire that entered the cabin came through the air conditioning return grills located on the sidewall at the floor level. These grills are open into the cheek area on each side of the cargo compartment. This area forms a duct that channels the exhaust air to the outflow valves located in the empennage crawlthrough aft of the cargo compartment. The pool fire melted the skin in the cheek area, opening a path to the grills. The fire in the overhead did not travel up through the sidewalls or through the ventilation ducts. The skin above the door was penetrated directly by the pool fire plume (figure A-8). Here the insulation was dislodged, allowing access to the overhead.

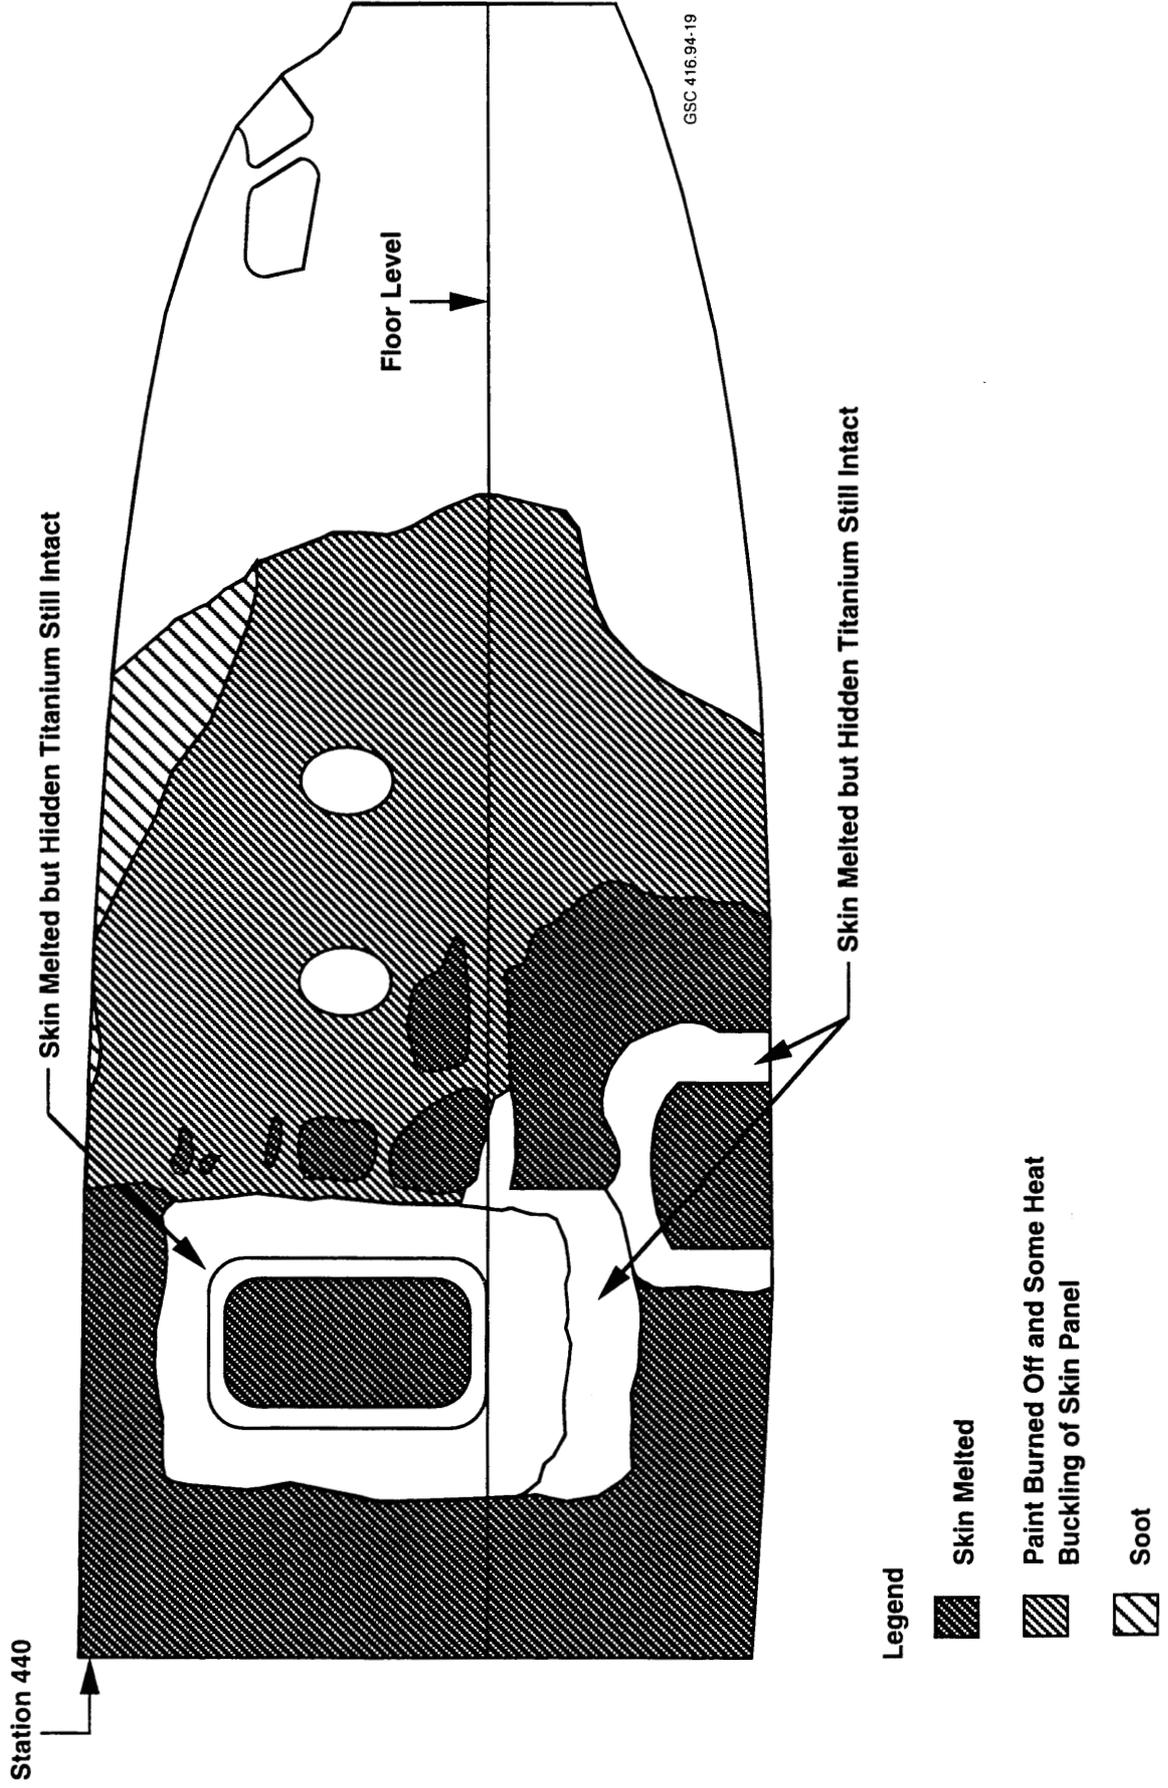
FIGURE B-8. TEST 2 EXTERIOR FIRE DAMAGE DIAGRAM, FORWARD FUSELAGE STARBOARD SIDE

Skin Penetration. The aluminum skin was extensively destroyed from the fire barrier, located at the compartment partition, to approximately 16 feet forward as shown in figure B-7. The damage extended from ground level up to the center or the top of the aircraft (figure B-8). The skin on the service door was completely melted away. The cargo door skin was also melted away. Nearly all of the skin below the floor level was melted. The two windows on the starboard side were checkered but were still in their frames.

Forward Service Door. The skin on the door was completely melted away. Both the door window pressure pane and fail-safe pane were gone from their frame and much of the frame was melted. The interior door panel was 80 percent destroyed leaving a hole approximately 2 by 4 feet to the outside.

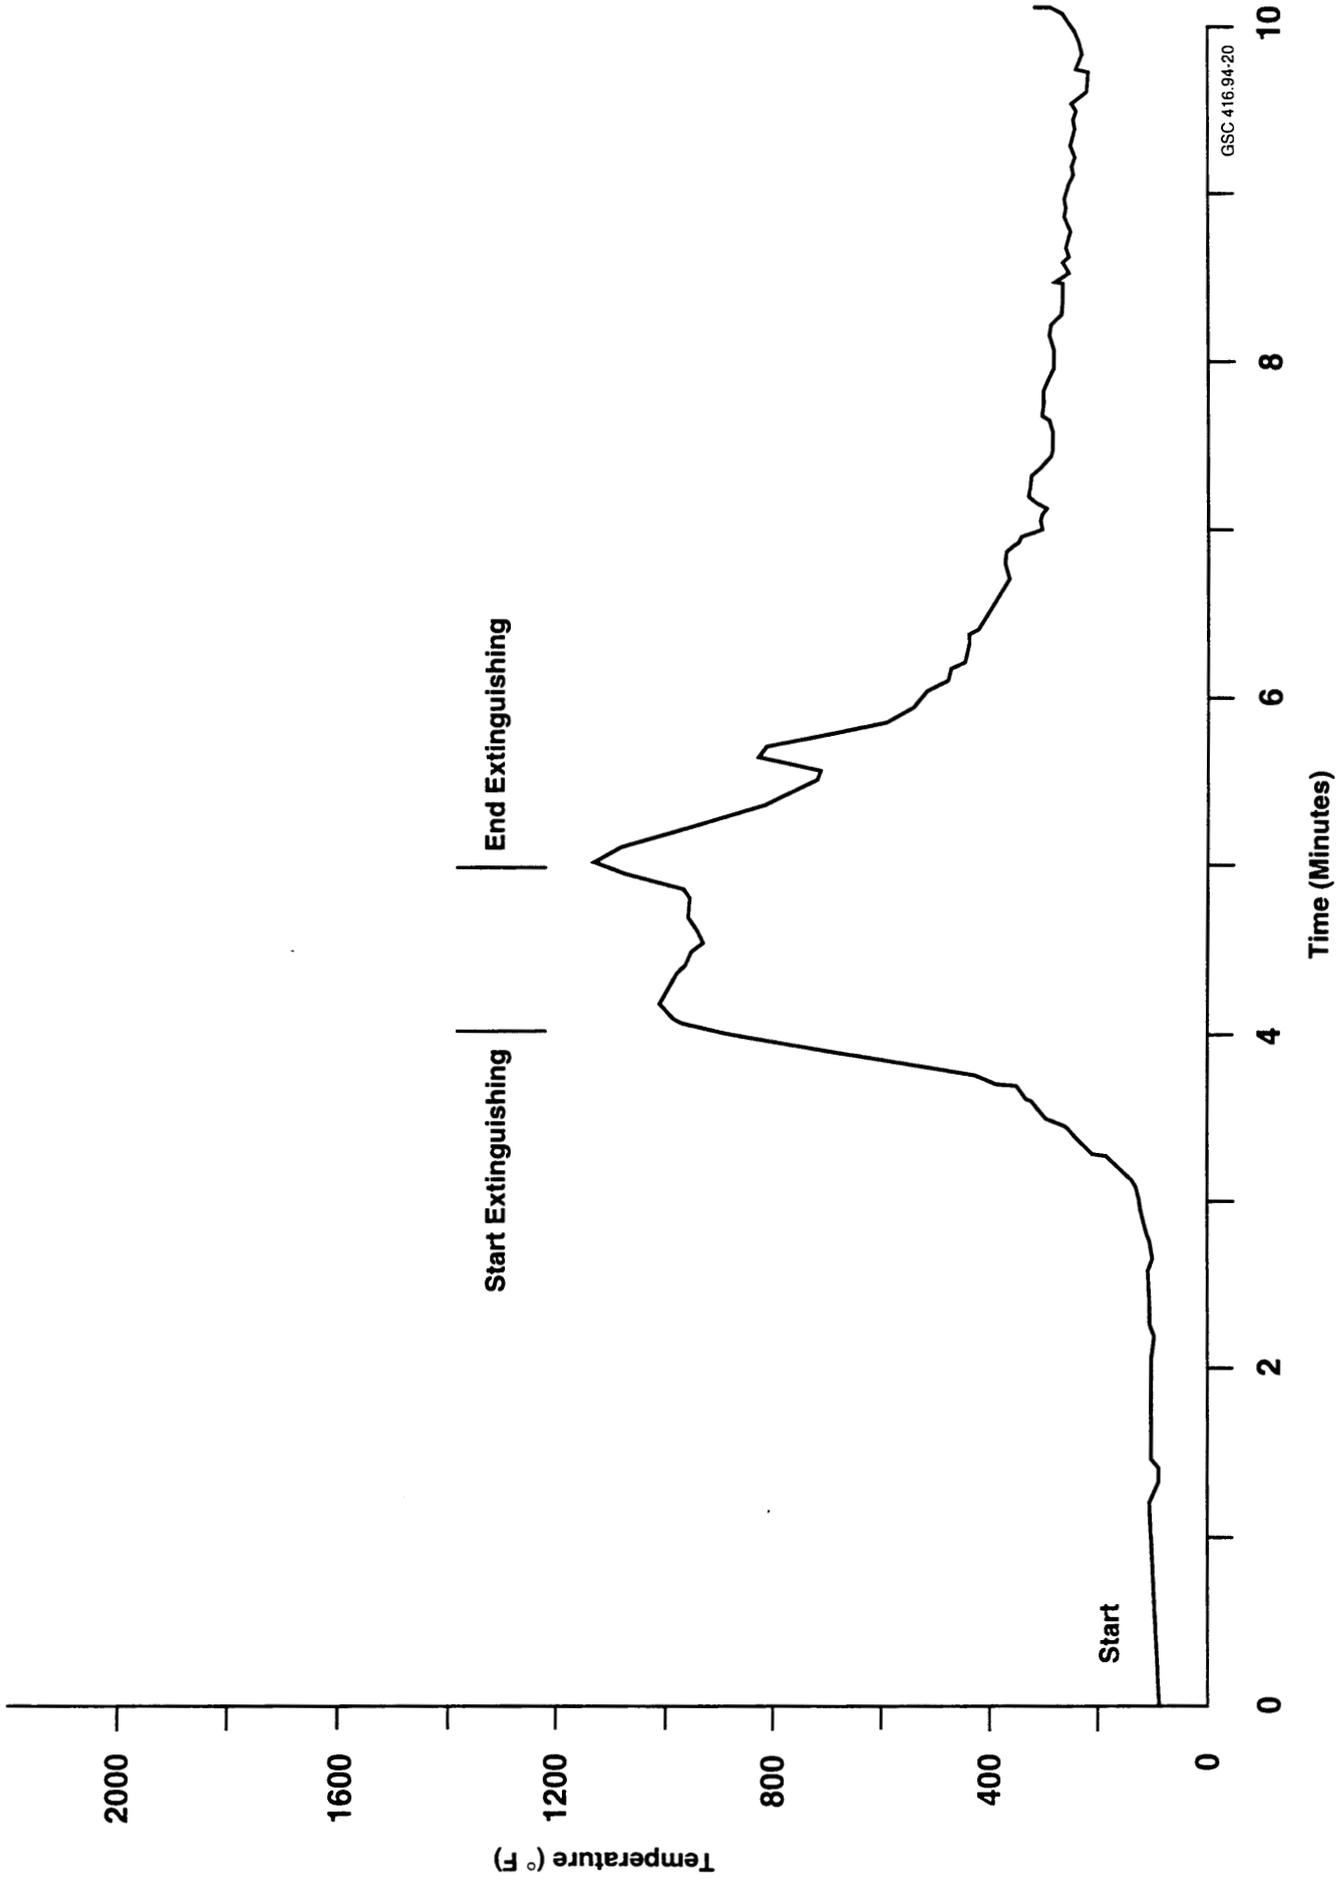
FIGURE B-9. TEST 2 AIR TEMPERATURE BETWEEN CABIN FLOOR AND THE CARGO COMPARTMENT AT STATION 270

Cargo Compartment. The fire breached the cargo compartment through the cargo door. The liner was blackened but not cracked where it was exposed in the cheek area. The interior of the compartment was sooted but undamaged. The area between the upper liner and the cabin floor was heavily sooted and the insulation charred but still intact. The temperature above the upper liner at station 270 reached a peak of 1100 °F (figure B-9). The cargo door was completely destroyed.

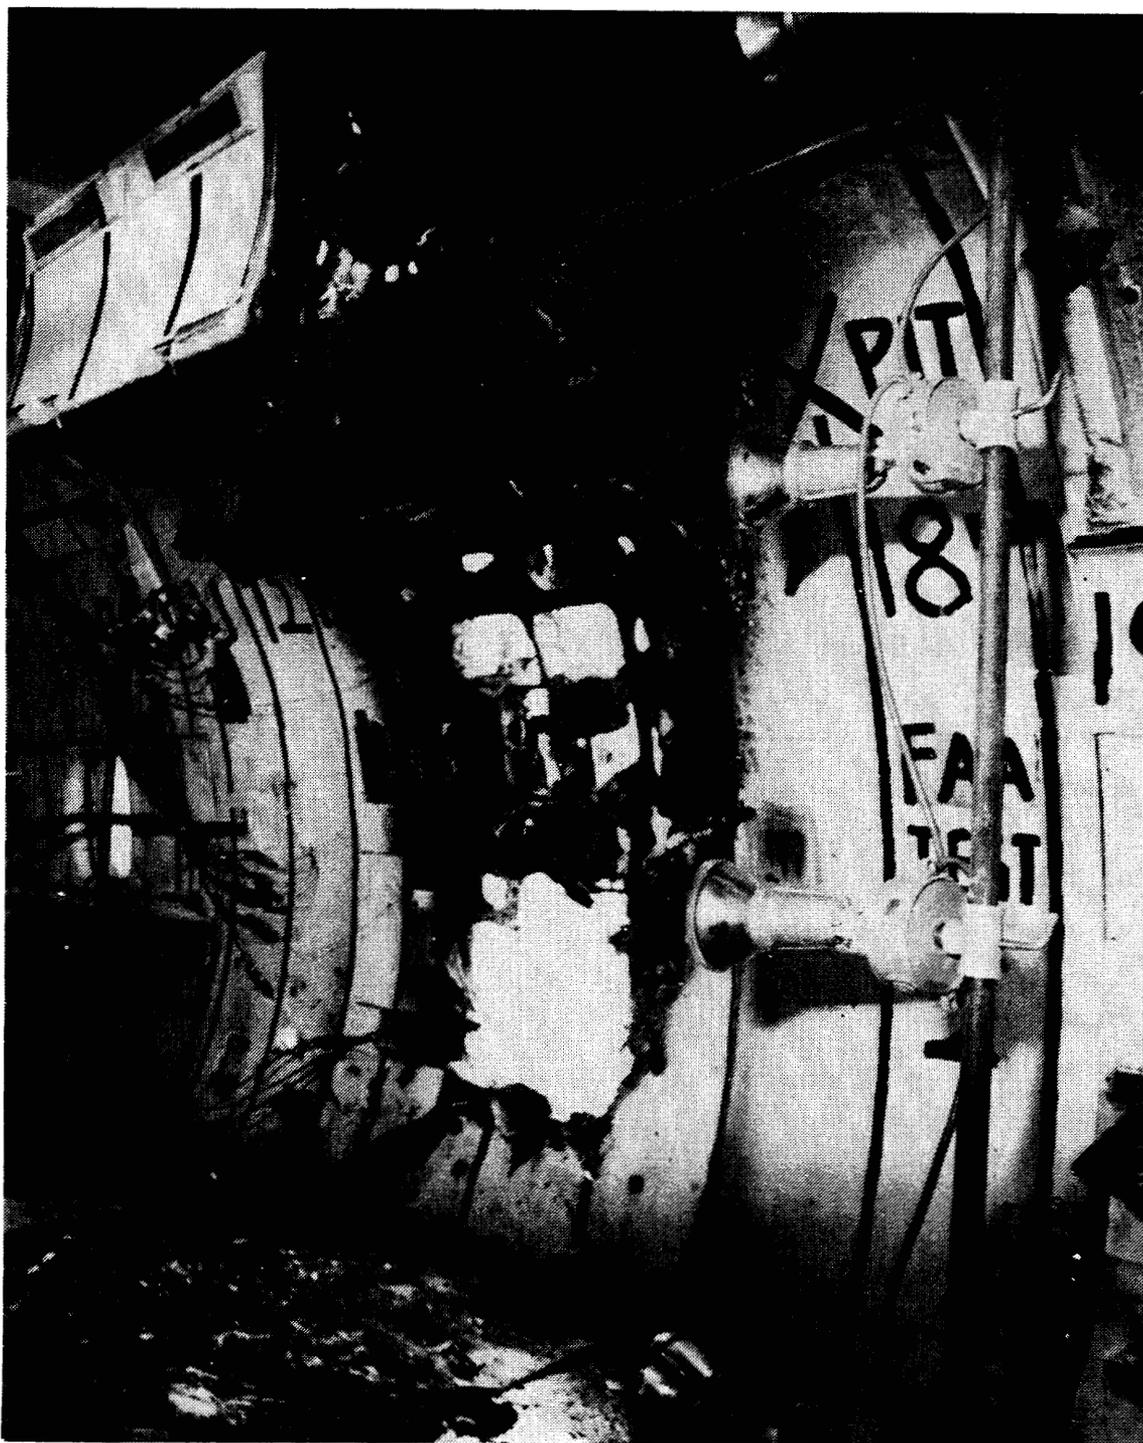
FIGURE B-10. TEST 2 CABIN INTERIOR STARBOARD SIDE SERVICE DOOR

Sidewall Panels. There was no damage to the sidewall panels forward of the starboard service door. The interior panel of the starboard service door was completely burned through as shown in figure B-10. The only insulation in the door consisted of one half-inch fiber glass bonded to the exterior side of the interior door panel. The panels aft of the door adjacent to the steel partition were heavily charred but not penetrated. The panels all along the starboard side (when removed from the aircraft) exhibited heavy charring on the fire side. In most cases the insulation protected the panels.

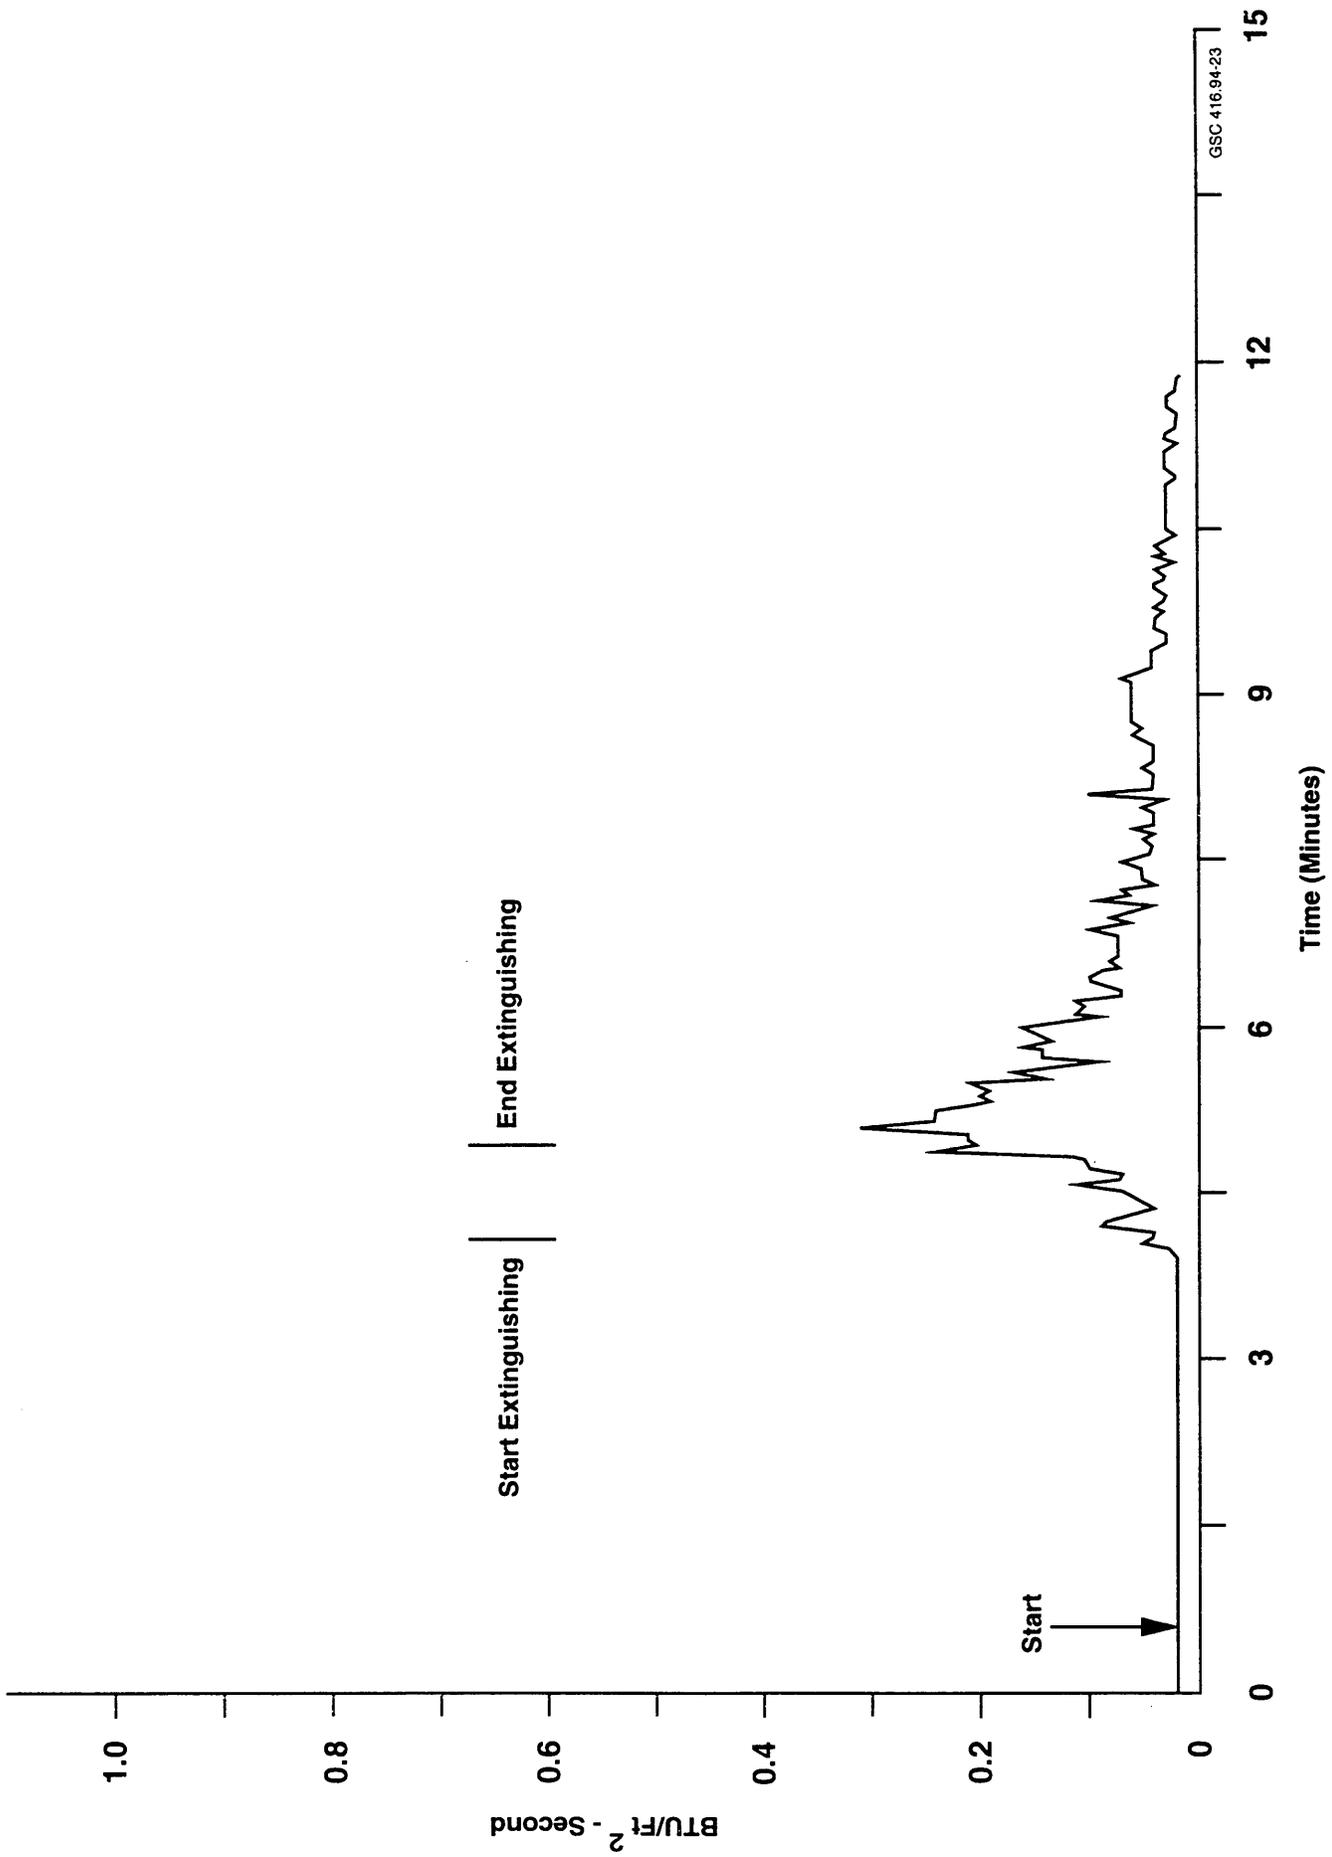
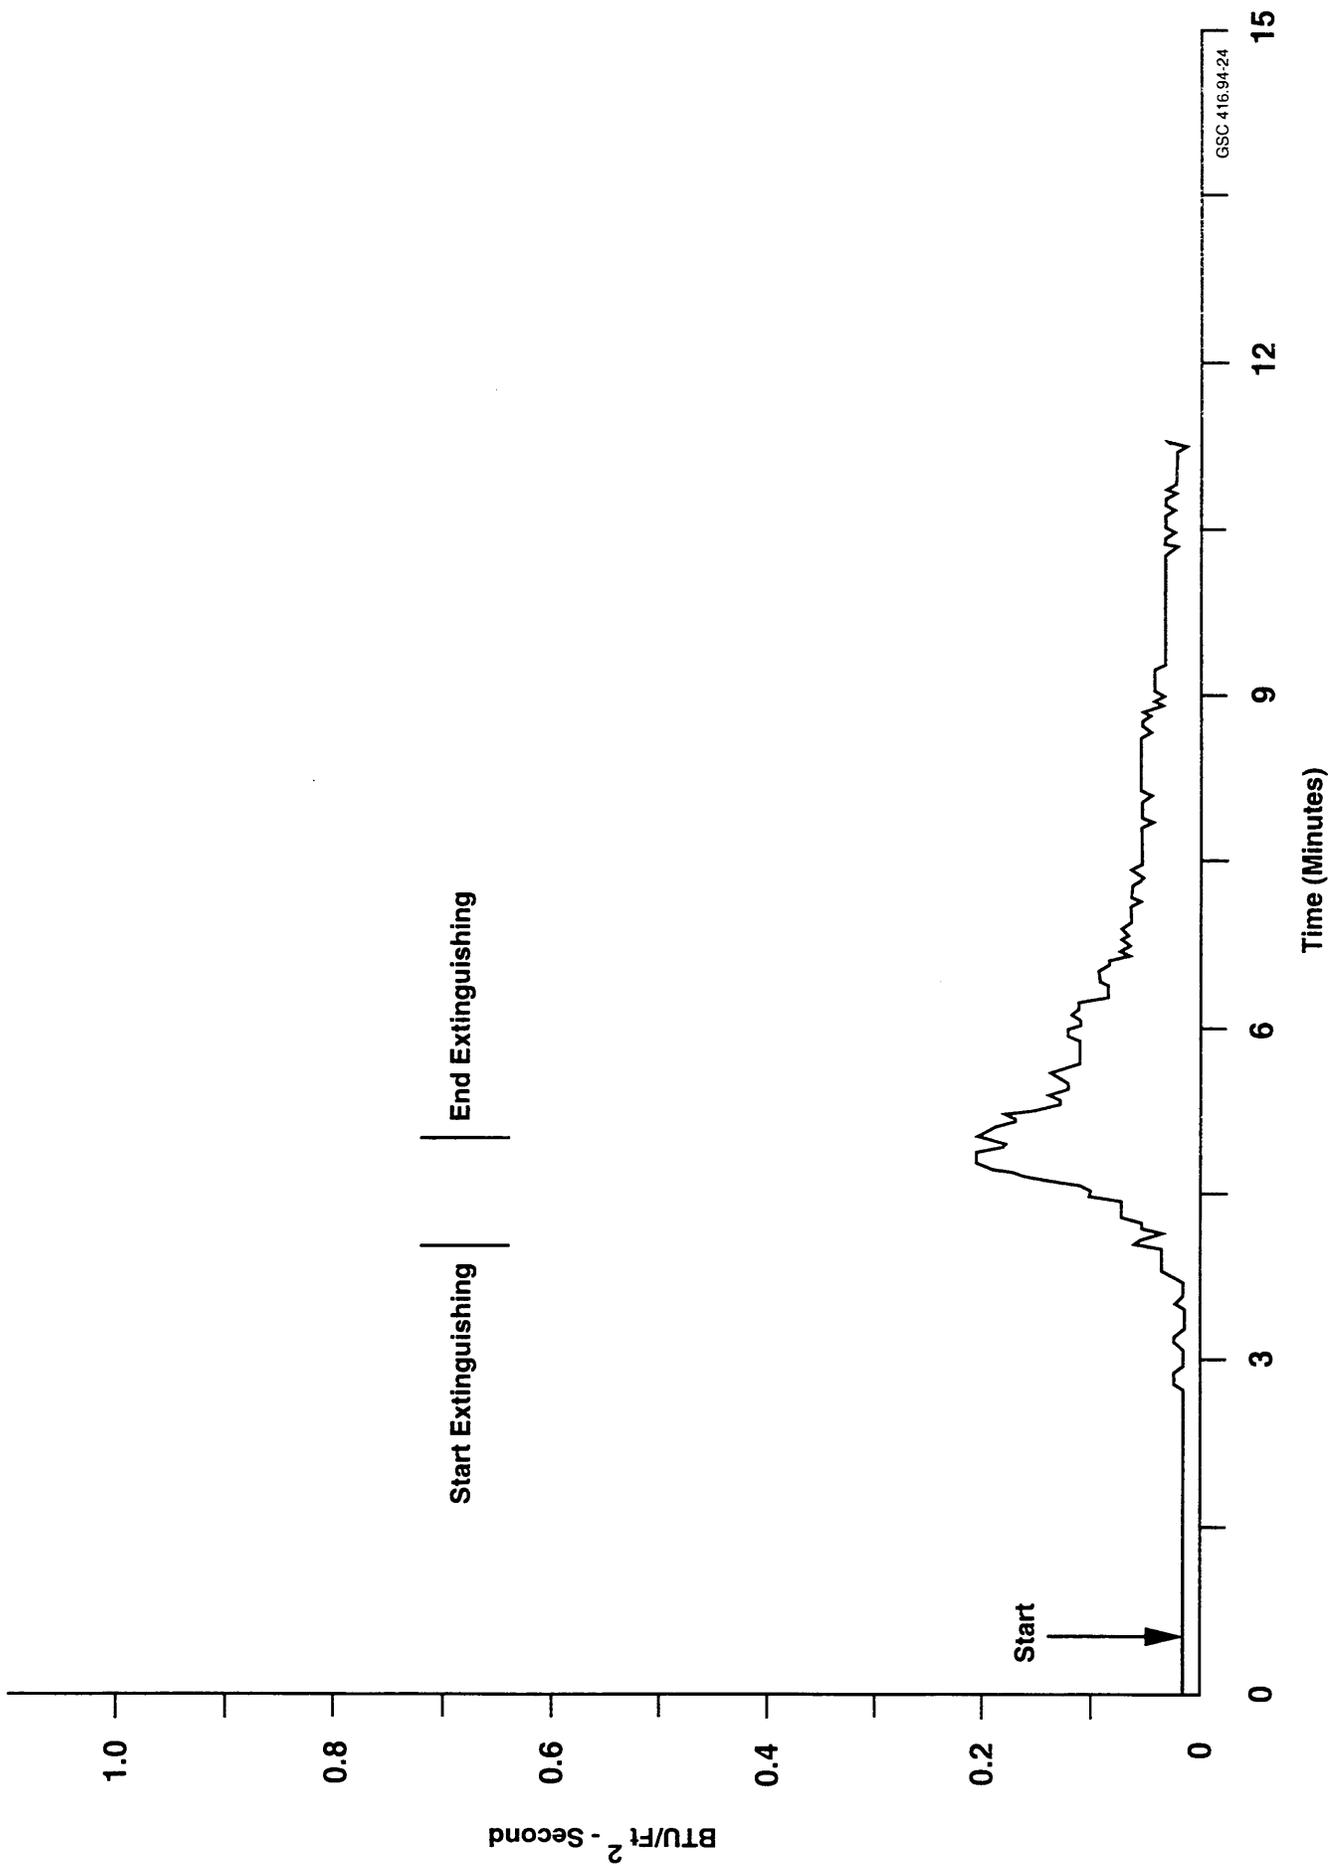
Windows. The temperatures of the pressure and fail-safe panes of the windows located at stations 241 and 287 stayed low when exposed to flame temperatures as high as 1800 °F. The pressure pane charred quickly providing an insulating layer that protected the fail-safe pane (figures B-11 and B-12). Calorimeters located inside the cabin and 18 inches from the windows registered heat flux values transmitted through the window panes of only 0.2 to 0.3 BTU/FT²-second. (figures B-13 and B-14).

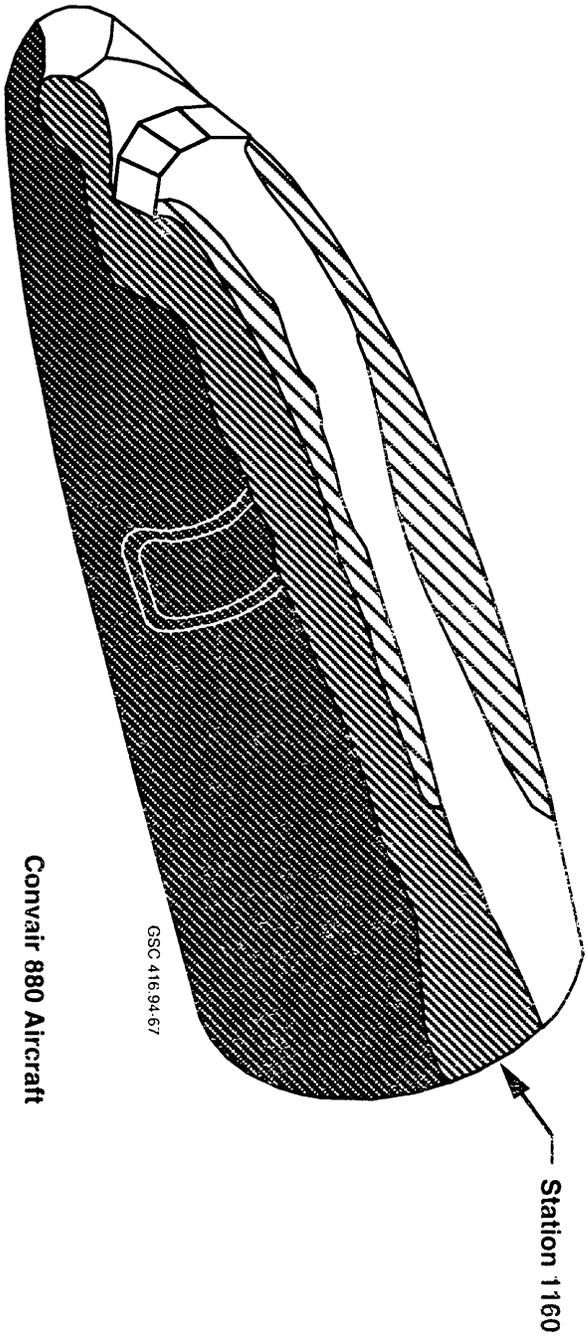
FIGURE E-13. TEST 5 EXTERIOR FIRE DAMAGE, FORWARD SECTION FUSELAGE PORT SIDE

**Paint Burned Off and Some Heat Buckling of Skin Panel**
 -

**Soot**

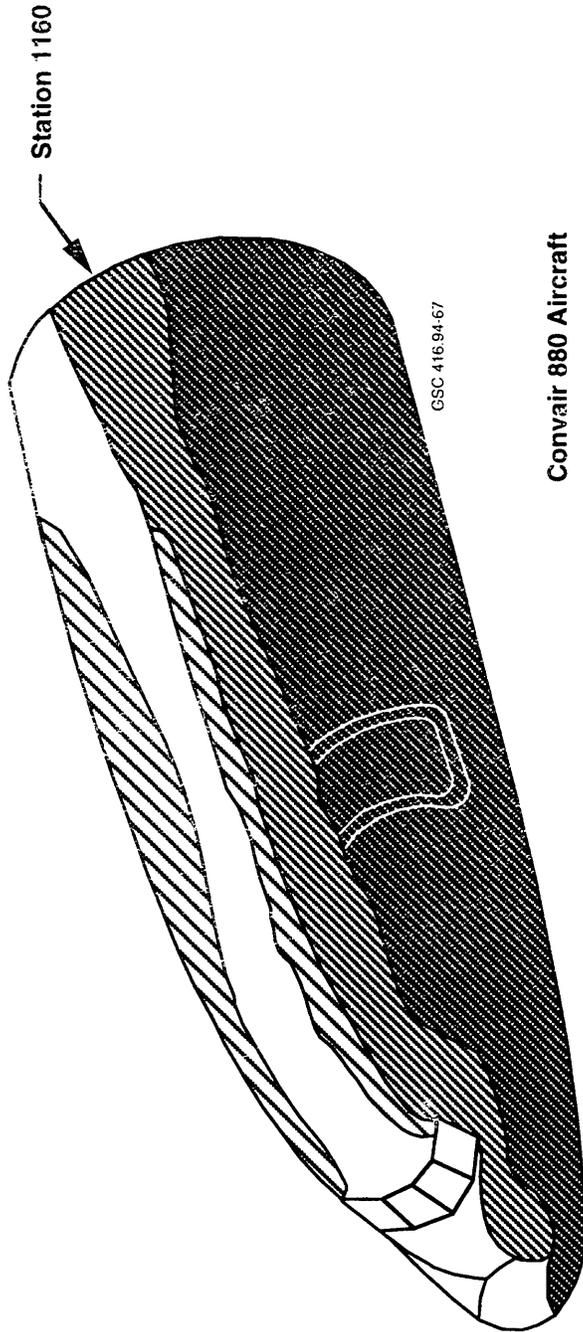
FIGURE E-13. TEST 5 EXTERIOR FIRE DAMAGE, FORWARD SECTION FUSELAGE PORT SIDE

Paint Burned Off and Some Heat Buckling of Skin Panel

Soot

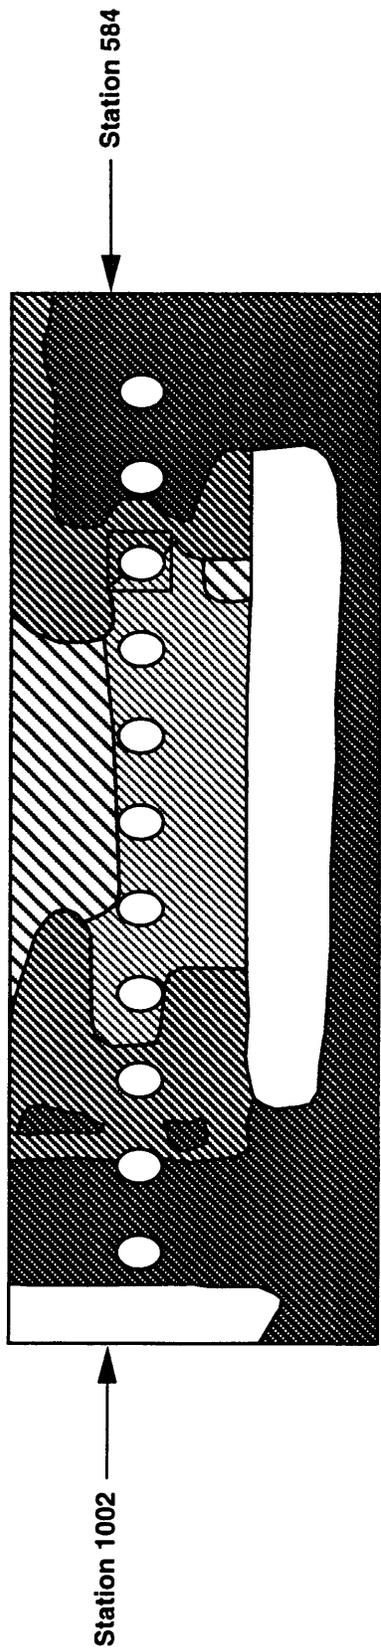
FIGURE F-7. TEST 6 EXTERIOR FIRE DAMAGE, CENTER SECTION FUSELAGE PORT SIDE

- Legend**
- Skin Melted
 - Paint Burned Off and Some Heat Buckling of Skin Panel
 - Soot
