1. Report No. DOT/FAA/AR-98/52		2. Government Accession No.		3. Recipient's Catalog No.	
4. Title and Subtitle FULL-SCALE TEST EVALUATION OF AIRCRAFT FUEL FIRE BURNTHROUGH RESISTANCE IMPROVEMENTS				5. Report Date January 1999

14. Sponsoring Agency Code ANM-112	
15. Supplementary Notes					
16. Abstract <p>This report summarizes the research and full-scale tests undertaken by the Federal Aviation Administration (FAA) to evaluate the fuselage burnthrough resistance of transport category aircraft that are exposed to large postcrash fuel fires. Twenty-eight full-scale tests were conducted in a reusable fuselage test rig to determine the effectiveness of thermal-acoustical insulation improvements in preventing or delaying fuselage burnthrough. The testing showed that the method of attaching the insulation to the fuselage structure had a critical effect on the effectiveness of the insulation material. In addition, the composition of the insulation bagging material, normally a thermoplastic film, was also shown to be an important factor. A number of fiberglass insulation modifications and new insulation materials were shown to be effective in varying degrees. For example, a heat-treated

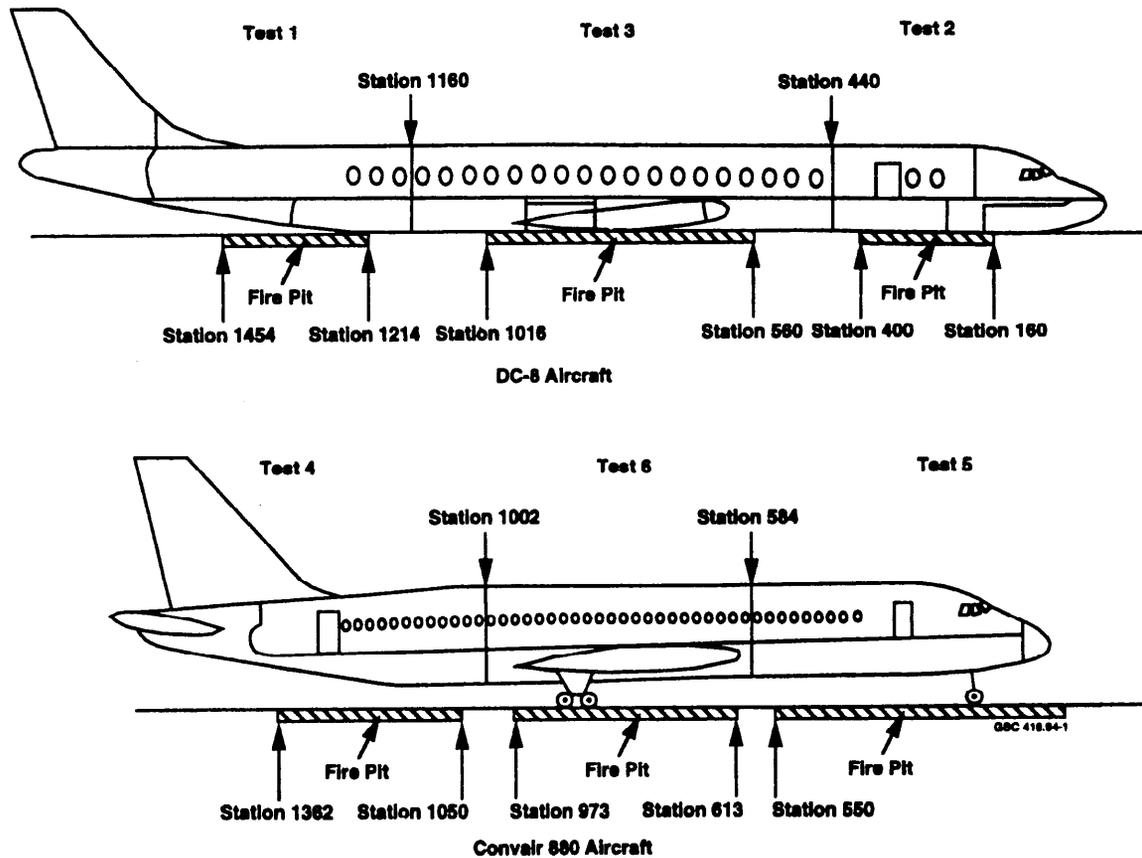
tested. Thus, each aircraft was tested three times in the following sequence: aft, forward, and center. [5] In the DC-8 tests, the aircraft was resting on its belly, simulating a crash with collapsed landing gear; the landing gear was extended during the tests on the Convair-880 (figure 1).

FIGURE 1. INITIAL SURPLUS AIRCRAFT TEST ARTICLES

To better understand and quantify the fuselage burnthrough problem, the FAA conducted a series of full-scale tests by subjecting surplus aircraft (DC-8 and Convair 880) fuselages to 400-square-foot jet fuel fires. The fuel fires were set adjacent to intact fuselage sections instrumented with thermocouples, heat flux transducers, and cameras to determine penetration locations, firepaths, and important event times. During the tests, each aircraft was divided into three sections by installing exterior barriers and internal partitions to confine the fire within the section being

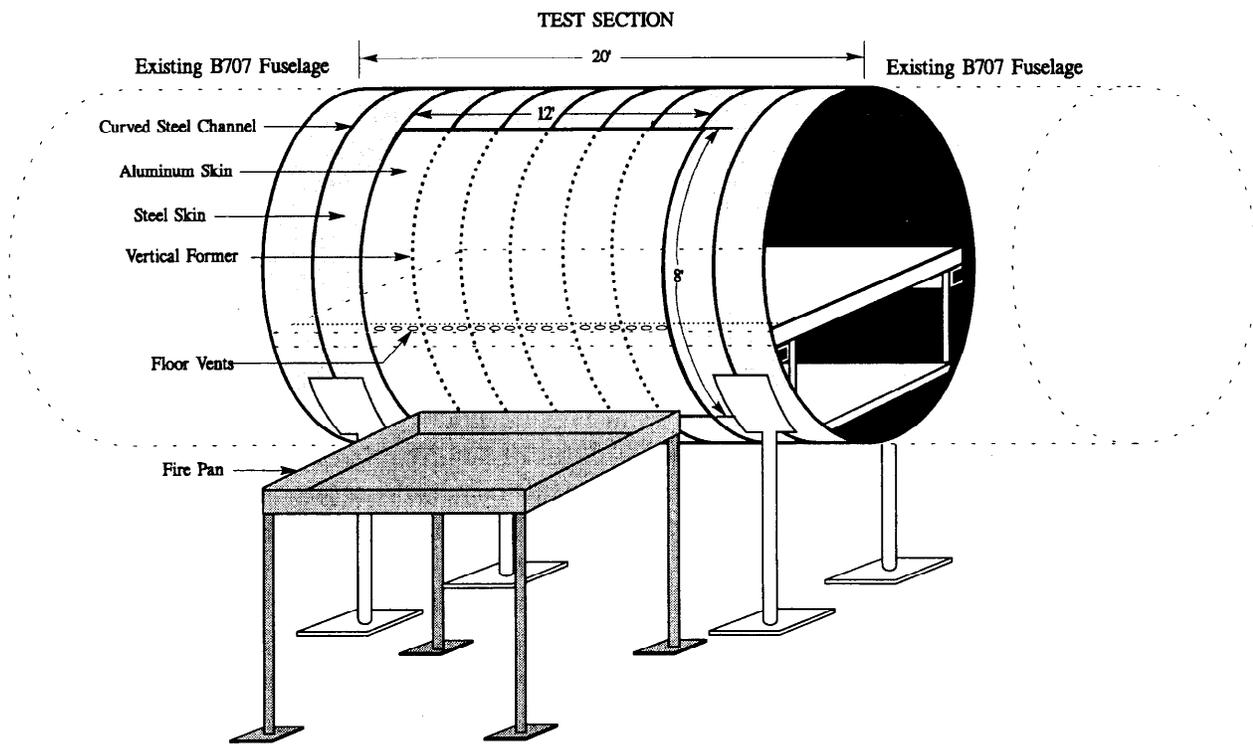
In the next phase of the program, a test apparatus to evaluate improvements under realistic conditions was developed. The construction of a full-scale test rig was the most practical approach that would allow repetitive testing and systematic evaluation of singular components. A 20-foot-long steel test rig was fabricated, a B-707 fuselage was cut in half to allow the test rig to be inserted between the two fuselage pieces (figure 2). This test rig had a 12- by 8-foot section of the outer skin removed which could be mocked-up with aluminum skin, thermal-acoustical insulation, floor and sidewall panels, carpet, and cargo liner. The mocked-up test rig extends beyond a 10-foot-long fire pan that was used to simulate the external fire, eliminating any edge effects or mating problems that might occur if the test rig/ B-707 fuselage seams were directly exposed to the fuel fire. Measurements of temperature, smoke, and fire gases (CO, CO₂, and O₂) were taken inside the test rig along with video coverage at several locations to determine exact burnthrough locations and times (figure 3).

FIGURE 2. FULL-SCALE FUSELAGE BURNTHROUGH TEST RIG

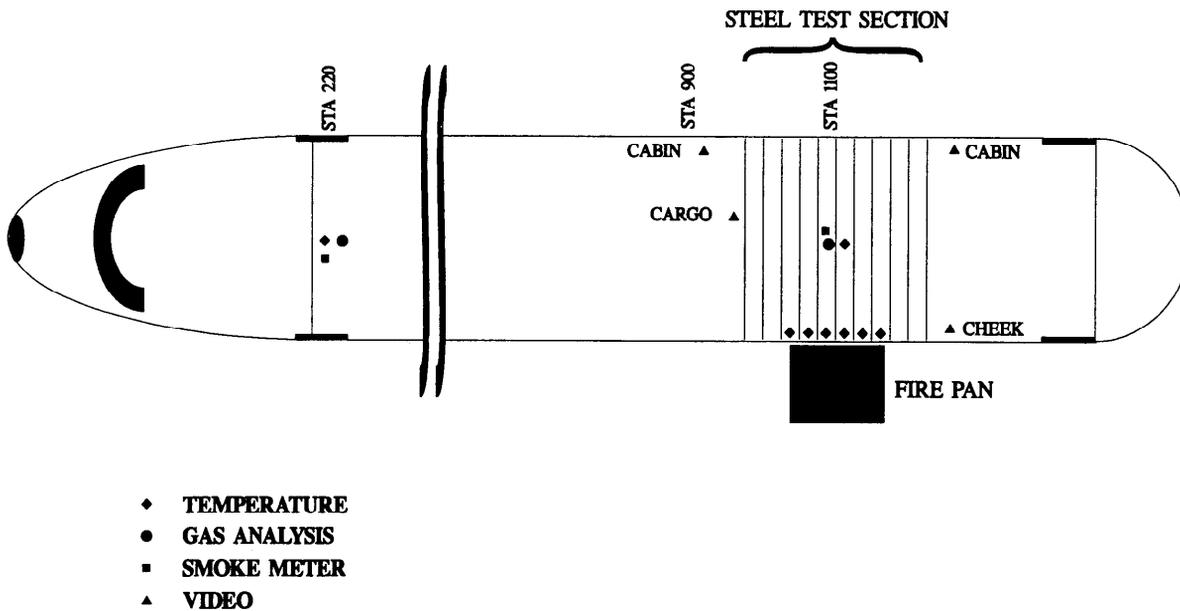
FIGURE 3. INSTRUMENTATION, FULL-SCALE TEST ARTICLE

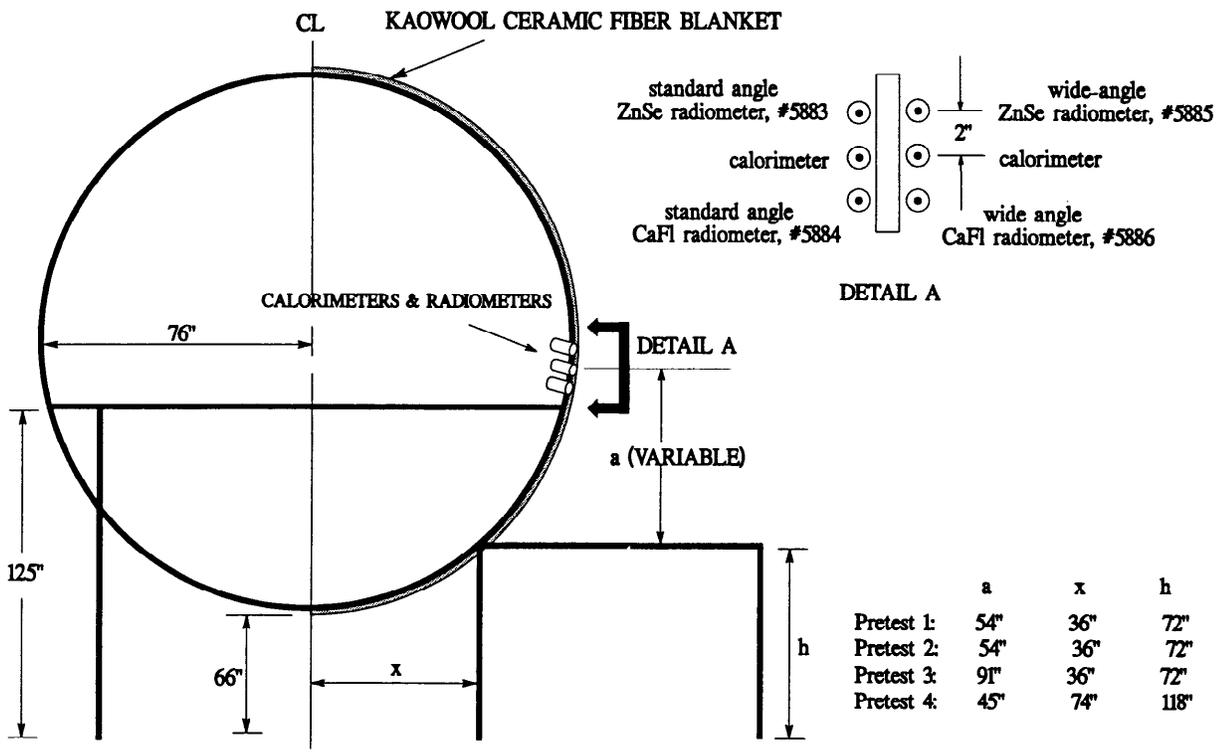
Before beginning the mock-up tests, the fuselage exterior was covered with a Kaowool ceramic fiber blanket on the surface exposed to the fire; the Kaowool covered approximately half of the fuselage circumference, from center top to center bottom. The exterior surface was then instrumented with thermocouples, calorimeters, and radiometers to quantify test fires at different fuselage locations (figures 4 and 5). During past test programs, ground fires ranging in size from 20' x 20' to 35' x 40' were ignited next to fuselages at the cabin floor level and adjacent to a Type A opening to simulate an open escape exit or fuselage rupture. It was determined from these earlier tests, however, that from a burnthrough standpoint, a more severe condition results when the fire is beneath the fuselage, allowing the higher temperatures of the upper flame area to come in contact with the lower fuselage. Two fire pan locations were tested using an 8' x 10' pan filled with 55 gallons of Jet-A fuel, and the location that provided the more severe results of the two was established as the standard fire condition for future material mock-up tests. These pretests also provided information on the radiative and convective heat flux produced by this size fire. Figure 6 plots the radiative and convective heat flux as a function of time measured by a thermogauge calorimeter that measures the combined radiative and convective heat flux. As shown in figure 6, the fuselage is subjected to a maximum heat flux of between 14 and 16 Btu/ft²-second. By comparison, a thermogauge radiometer with a 136° angle of incidence (radiative heat flux only) reached approximately 12 Btu/ft²-second.

FIGURE 4. CALORIMETER AND RADIOMETER LOCATION, FIRE OUTPUT DETERMINATION

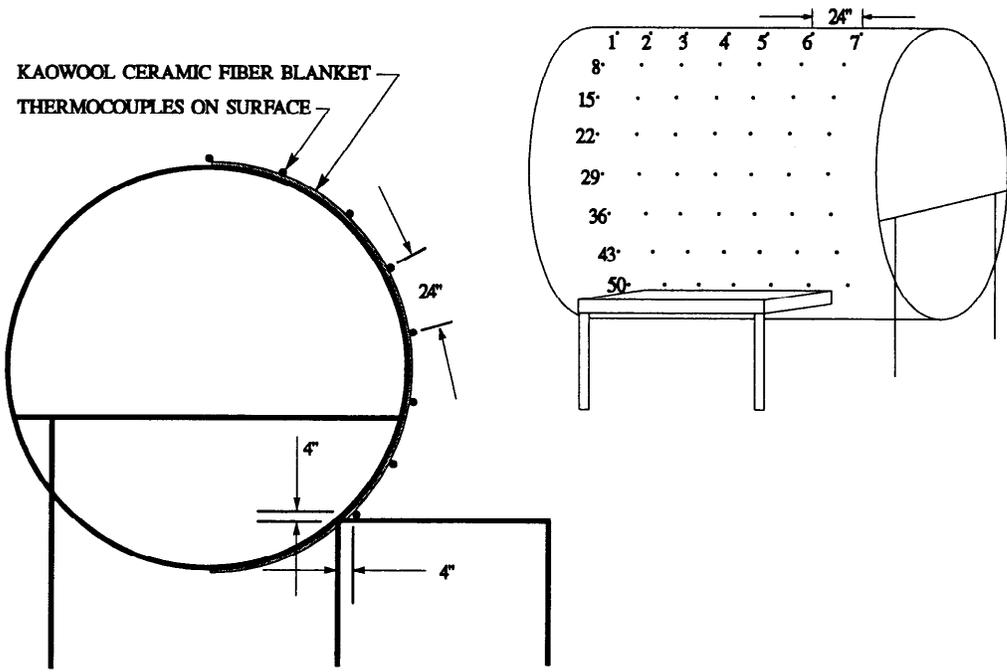
FIGURE 5. THERMOCOUPLE LOCATION, FIRE OUTPUT DETERMINATION

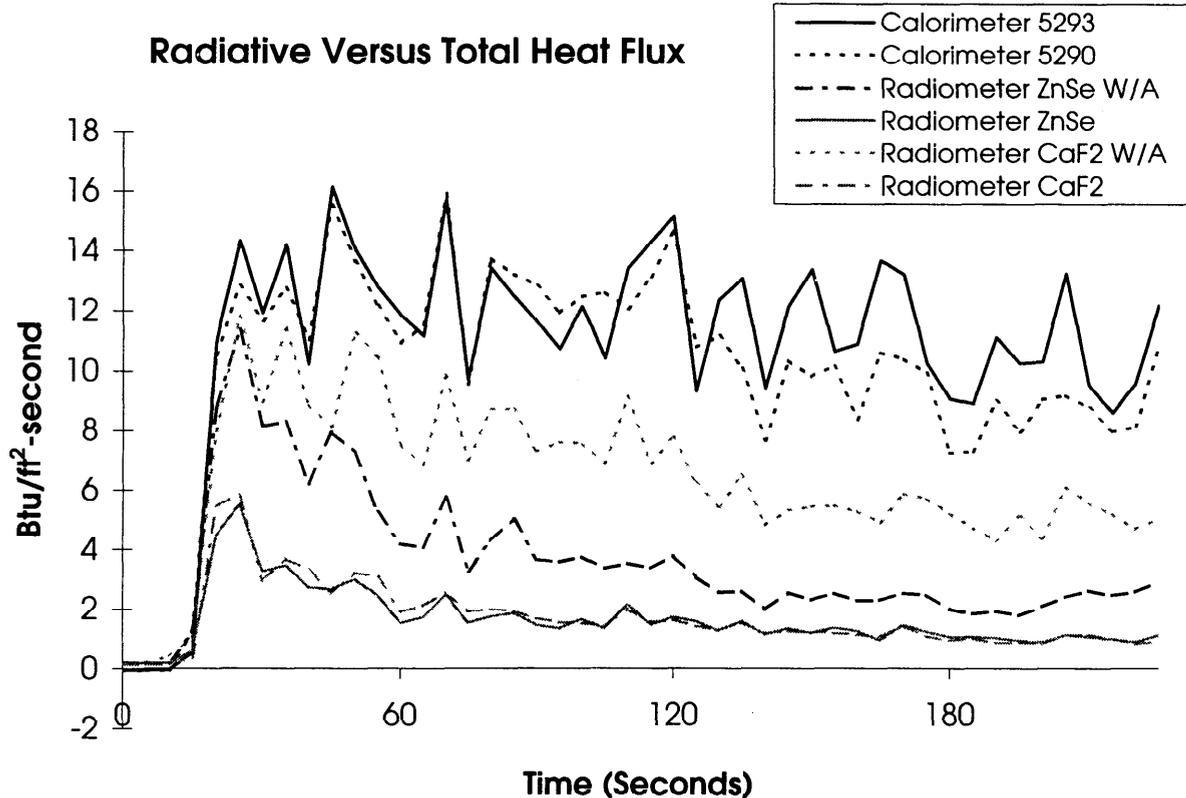
FIGURE 6. TEST RIG HEAT FLUX MEASUREMENTS

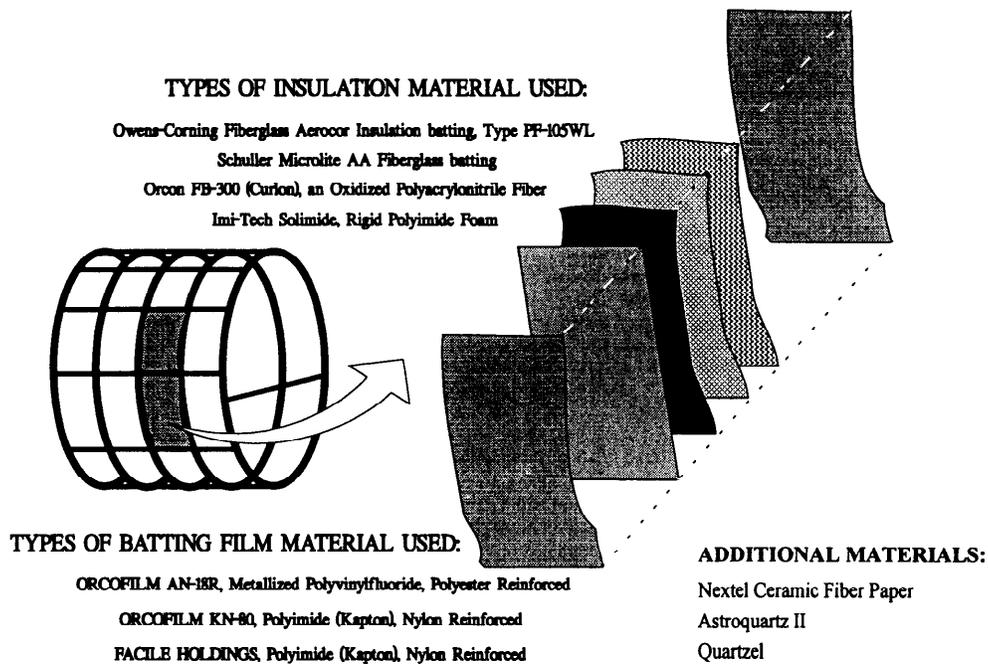
FIGURE 7. INSULATION BATTLING CONSTRUCTION

To evaluate potential improvements in materials and systems for better resistance to fuel fire penetrations, a baseline test arrangement was established using in-service materials. An aluminum skin section measuring 8 feet high by 12 feet wide was installed where the original steel skin of the test rig was removed. It consisted of two sheets of 0.063-inch-thick Alclad 2024 T3 aluminum heliarc welded together. The aluminum panel extended from the lower fuselage quadrant up to the window level and was mounted to the test rig stringers and ribs using steel rivets to reduce the potential for separation during testing. The remaining area of the test rig was covered with 22-gauge sheet metal. The first several tests used custom-made insulation batting consisting of Owens-Corning Aerocor fiberglass insulation encapsulated in Orcon brand heat shrinkable metallized polyvinyl fluoride (PVF) film (also known as Tedlar), type AN-18R. The insulation batting was sized to fit in the spaces outlined by the vertical formers and the horizontal stringers of the test rig (figure 7). The insulation batts spanned the entire area of the aluminum skin, 8 by 12 feet. In the test rig cargo compartment, 0.013-inch-thick Conolite BMS 8-2A fiberglass liners were installed in both the ceiling and sidewall areas facing the fire and held in place by steel strips of channel screwed into the steel frame of the test rig. An M.C. Gill "Gillfab" 4017 honeycomb floor panel measuring 4 by 12 feet was installed in the test rig cabin floor area and covered with FAA-approved aircraft quality wool/nylon carpet. The remaining test rig cabin floor area consisted of corrugated sheet steel. Interior sidewall panels from an

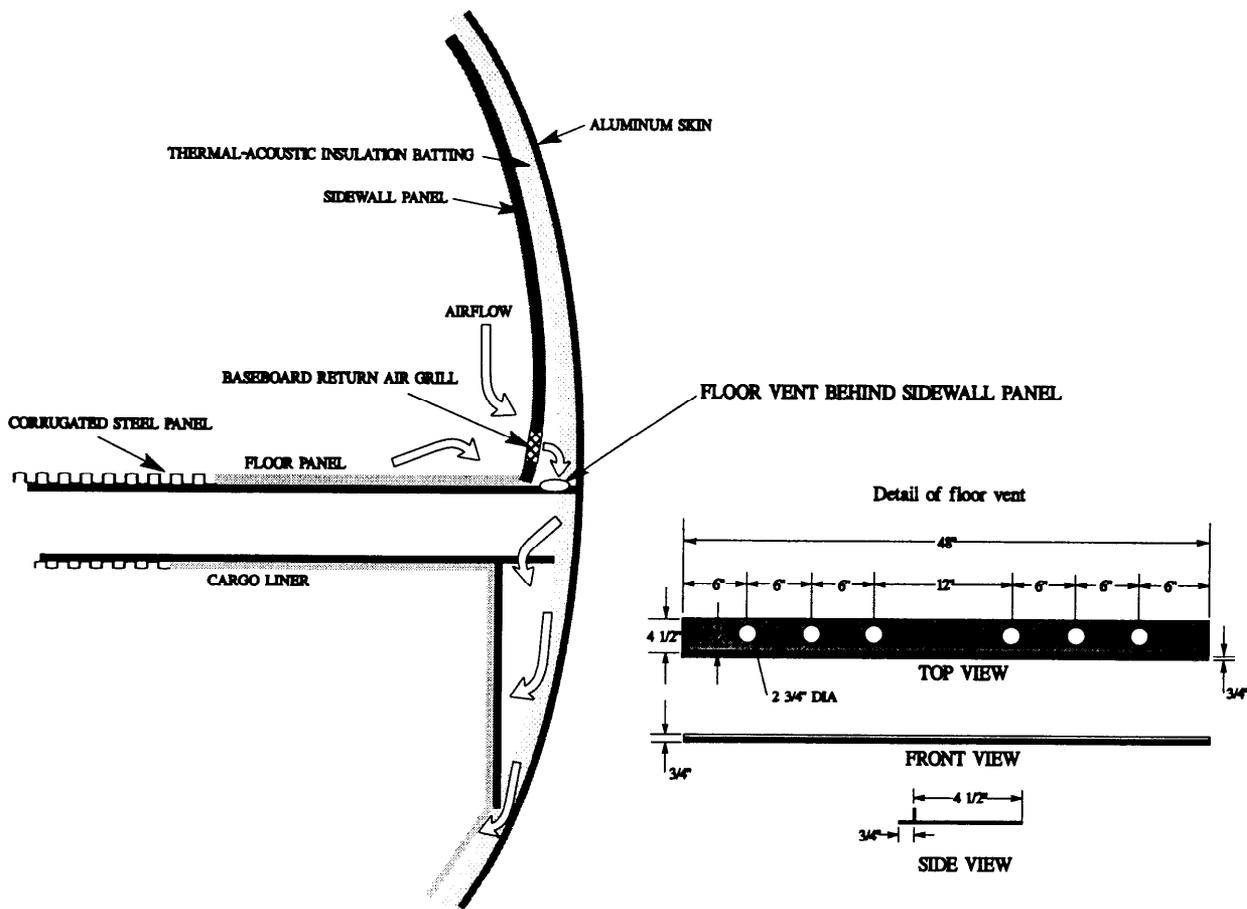
FIGURE 8. CROSS SECTION DETAIL

During the first test, the fire burned through the aluminum skin within 30 seconds and quickly displaced or penetrated the thermal-acoustical insulation batting, allowing flames to enter the cheek area within 40 seconds. The actual point of first penetration into the cabin was difficult to determine, since the fire penetrated both the sidewall panels and baseboard return air grills at nearly the same time. It was determined that there was not a complete coverage by the 1-inch-thick thermal-acoustical insulation batts, which had been attached to the test rig by loosely packing it into the spaces between the stringers and formers and then taping all edges using fiberglass tape. Since the major objective was to determine the effectiveness of the thermal-acoustical insulation batt when it is not physically displaced, efforts were made to better secure the batting material. During the next test, the insulation batts were held in place with steel spring clips that attached the film moisture barrier directly to the test rig frame. The thickness of the insulation batt was also increased for these tests since an inspection of several surplus fuselages revealed that the insulation batt was at least 3 inches thick in the sidewall area (the insulation batt actually becomes much thinner at the extreme lower section of the fuselage due to less acoustical requirements). Although the thickness of the insulation batt varies slightly between aircraft, it

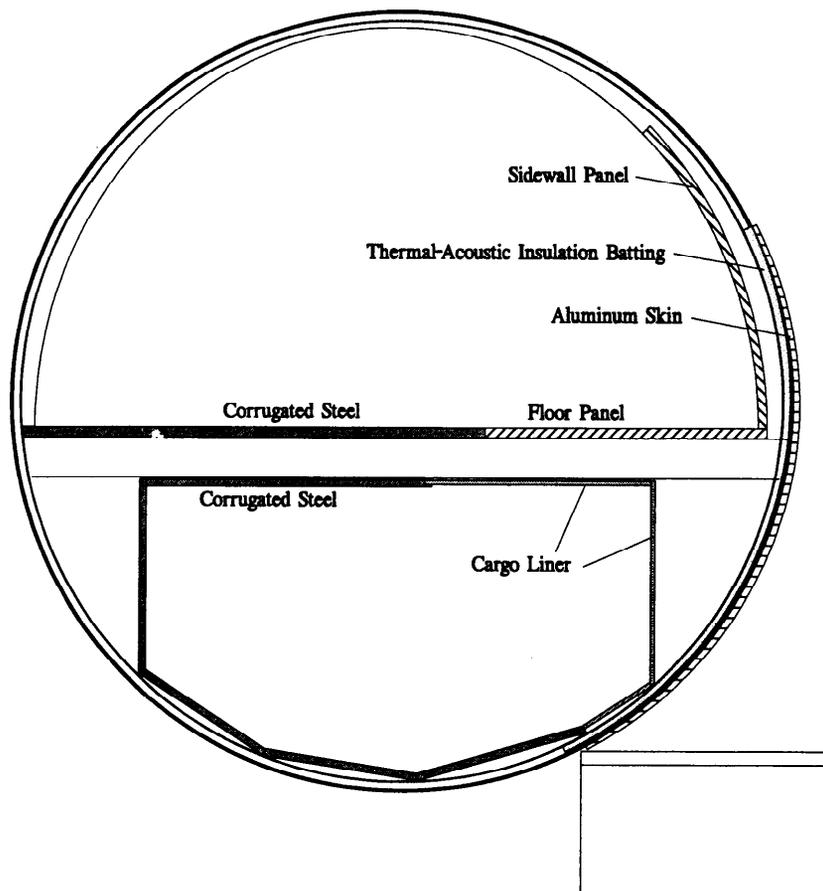
FIGURE 9. TEST RIG MATERIAL USAGE AND LOCATION DURING INITIAL BASELINE TESTS

MD-80 aircraft were used; these panels used an aluminum substrate that did not meet the current FAA fire test regulations regarding heat release rate. The outboard cabin floor area contained steel plating with 3-inch-diameter holes to simulate the venting area between the floor and cheek area. Additionally, an aluminum mesh was installed below the sidewall panels to simulate the baseboard air return grills (figure 8). In general, the major components of a typical aircraft fuselage were represented in the test rig (figure 9).

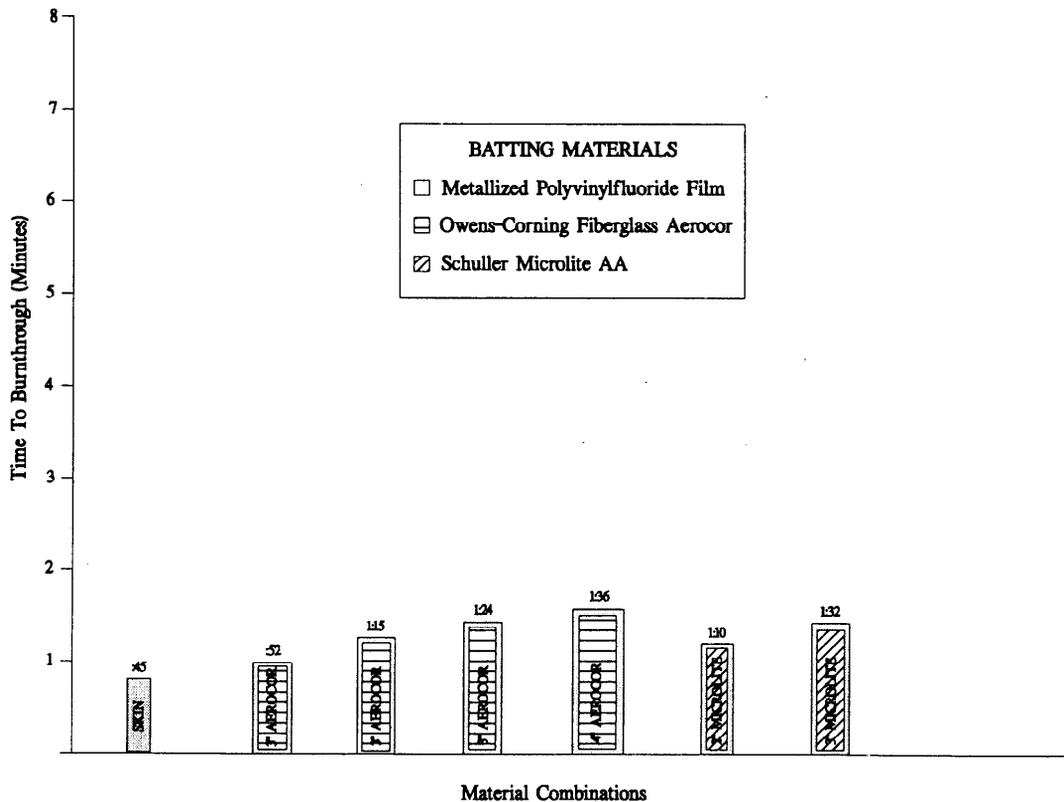
An evaluation of current fiberglass insulation was conducted in which the effects of the thickness and the method of installation on burnthrough time were investigated. Several tests were performed using a varying number of layers. As shown in figure 10, the first 3 Aerocor tests used 3-inch-thick insulation encased in a heat shrinkable metallized polyvinyl fluoride film. The method of insulation batting attachment was refined during each test, as the fire visibly dislodged the batting materials during the first and second tests causing burnthrough in 52 seconds and 1 minute 15 seconds respectively. During the third Aerocor test, both the moisture film barrier and the insulation material inside the film were attached to the frame. Heavier spring clips were used around the entire perimeter of each insulation batt, which proved to be a very effective attachment system. A fourth Aerocor test was conducted using an additional 1-inch layer of insulation, which provided an additional 12 seconds. Thus, a secured insulation batting provided about 45 seconds of additional protection after the aluminum skin melted. The time to burnthrough was determined by visual observation by video cameras located at various points in the test rig interior. The actual time is somewhat subjective, since the exact time and location are not always clearly defined.

FIGURE 10. EVALUATION OF CURRENT INSULATION MATERIALS

Since the Aerocor is a somewhat older material, additional tests were conducted using Microlite AA insulation, which is currently used on most transport category aircraft. As shown, there was only a marginal increase in the burnthrough resistance offered by the 3-inch Microlite material (1 minute 32 seconds versus 1 minute 24 seconds using 3-inch-thick Aerocor). The test rig burnthrough times compared favorably with past tests using surplus aircraft where flame penetration was observed in approximately 2 minutes 30 seconds. [6] Assuming that the sidewall panels, flooring, and cargo liner in the surplus aircraft likely provided an additional minute of protection, it was concluded that the mock-up tests were a reasonable representation of actual crash fire conditions.

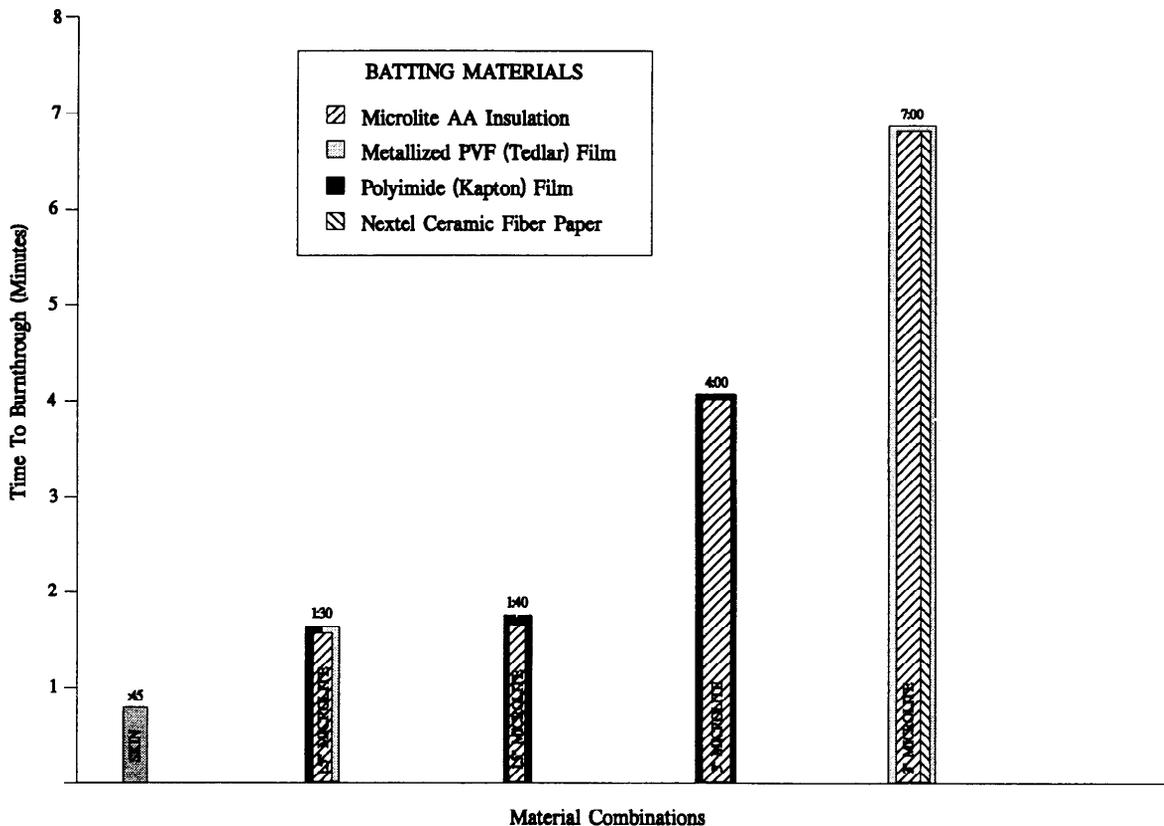
smoke emission characteristics was evaluated. The use of polyimide film as a moisture barrier for commercial aircraft insulation is not new, having been introduced on the L-1011. The polyimide film displayed improved flame resistance compared to polyvinyl fluoride film as shown in figure 11. For example, comparable burnthrough times were exhibited when polyimide film was used with half the thickness of insulation (1.5 inches as compared to 3 inches of insulation used with metallized polyvinyl fluoride film). The most notable test results occurred when 3-inch-thick Microlite AA insulation was used with the polyimide film. This combination was capable of resisting burnthrough for 4 minutes or an increase of approximately 2 minutes 30 seconds over the identical thickness of insulation material used with the metallized polyvinyl fluoride film.

FIGURE 11. EVALUATION OF MODIFIED CURRENT INSULATION MATERIALS

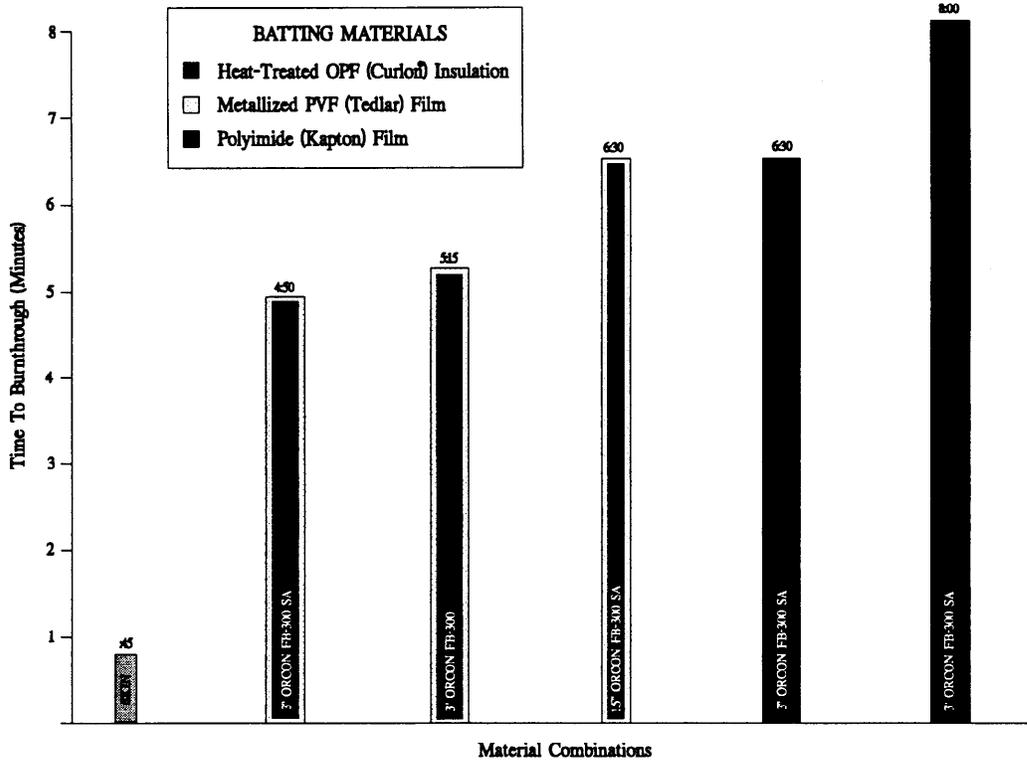
FIGURE 12. EVALUATION OF OXIDIZED POLYACRYLONITRILE FIBER

The insulation system incorporating Curlon® was originally marketed jointly by Orcon Corporation and RK Carbon International under the trade name FB-300. Orcon subsequently purchased the sole right to manufacture the insulation system under the trade name Orcobloc. The insulation system is unique in that it could potentially be used as a drop-in replacement for the current fiberglass insulation (i.e., it possesses qualities similar to fiberglass for the intended use in aircraft applications). Early versions of the FB-300 were somewhat inferior to the current fiberglass materials in terms of sound absorption and noise attenuation, which is the primary purpose of insulation in the window belt area. The fabrication process was altered slightly to produce a better performing material known as FB-300 SA (superior acoustics). Both materials were tested extensively in the full-scale test rig; the results are shown in figure 12. The Curlon® material was extremely effective at resisting flame penetration for at least 5 minutes during several tests.

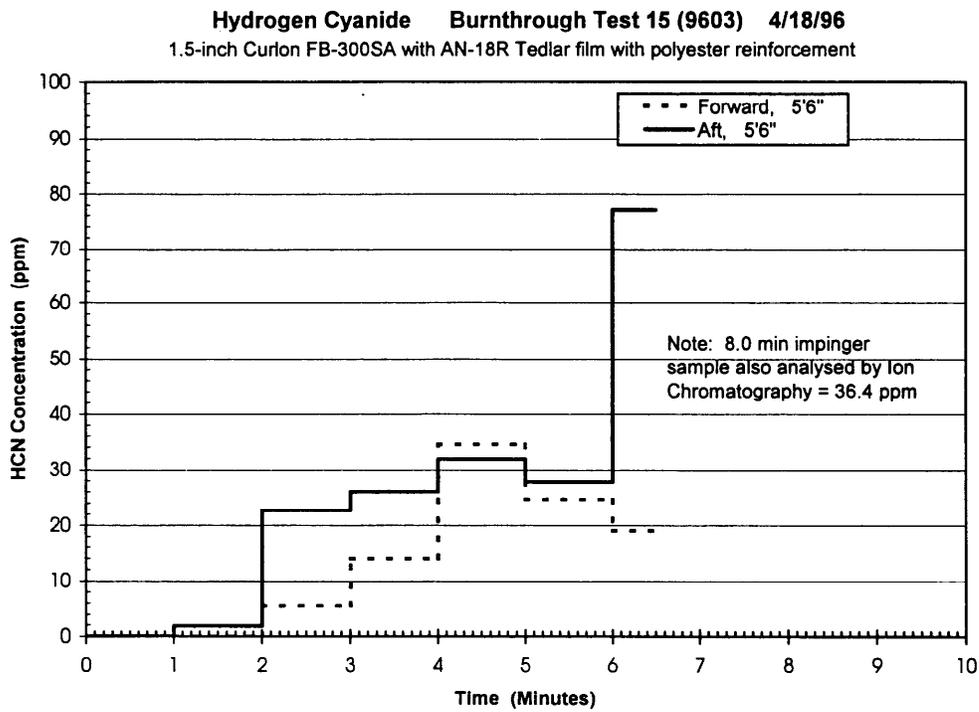
FIGURE 13. HYDROGEN CYANIDE MEASURED BY ION CHROMATOGRAPHY METHOD DURING TEST 15

Hydrogen cyanide was measured at two locations within the cabin, one close to the burnthrough area and another near the front of the test fuselage, both at heights of 5 feet 6 inches. Small amounts of hydrogen cyanide were collected during several of the tests (figures 13 and 14) indicating the decomposition products yielded when Curlon® is exposed to elevated temperatures would not inhibit passenger escape.

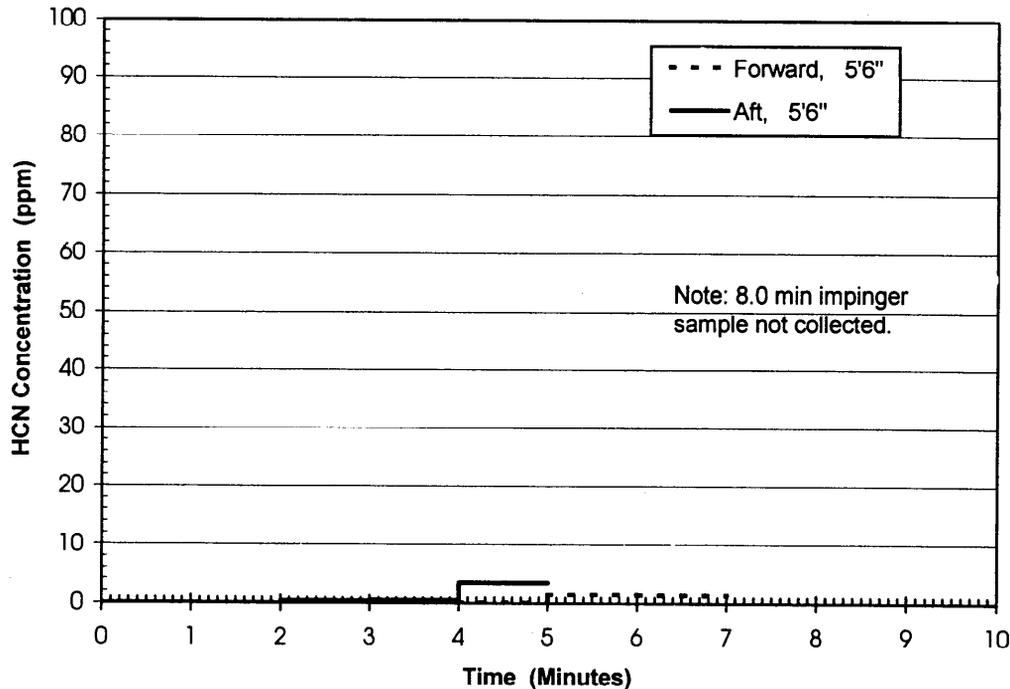
Hydrogen Cyanide Burnthrough Test 16 (9604) 5/06/96
 3-inch Curlon FB-300SA with KN-80 Kapton film with nylon reinforcement

FIGURE 14. HYDROGEN CYANIDE MEASURED BY ION CHROMATOGRAPHY METHOD DURING TEST 16

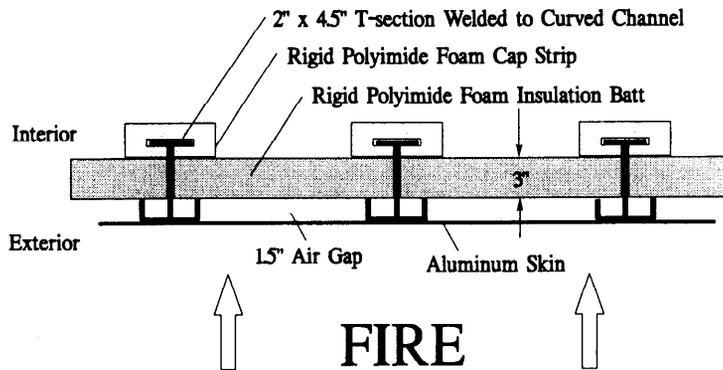
(a) Initial Attachment Method Using Vertical Cap Strips

FIGURE 15. RIGID POLYIMIDE FOAM ATTACHMENT METHOD

Before the full-scale tests, the test rig was modified to hold the rigid foam, since it did not require clips to hold the batting material in place. Three steel T-sections with cross sections 2 inches wide by 4.5 inches high were installed along each of the vertical curved steel channels as shown in figure 15(a). The insulation batts were held in place by rigid foam cap strips that snapped in place over the top of the steel T-section at the edge of each insulation batt. No moisture barrier film was used.

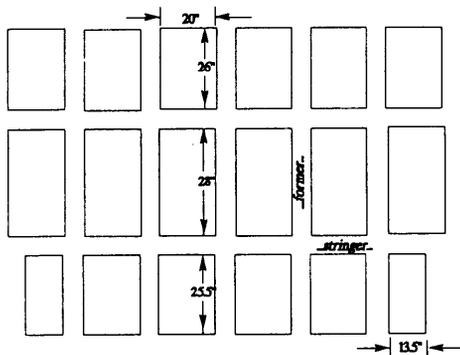
(b) Size and Location of Openings Between Stringers and Formers

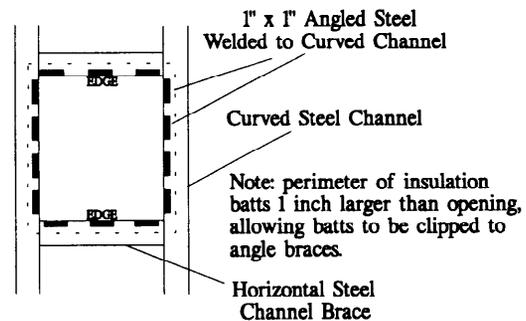
(c) Modified Attachment Method Using Steel Perimeter Clips

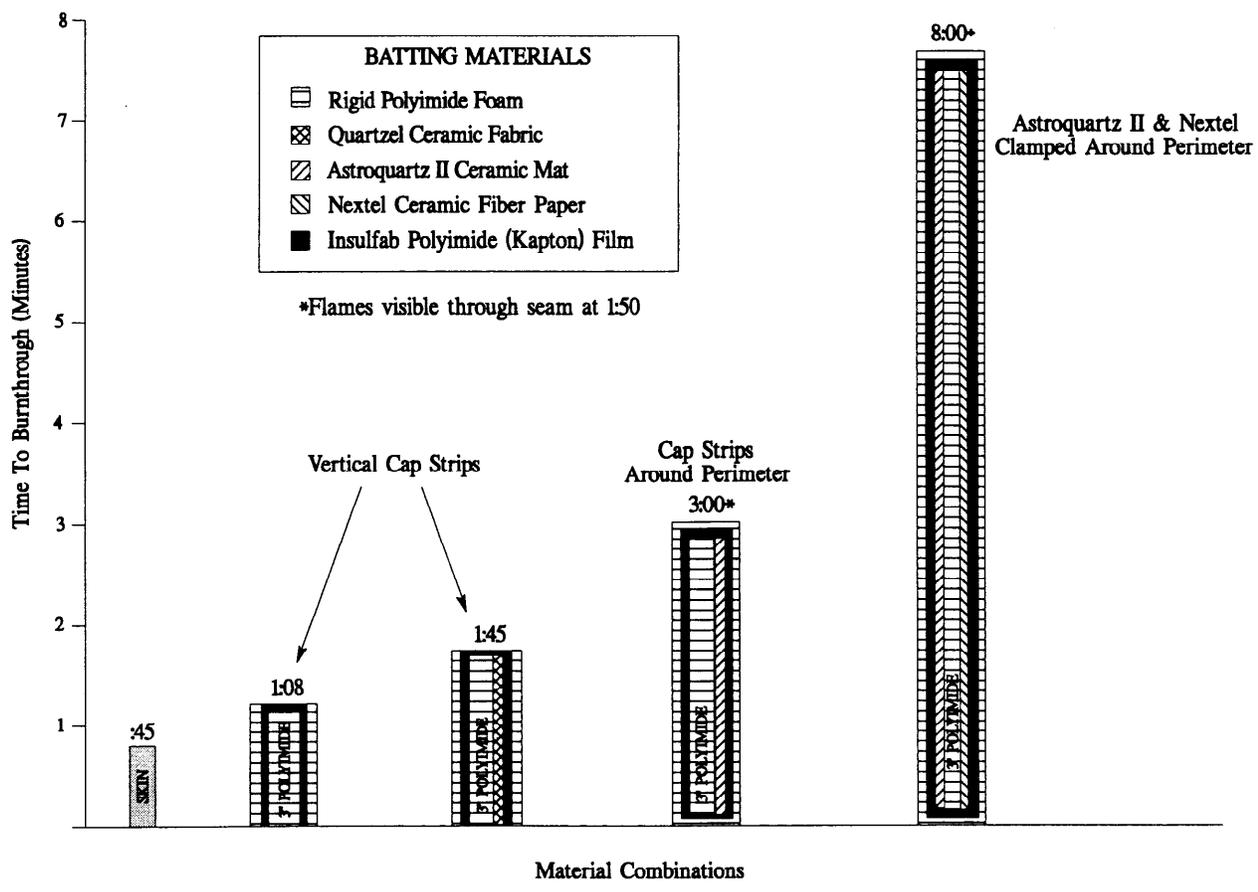
FIGURE 16. EVALUATION OF RIGID POLYIMIDE FOAM

During the first test, the insulation batts were 3-inch-thick Solimide[®] rigid foam heat sealed in a bag of Insulfab[®]-reinforced polyimide film, supplied by Facile Holdings, Inc. For this insulation system, burnthrough occurred at 1 minute 8 seconds, approximately 20 seconds less than fiberglass batting. In an effort to extend the burnthrough time, a second test was run in which Quartzel[®], a vitreous silica wool barrier, was placed in the insulation batts, not unlike the earlier fiberglass-enhanced tests with Nextel[™]. The Quartzel[®] improved the burnthrough resistance of the rigid foam material, but the system was less effective than the system with the Nextel[™]-enhanced fiberglass system and the Curlon[®]. The weakness appeared to be at the horizontal seam location where the individual batts matted together. The absence of an attachment system along the top and bottom edges of each batt allowed flames to propagate to the inboard face early in the test. After reviewing the video coverage, it was confirmed that the system was, in fact, failing at the top and bottom seams rather than because of burnthrough of the material. To rectify the problem, horizontal cap strips were used in addition to the vertical cap strips already used in

the previous tests to hold the insulation to the test frame. A third test was conducted with this arrangement and the use of another fire-blocking material known as Astroquartz II[®], a quartz fabric. The additional horizontal cap strips aided in extending the burnthrough time, but still not to the level attained by the other systems. An additional test was conducted to repeat the third test using an installation method that would allow direct attachment of the fire-blocking material to the test frame, similar to the method used during the Nextel[™]-enhanced test. For this test, 4 inch lengths of 1-inch angled steel were welded to the periphery of each opening in the test rig to allow the batts to be clamped around the entire perimeter (figure 15c). Each of the batts contained the previously used Astroquartz II[®] ceramic mat in addition to a thin layer of Nextel[™] ceramic fiber paper, which was also used in a previous test with fiberglass insulation. This configuration provided the best result amongst the rigid polyimide tests, resisting flame penetration for over 8 minutes (figure 16). A summary of all tests is shown in table 1 and known properties of the materials used in the full-scale tests are included in table 2. A temperature versus time plot for all material combinations is shown in figure 17.

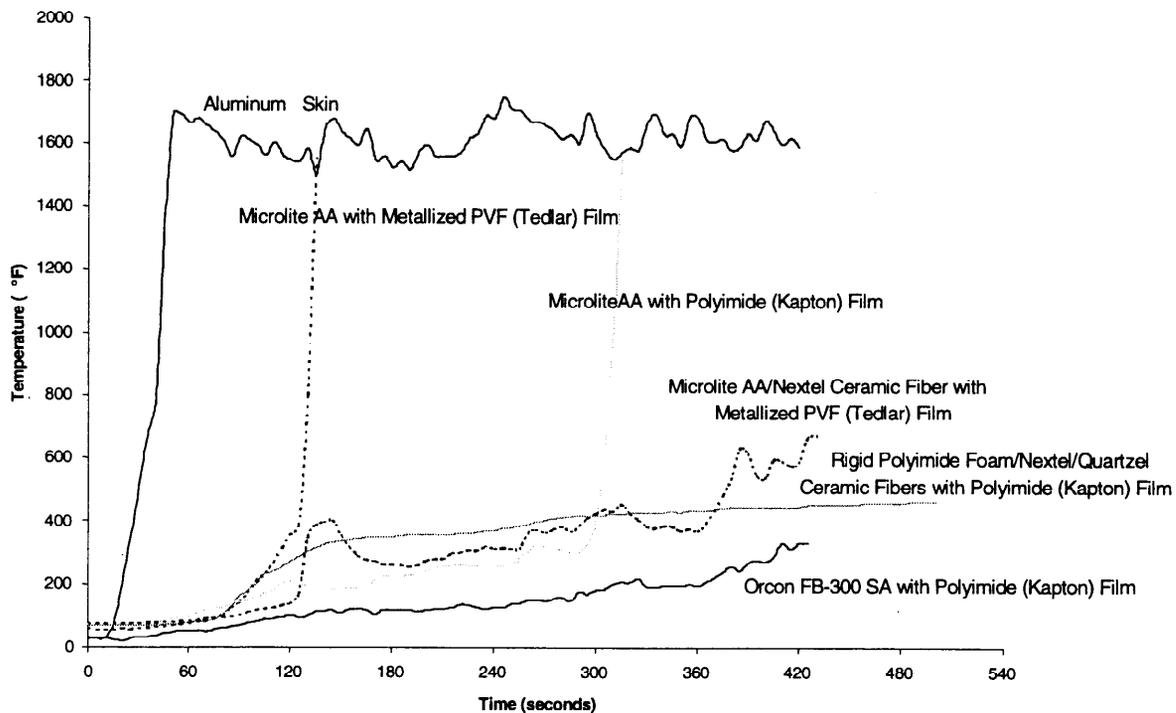
FIGURE 17. SIDEWALL AREA TEMPERATURE COMPARISON FOR VARIOUS MATERIALS

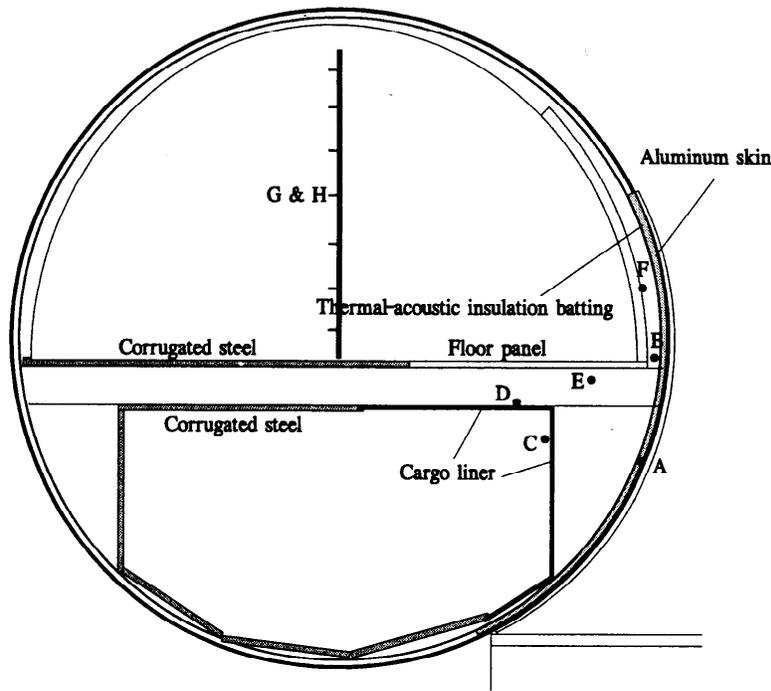
- A, Thermocouples 1-4 behind lower skin (cheek area)
- B, Thermocouples 5-8 above floor vents
- C, Thermocouples 9-12 behind cargo liner sidewall
- D, Thermocouples 13-16 above cargo liner ceiling
- E, Thermocouples 17-20 below cabin floor
- F, Thermocouples 21-24 behind skin/insulation (cabin)
- G, Thermocouples 25-31 on tree (burnthrough area)
- H, Thermocouples 32-38 on tree (forward area)

FIGURE 18. THERMOCOUPLE ARRANGEMENT FOR BASEBOARD GRILL TESTS

An initial baseline test was conducted in which the test rig was configured with a 4- by 12-foot burnthrough area, roughly half of the area used for most previous tests. Since the investigation focused on the cheek area only, there was no need to involve more materials than required. The 4-foot-high burnthrough area was centered above and below the cabin floor and riveted in place similar to previous tests. Insulation bags of Microlite AA with metallized polyvinyl fluoride film were installed in the cabin sidewall, above the floor only. For test purposes, there was no insulation below the floor, since it was assumed that the batts would be displaced during an actual fire. In addition to the sidewall insulation, interior sidewall panels were installed along with an M.C. Gill Gillfab 4017 honeycomb floor panel measuring 4 by 12 feet and covered with FAA-approved aircraft quality wool/nylon carpet and cargo liner in the lower compartment. Thermocouples were located in the following areas: behind the skin, inside floor openings behind the sidewall panel, behind the cargo liner (sidewall), above the cargo liner (ceiling), below the cabin floor, and behind the cabin sidewall panel (figure 18). In each of these locations, a thermocouple was placed in the area between the vertical formers; a total of four thermocouples were used in each area. Temperatures were also monitored at two tree locations inside the cabin, one near the burnthrough area and another in the forward fuselage.

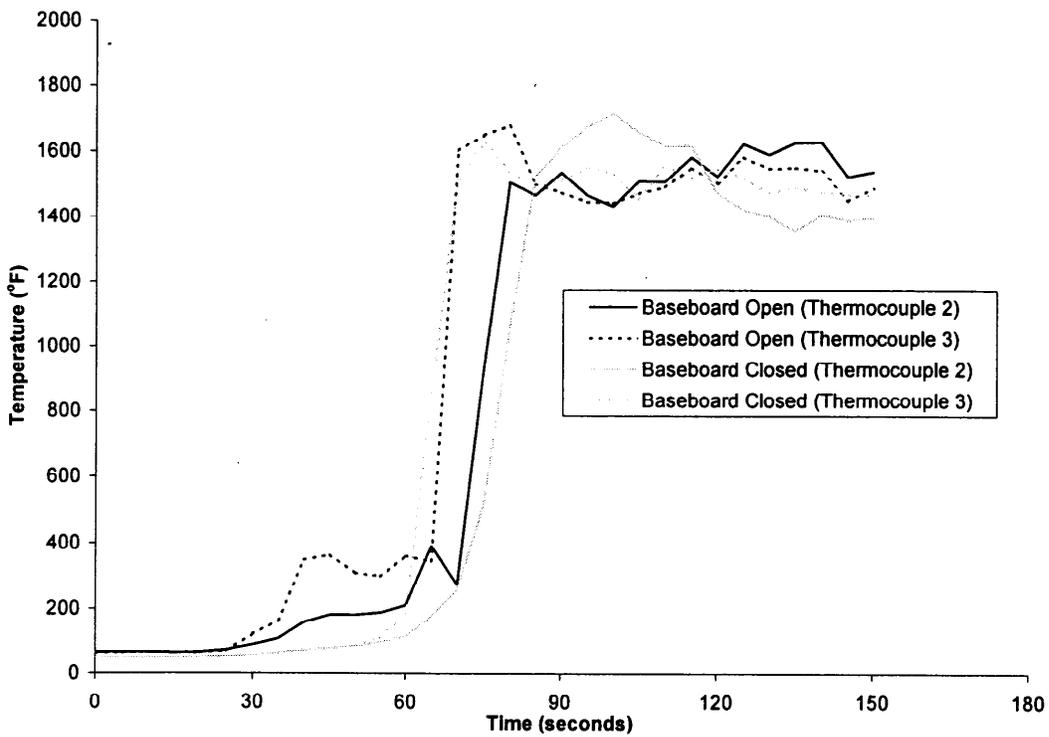
FIGURE 19. TEMPERATURE COMPARISON BEHIND LOWER SKIN

A review of the temperature data indicated a similar fire development in the blocked-grill test and the open-grill test, as the temperature profiles were nearly identical behind the lower (cheek area) skin, below the cabin floor, and at the floor vent area (figures 19, 20, and 21). In each of the figures, the second and third of the four thermocouples are displayed for each test. A moderate delay in the temperature rise behind the sidewall panel was measured during the test in which the grills were blocked off (figure 22). It appeared that the grill blockage prevented the fire from propagating up behind the cabin sidewall panel. However, the temperature profiles inside the cabin were nearly identical, indicating a minimal impact on the overall test (figure 23). The minimal impact from the grills could be a result of the severity of the tests because the fire was initially allowed to progress directly into the cheek area without obstruction from insulation (insulation was not used during these tests). As a result, the flames quickly entered the cabin through seams in the sidewall panels during both tests, essentially minimizing the effect (if any) of the grill area being blocked.

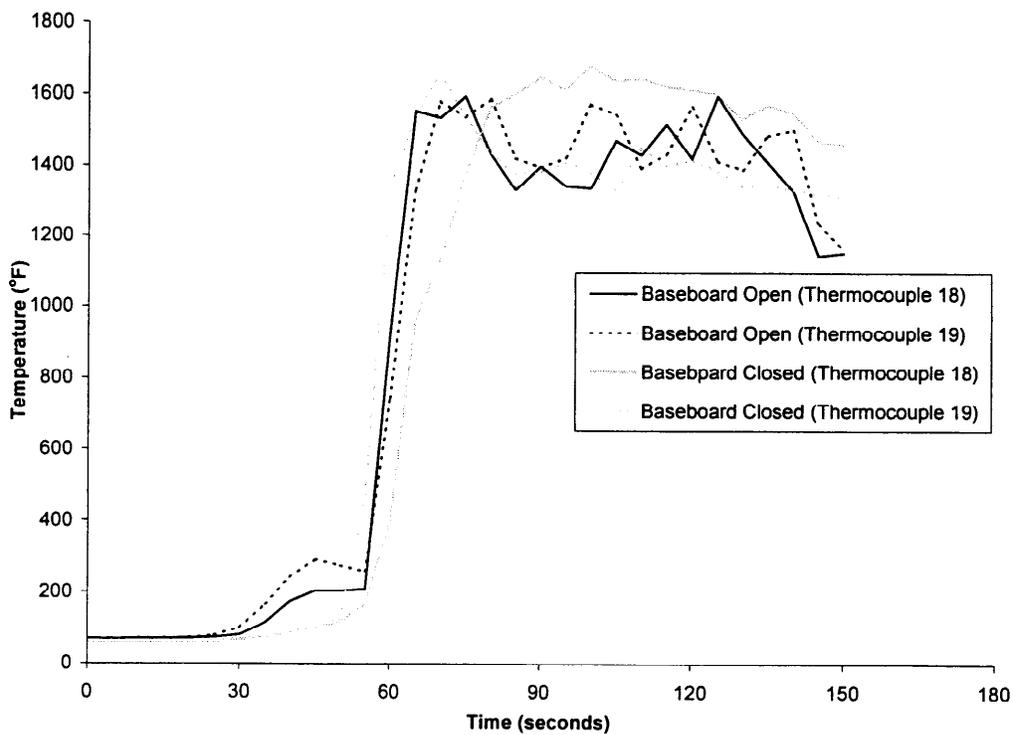
FIGURE 20. TEMPERATURE COMPARISON BELOW CABIN FLOOR
