1. Report No. DOT/FAA/AR-98/52		2. Government Accession No.		3. Recipient's Catalog No.	
4. Title and Subtitle FULL-SCALE TEST EVALUATION OF AIRCRAFT FUEL FIRE BURNTHROUGH RESISTANCE IMPROVEMENTS				5. Report Date January 1999

14. Sponsoring Agency Code ANM-112	
15. Supplementary Notes					
16. Abstract <p>This report summarizes the research and full-scale tests undertaken by the Federal Aviation Administration (FAA) to evaluate the fuselage burnthrough resistance of transport category aircraft that are exposed to large postcrash fuel fires. Twenty-eight full-scale tests were conducted in a reusable fuselage test rig to determine the effectiveness of thermal-acoustical insulation improvements in preventing or delaying fuselage burnthrough. The testing showed that the method of attaching the insulation to the fuselage structure had a critical effect on the effectiveness of the insulation material. In addition, the composition of the insulation bagging material, normally a thermoplastic film, was also shown to be an important factor. A number of fiberglass insulation modifications and new insulation materials were shown to be effective in varying degrees. For example, a heat-treated

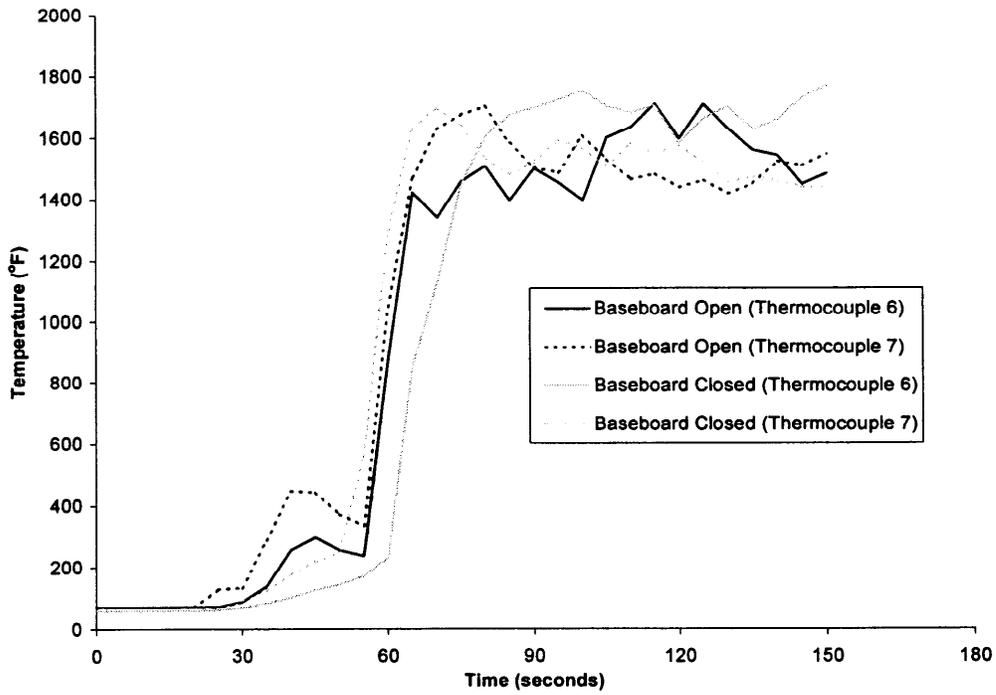
FIGURE 21. TEMPERATURE COMPARISON AT FLOOR VENT AREA

A review of the temperature data indicated a similar fire development in the blocked-grill test and the open-grill test, as the temperature profiles were nearly identical behind the lower (cheek area) skin, below the cabin floor, and at the floor vent area (figures 19, 20, and 21). In each of the figures, the second and third of the four thermocouples are displayed for each test. A moderate delay in the temperature rise behind the sidewall panel was measured during the test in which the grills were blocked off (figure 22). It appeared that the grill blockage prevented the fire from propagating up behind the cabin sidewall panel. However, the temperature profiles inside the cabin were nearly identical, indicating a minimal impact on the overall test (figure 23). The minimal impact from the grills could be a result of the severity of the tests because the fire was initially allowed to progress directly into the cheek area without obstruction from insulation (insulation was not used during these tests). As a result, the flames quickly entered the cabin through seams in the sidewall panels during both tests, essentially minimizing the effect (if any) of the grill area being blocked.

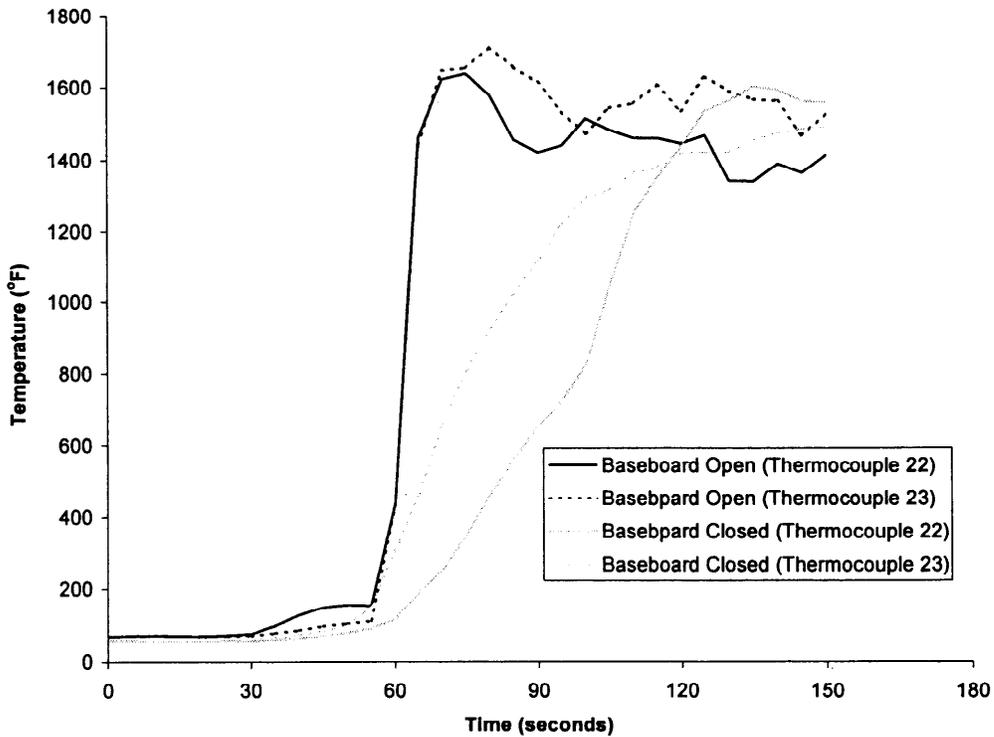
FIGURE 22. TEMPERATURE COMPARISON AT SIDEWALL LOCATION

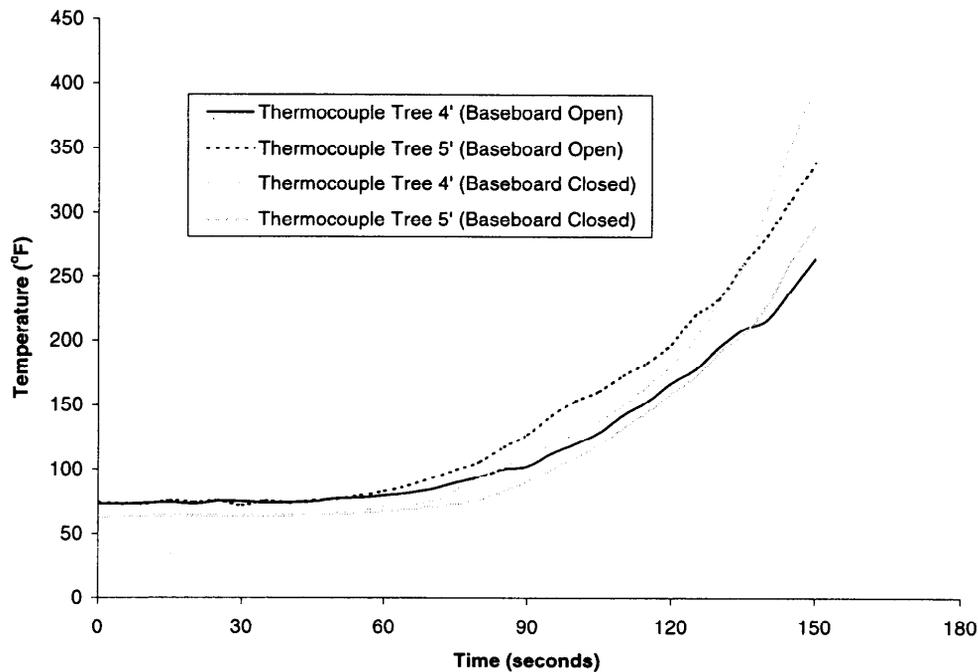
FIGURE 23. THERMOCOUPLE TREE TEMPERATURE COMPARISON IN FUSELAGE

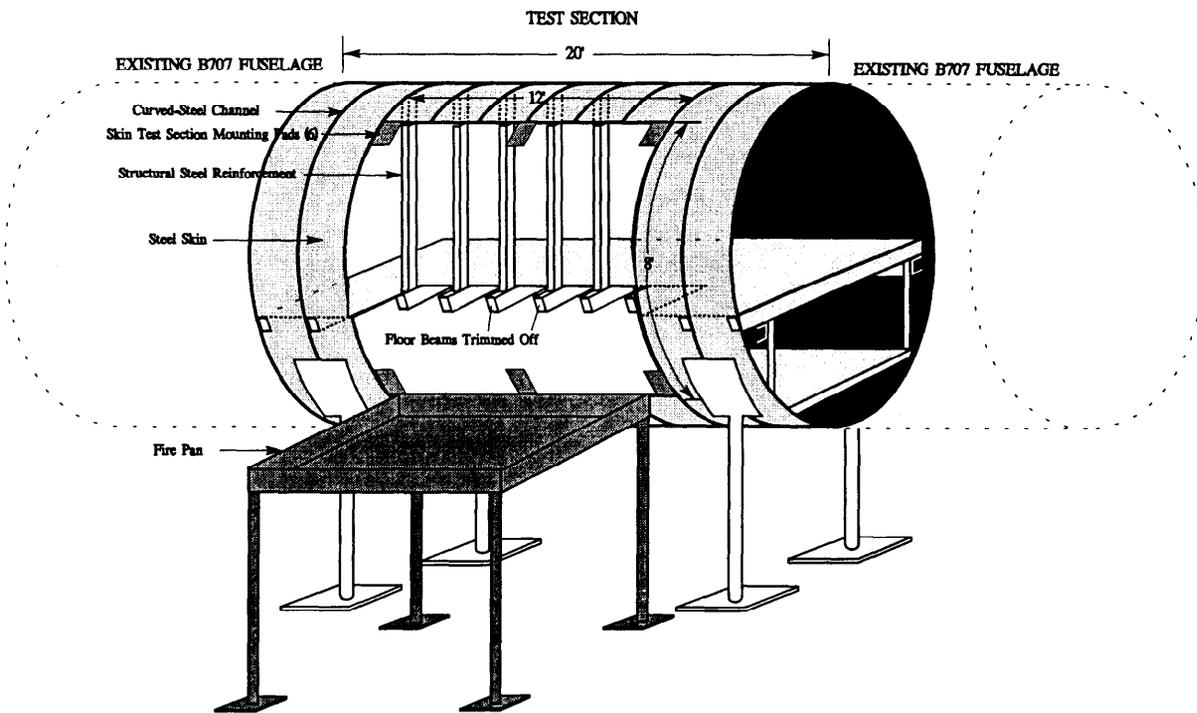
FIGURE 24. MODIFIED TEST RIG USED TO EVALUATE ACTUAL SKIN SECTION

The heat-treated OPF was chosen for these tests since it could be considered a drop-in (direct) replacement for the current insulation systems, and it exhibited favorable burnthrough resistance qualities during full-scale tests. In order to evaluate the material under realistic conditions, the steel test rig was modified considerably. First, large sections of 5 of the 11 curved-steel channels were removed from the area that faced the fuel fire to provide an opening. This area was then reinforced from the inside and also around the perimeter to prevent collapse of the structure (figure 24). Next, steel mounting pads were attached at six points around the periphery of the opening in order to accept an actual fuselage section (figures 24 and 25).
