ORCON CORPORATION
1570 Atlantic Street
Union City, CA 94587-3299
510-489-8100
Fax: 510-489-6436

Subject: Comments regarding FAA NPRM, 14 CFR Part 25 et al., "Improved Flammability Standards for Thermal/Acoustic Materials Used in Transport Category Airplanes; Proposed Rule", issue date, September 20, 2000.

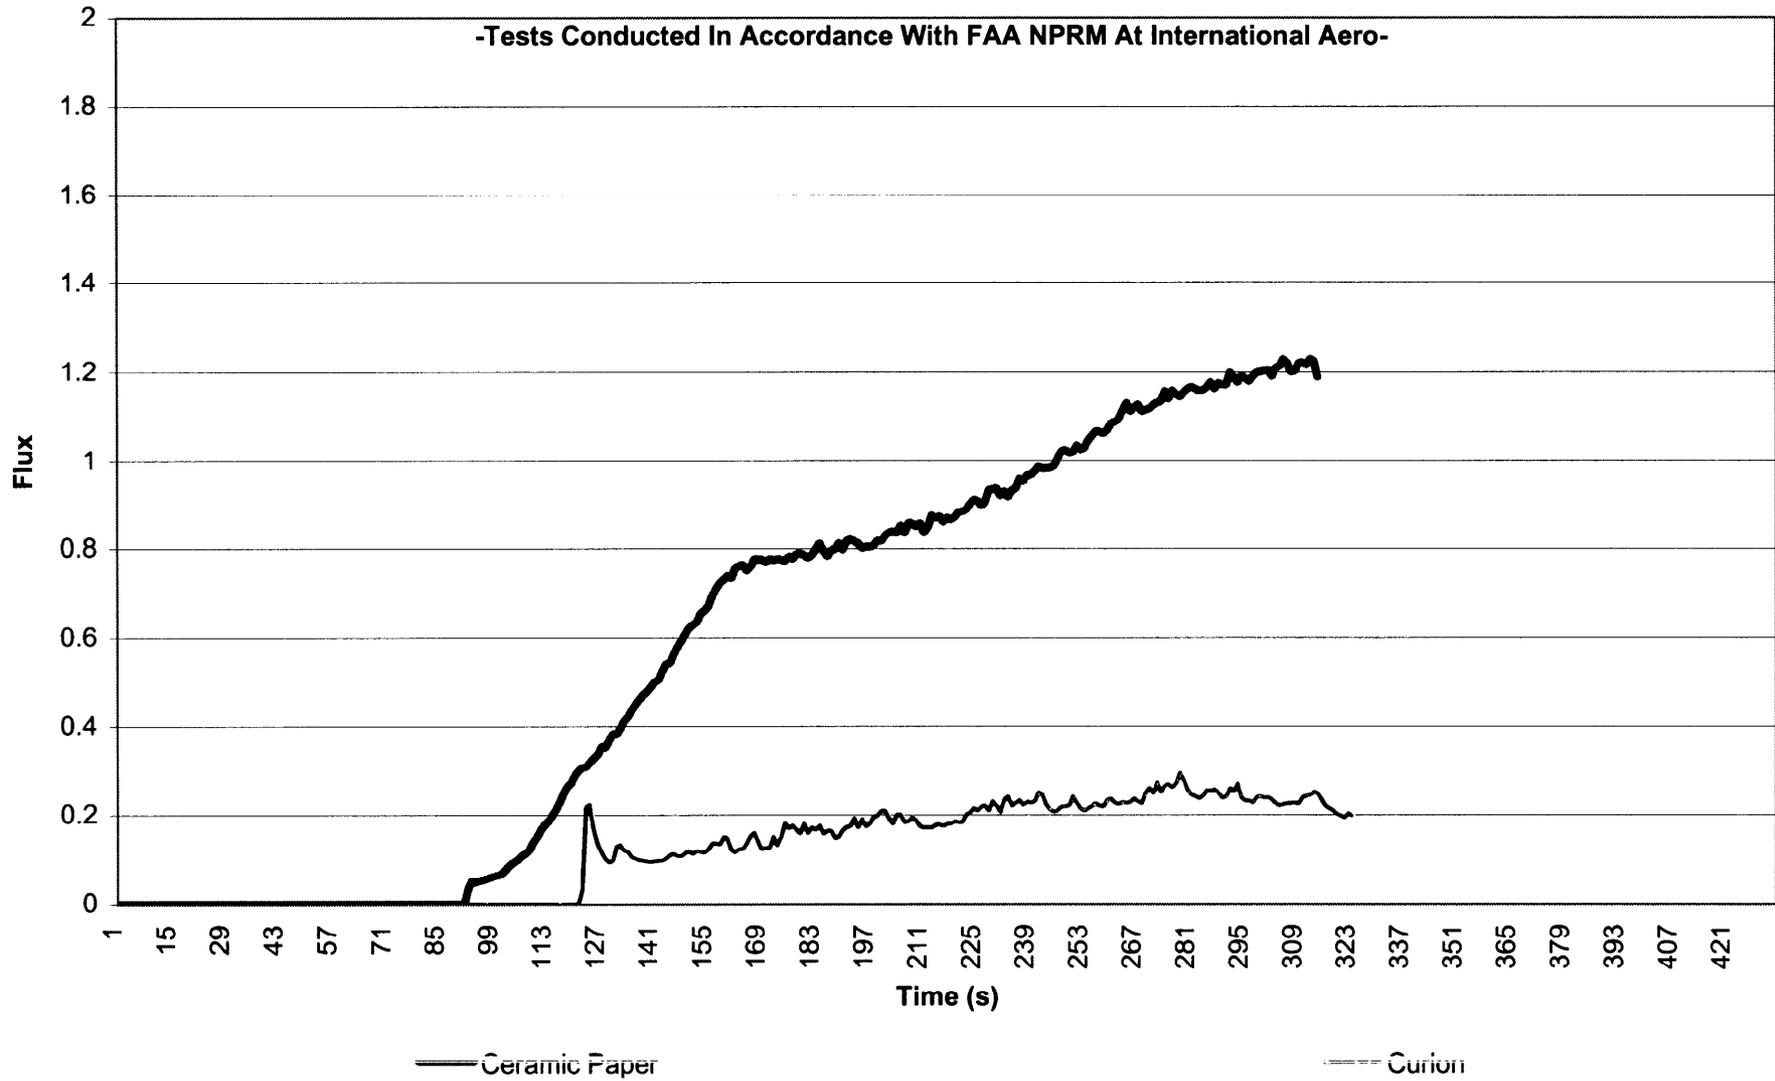
Burnthrough Performance of Refractories (Ceramic) vs. High Performance Insulation (Curlon®)

- 3.4.1 We recommend reduction of allowable heat flux to 0.5 BTU ft²/sec. to curtail the chance of excessive heat buildup and possible flashover. Allowable heat flux of 2.0 BTU FT²/sec appears to be excessive as it allows substantial heat buildup in the rig area backface. The attached curves show a typical heat flux buildup with non-insulative burnthrough material (ceramic) vs. minimal heat buildup with insulative burnthrough protection materials (Curlon).
