# ***CCMTA Load Security Research Project***

**Report # 12**

## **TESTS ON METHODS OF SECUREMENT FOR LARGE BOULDERS**

October 1997

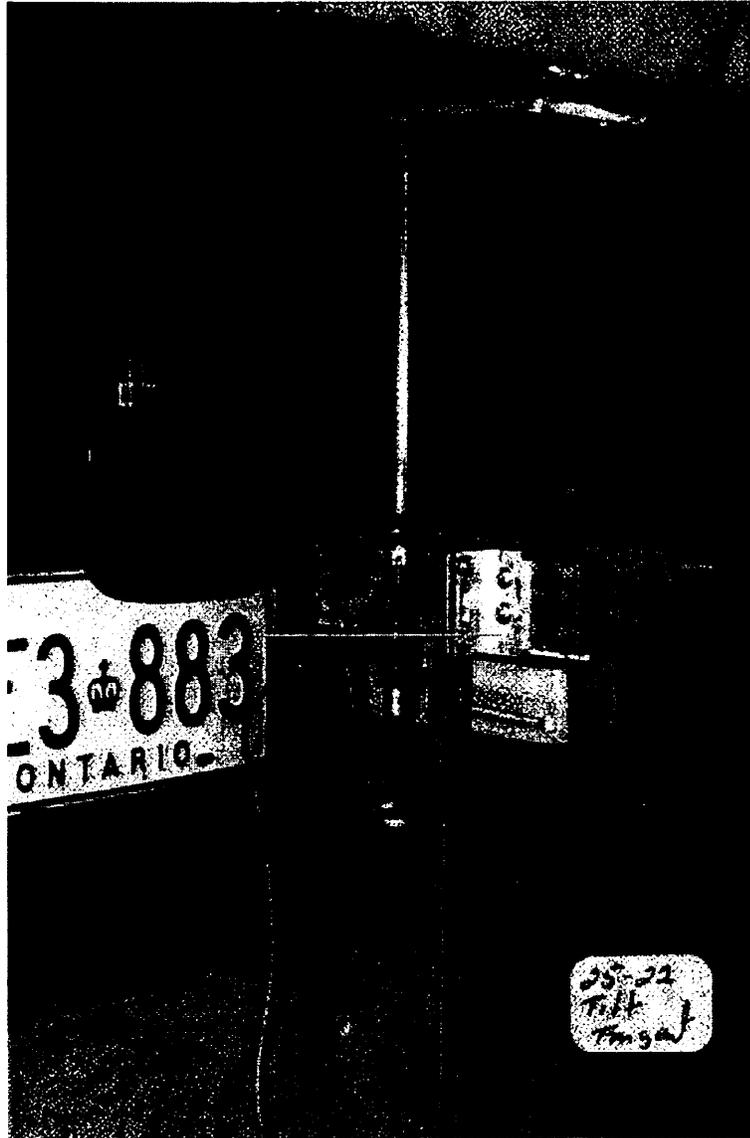
**Figure 6/ Tilt Angle Tangent Device**

A mechanical device was developed for this test that transformed the tangent of the tilt angle of the deck into a linear motion, which was then measured using a pull-cord transducer. This device is shown in Figure 6. A second pull-cord transducer was modified with a reverse push rod assembly to measure motion of the boulder on the outstroke. It was attached to the bed with the rod contacting the boulder. Each tiedown was secured to the truck deck with a three link piece of chain, where the middle link was strain gauged with a four-arm bridge. These links were individually calibrated, and served as load cells.

Data from these instruments was captured into a PC-based data acquisition system at a sample rate of 50 Hz per channel. This sample rate provided adequate definition to measure forces in the tiedowns and identify first movement of the boulder. Two video cameras were also used as part of data capture. A mini camera was mounted on a boom overlooking the boulder, as illustrated in Figure 4, and the second camera was focussed on a digital readout of the tangent of the tilt angle. Its image was inset in the

screen image from the overhead camera, which provided a direct visual readout of the equivalent external acceleration at which a boulder moved.
